RECALL CAMPAIGN BULLETIN

NTB13-032b

VOLUNTARY SAFETY RECALL CAMPAIGN 2013 SENTRA OCS SENSORS

CAMPAIGN ID #: PC213
NHTSA #: 13V-069
APPLIED VEHICLES: 2013 Sentra (B17)

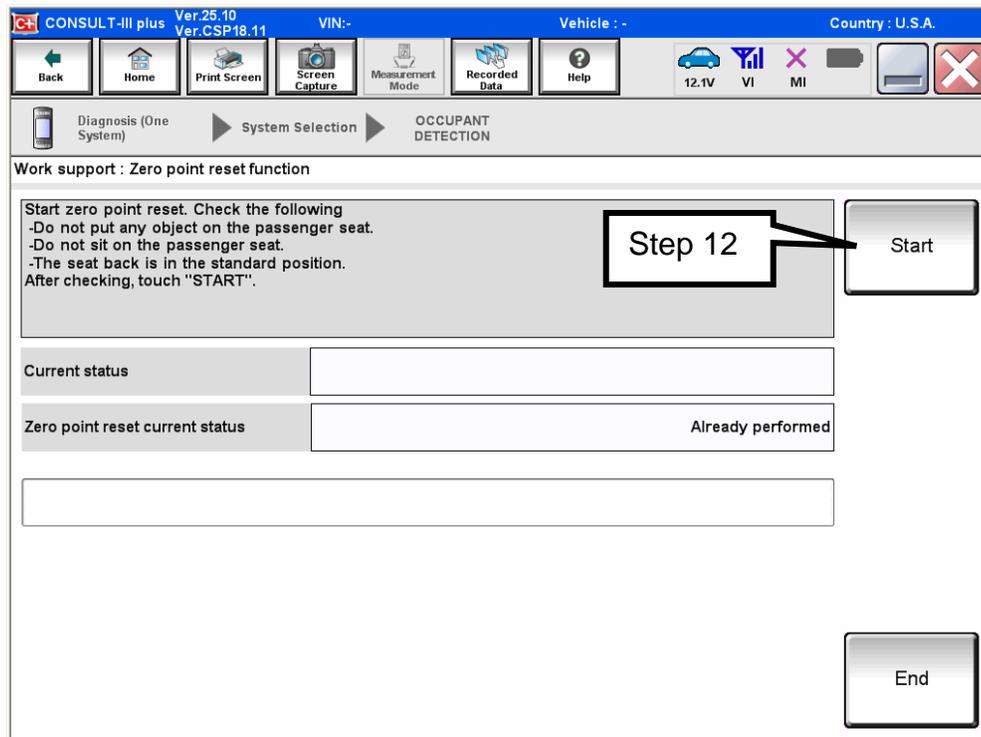
Figure Z5

NOTE: Zero Point Reset must be performed even if:

- “Current status” indicates “Completed”, or
- “Zero point reset current status” indicates “Already performed”

13. Wait for Zero Point Function to complete.

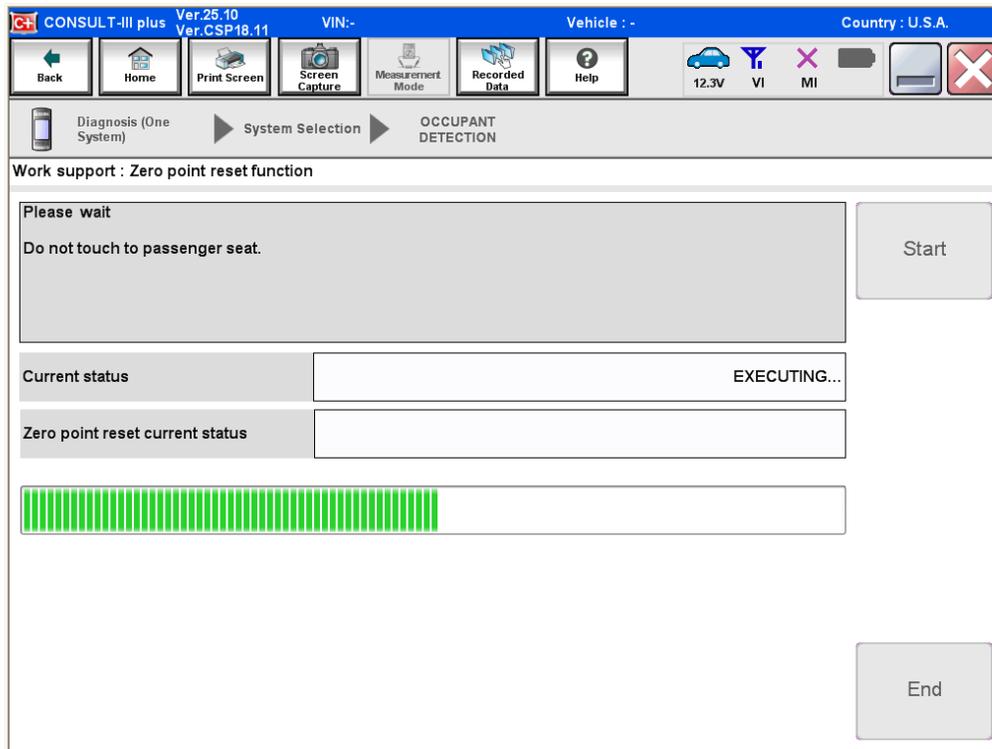
Figure Z6

If Zero Point Reset will not complete:

- a. Turn the ignition OFF.
- b. Make sure all electrical connectors under the seat are **securely connected**.
 - Body harness to seat harness.
 - OCS sensors
 - OCS Control Unit.
- c. Try Zero Point Rest again.
- b. If it still will not complete, an installation process or step was not followed exactly as specified.
 - Recheck / re-perform the OCS sensor installation process.
 - **Pay special attention to the 14 mm nut torque (steps 29 & 30 on pages 19 & 20).**
