SAFETY RECALL BULLETIN

SUBJECT:			No: SR-13-009REVII
2008-2013 LANCER EVOLUTION CLUTCH MASTER CYLINDER – SAFETY RECALL CAMPAIGN – REVISED			DATE: April, 2014
			MODEL: 2008 – 2013 Lancer Evolution
CIRCULATE TO:	<input checked="" type="checkbox"/> GENERAL MANAGER	<input checked="" type="checkbox"/> PARTS MANAGER	<input checked="" type="checkbox"/> TECHNICIAN
<input checked="" type="checkbox"/> SERVICE ADVISOR	<input checked="" type="checkbox"/> SERVICE MANAGER	<input checked="" type="checkbox"/> WARRANTY PROCESSOR	<input checked="" type="checkbox"/> SALES MANAGER

This bulletin supercedes SR-13-009REV, issued December, 2013 to add an inspection only campaign operation. See the Inspection Procedure Section for additional details. Changes are italicized and indicated by ◀.

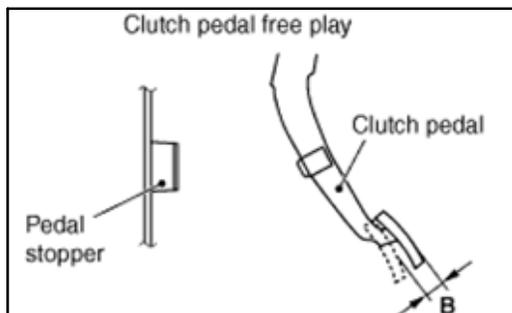
8. Once reinstalled, measure the clutch pedal free play and clutch pedal height when the clutch is disengaged.
 - a. Clutch pedal free play, measurement "B", should be between 0.16 – 0.35 in (4 – 9 mm). If measurement "B" is not within the provided range, ensure the clutch pedal spherical pin is properly connected to the clutch master cylinder piston rod and measure again.

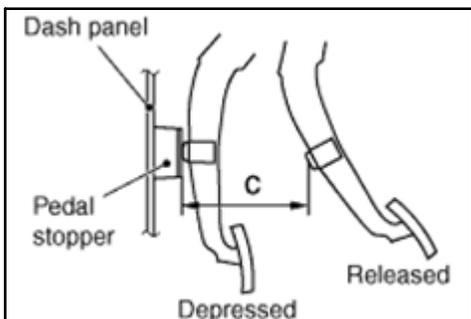
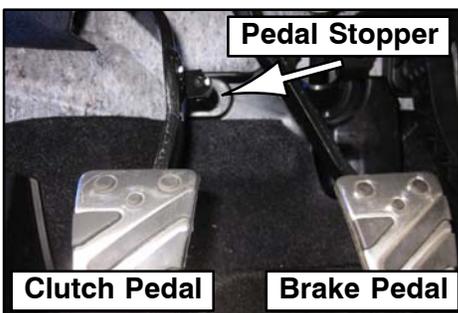
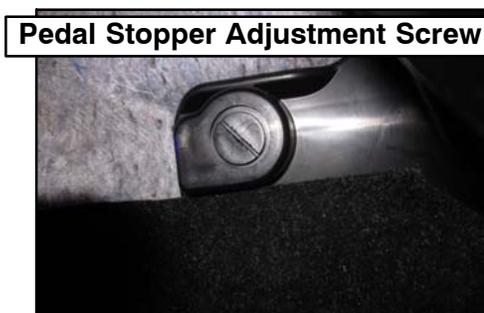
- b. Clutch pedal height, measurement “C”, should be between 4.33 – 4.56 in (110 – 116 mm). If measurement “C” is not within the provided range, you may rotate the pedal stopper adjustment screw to adjust the clutch pedal height.

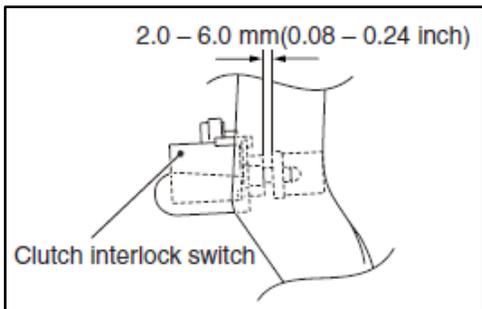
9. Check the switch components and ensure they are set to the following factory specifications:
- a. Clutch interlock switch, measured while the pedal is completely depressed. You may rotate the pedal stopper adjustment screw (as shown in Step 8b) to adjust the height of the clutch interlock switch when the pedal is completely depressed.

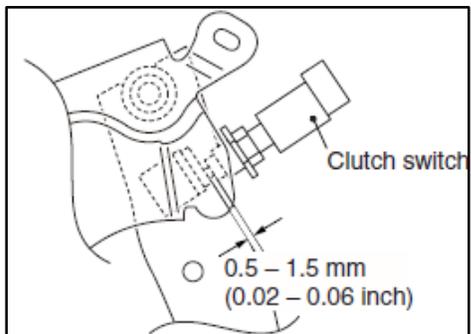
- b. Clutch switch, measured while the pedal is completely released. You may adjust the clutch switch by loosening the lock nut and rotating the body of the clutch switch.

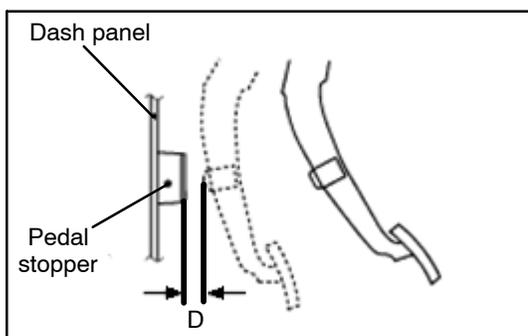
15. Complete one final check to the clutch pedal. Ensure the gap between the clutch pedal and pedal stopper at the point of clutch disengagement, measurement "D", is greater than 0.53 in. (13.5mm). If not within specification, diagnose per the applicable model year Lancer Evolution Service Manual – Group 21: Clutch > On-Vehicle Service > Clutch Pedal Check.
