RECALL CAMPAIGN BULLETIN

NTB14-027

VOLUNTARY SAFETY RECALL CAMPAIGN OCCUPANT CLASSIFICATION SYSTEM MODULE REPROGRAMMING

CAMPAIGN ID #: R1405

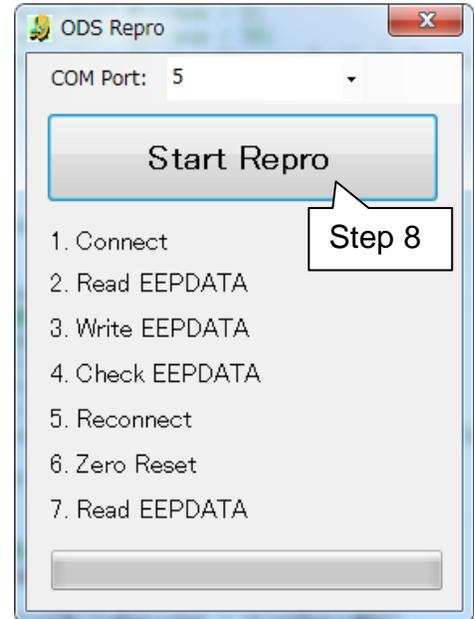
Figure 3

NOTE: If the error message “an error occurred on connection” displays:

- a. Disconnect the J-51594 OCS reprogramming cable, both ends.
- b. Reconnect the cable; make sure it is securely connected at both ends.

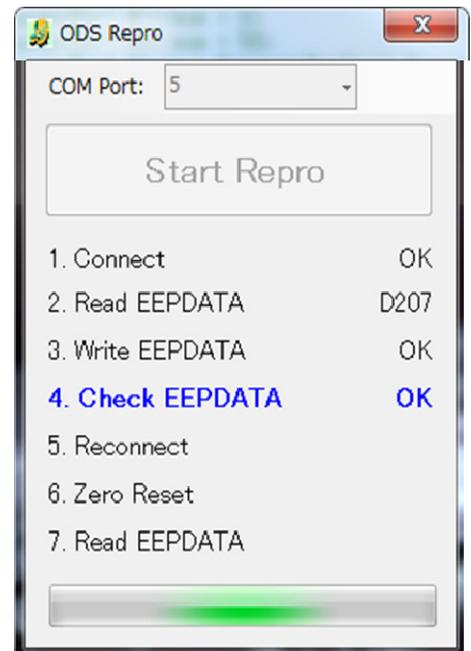
Figure 5

- Items 1 through 4 will likely complete quickly.
- If the OCS reprogramming stops (displays NG) at item 1,2,3 or 4, refer to Figures 10 through 13 on pages 8 and 9.

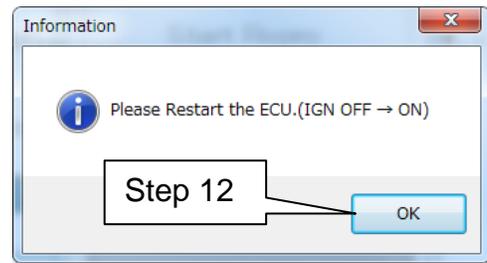
Figure 6

- After selecting OK in Figure 6, the OCS reprogramming will likely complete items 5 through 7 quickly (see "Complete" screen, Figure 8 below).
- If the OCS reprogramming stops (displays NG) at item 5, 6 or 7, refer to Figures 13 through 15 on pages 10 and 11.

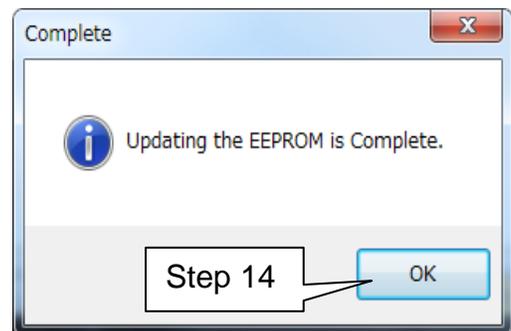
Figure 8

13 When this screen displays (Figure 8), OCS reprogramming is complete.
