**NUMBER:** 21-013-14 REV. A

**GROUP:** Transmission and Transfer Case

N28 Transmission Oil Cooler Tube Interim Repair

2012-2013 (JK) Wrangler

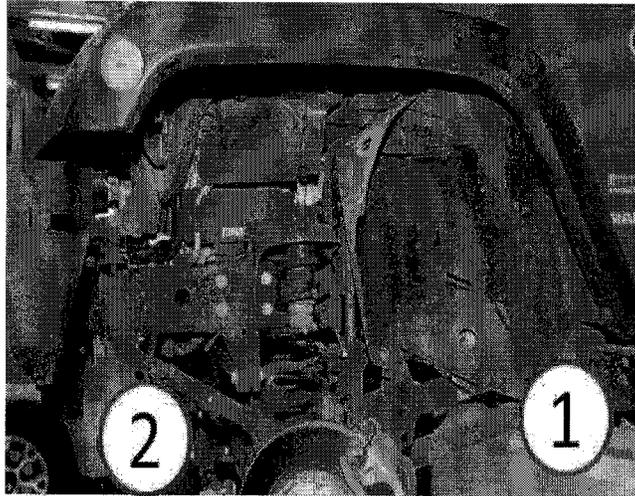
**Fig. 1 Splash Shield**

1. Remove and save the left front wheel and tire assembly.
2. Partially remove the left front wheel liner to gain access to the transmission oil cooler tube and power steering return tube (Fig.1).
