**TECHNICAL INSTRUCTIONS**  
**FOR**  
**VOLANTARY SAFETY RECALL CAMPAIGN SET15B**  
**FRONT PILLAR GARNISH LH TOP CLIP REPLACEMENT**  
**CERTAIN 2015 MODEL YEAR SIENNA**

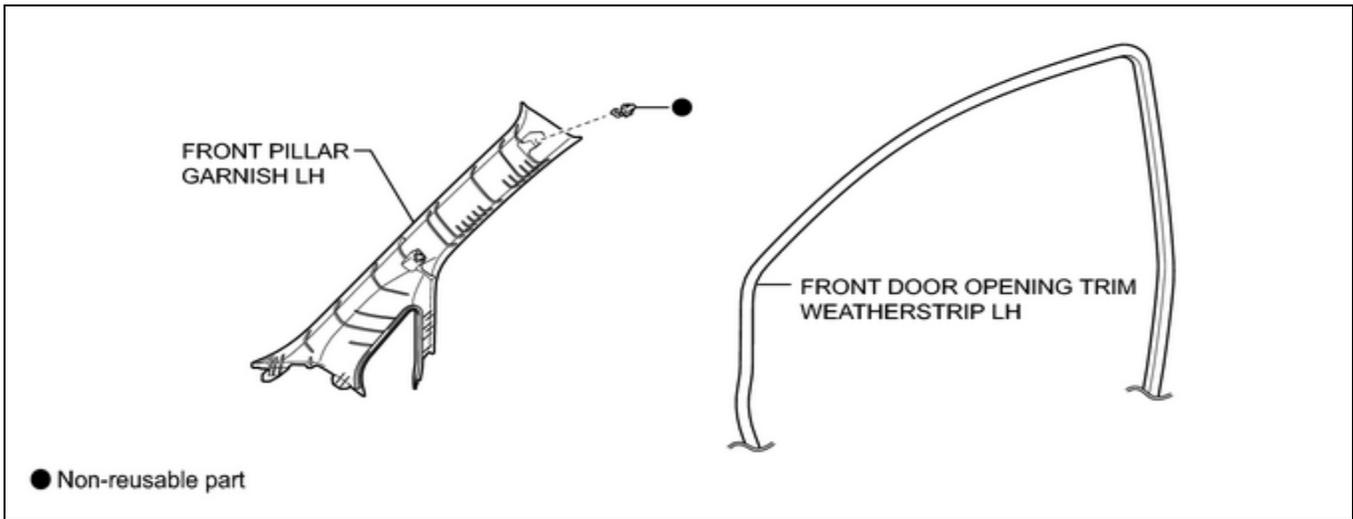
## V. COMPONENTS

SET either installed, or sold to dealers to install, accessory overhead entertainment systems for 2015 Toyota Sienna. The installation instructions associated with those systems stated that the A-pillar garnish clip could be reused as part of the installation. The installation instructions should have indicated that the A-pillar garnish clip should be replaced and not re-used. As a result, the A-pillar garnish clip may not have been replaced. The A-pillar garnish is in the deployment path of a side curtain airbag. If the A-pillar garnish clip has been damaged during the installation of the overhead entertainment system and is reused, there is the potential for the A-pillar garnish to become detached during a curtain airbag deployment and cause injury to an occupant.
