ZOOM-ZOOM

DATE: November 2015

SUBJECT: **Driver Air Bag Inflator Final Repair - Safety Recall 8215F**

Driver Air Bag Inflator Final Repair - Safety Recall 8215F NHTSA Campaign No. 15V-382

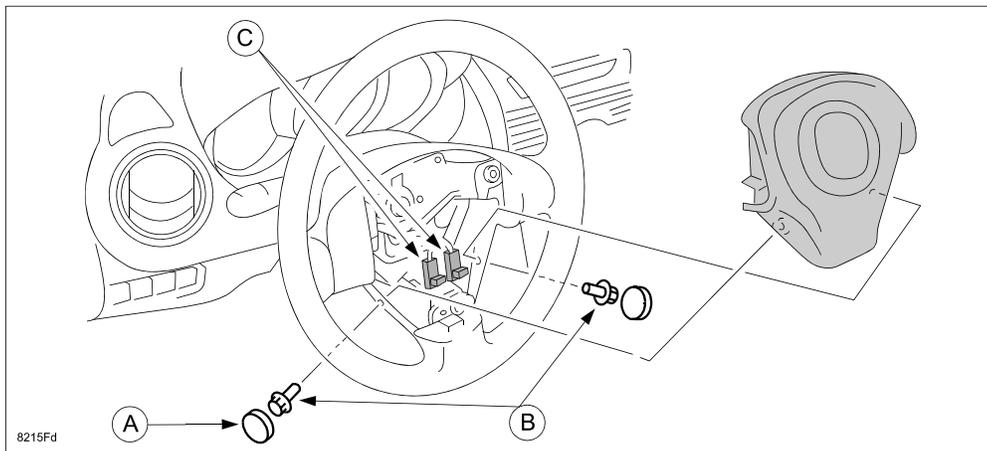
1. Turn the ignition switch to the LOCK position.
2. Record the customer's preset radio stations.
3. Disconnect the negative battery cable and wait for one (1) minute or more.
4. Remove the driver-side air bag module.
 - a. Remove the covers (A).
 - b. Remove the bolts (B).
 - c. Disconnect the connectors (C). Using a flathead screwdriver, pry out the connector's stopper plate.

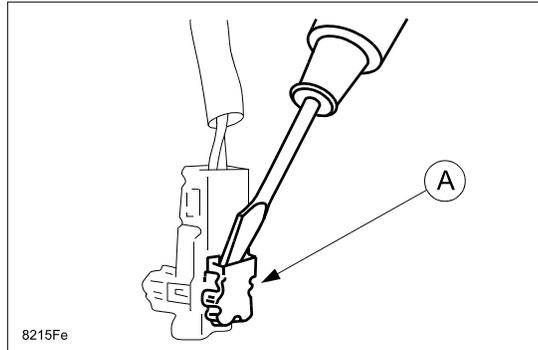
- Be careful when prying out the stopper plate (A). Otherwise, damage to the stopper plate could occur. Or if it pops off and is lost, it is not available as a separate part.
- The stopper plate must be pryed up before disconnecting the connector. Otherwise, the connector could be damaged if trying to disconnect it with the stopper plate engaged.
- Use extreme care when disconnecting the connector. Otherwise, damage to the connector could occur.

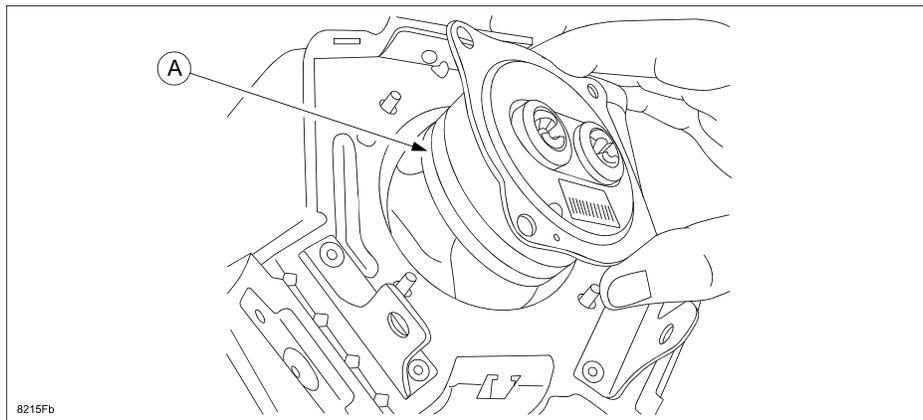
1. Set the airbag face down onto a surface that will not scratch or damage the airbag face.
2. Remove the 4 nuts, then remove the inflator (A) from the air bag body. Discard the original nuts.

NOTE: DO NOT use an impact wrench.

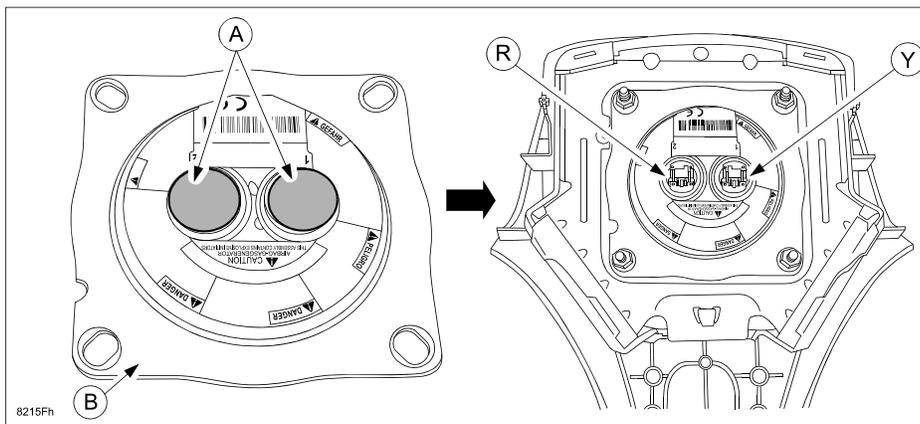
4. Peel off the dust-proof seal and confirm the two terminals of red (R) and yellow (Y) layouts correctly as shown.

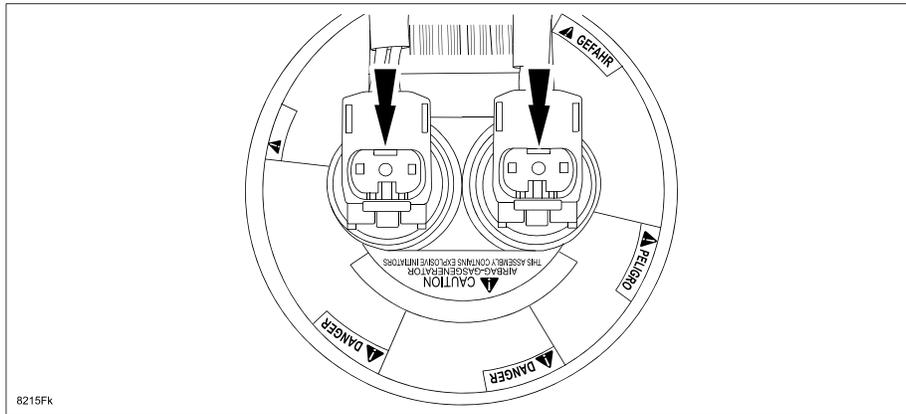
1. Install the driver-side air bag module.
 - a. Re-connect the connectors (A) to air bag module, securely locking the connectors by depressing the stoppers on the connector back.

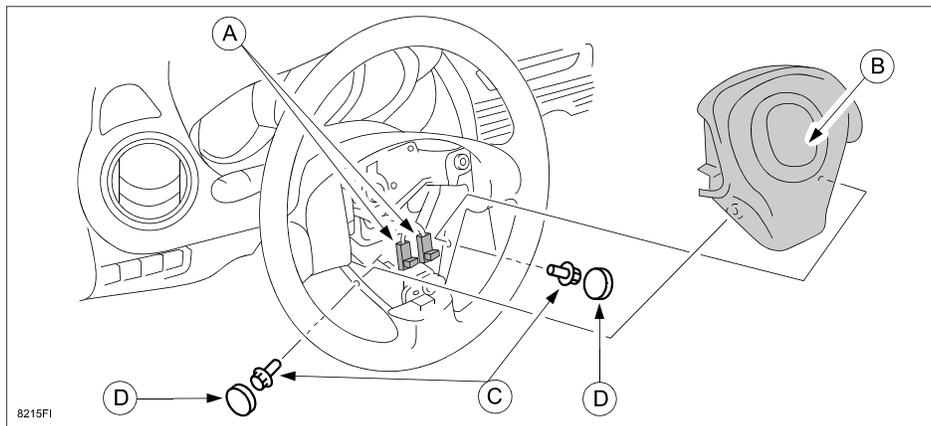
- b. Install the air bag module (B).
 - c. Install the bolts (C).
 - Tightening Torque: 78 - 112 in-lbf. {8.9 - 12.7 Nm}**
 - d. Install the covers (D).

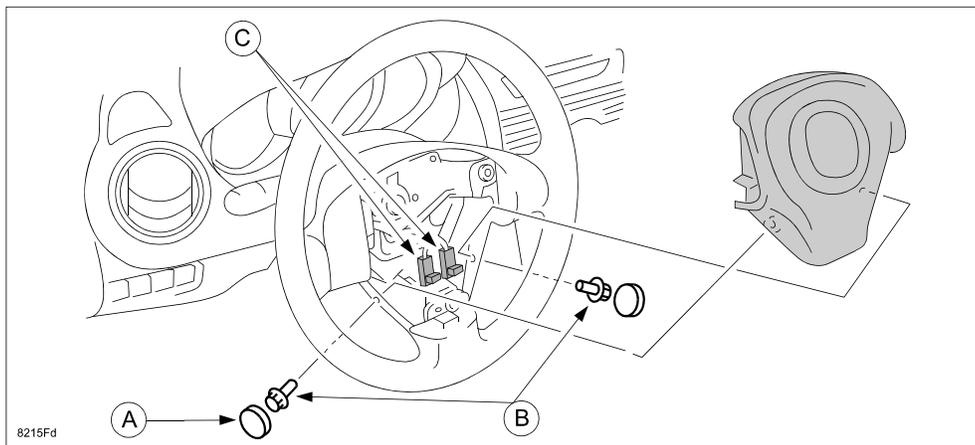
- c. Disconnect the connectors (C). Using a flathead screwdriver, pry out the connector's stopper plate.

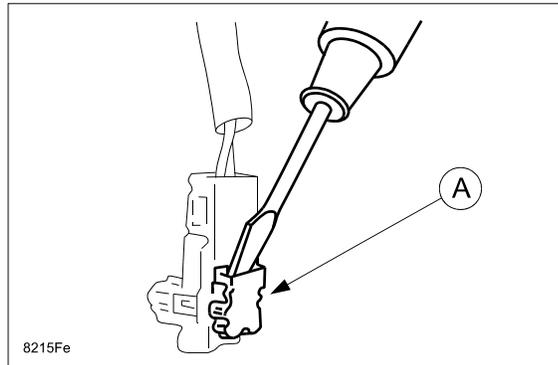
- Be careful when prying out the stopper plate (A). Otherwise, damage to the stopper plate could occur. Or if it pops off and is lost, it is not available as a separate part.
- The stopper plate must be pryed up before disconnecting the connector. Otherwise, the connector could be damaged if trying to disconnect it with the stopper plate engaged.
- Use extreme care when disconnecting the connector. Otherwise, damage to the connector could occur.

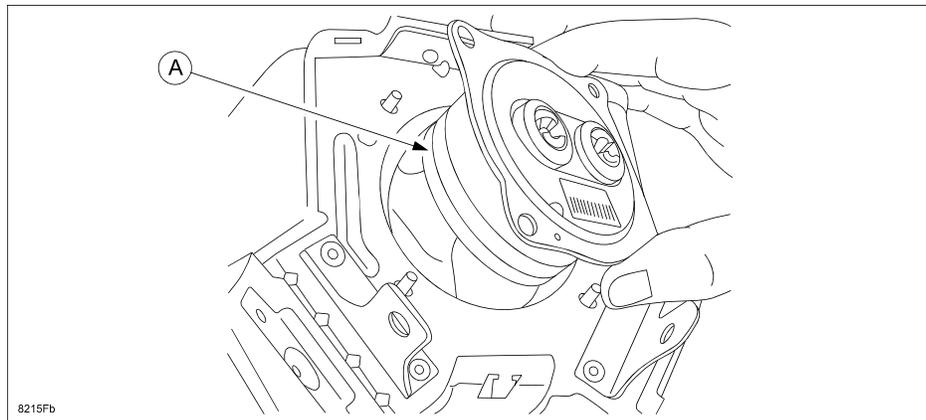
1. Set the airbag face down onto a surface that will not scratch or damage the airbag face.
2. Remove the 4 nuts, then remove the inflator (A) from the air bag body. Discard the original nuts.

NOTE: DO NOT use an impact wrench.

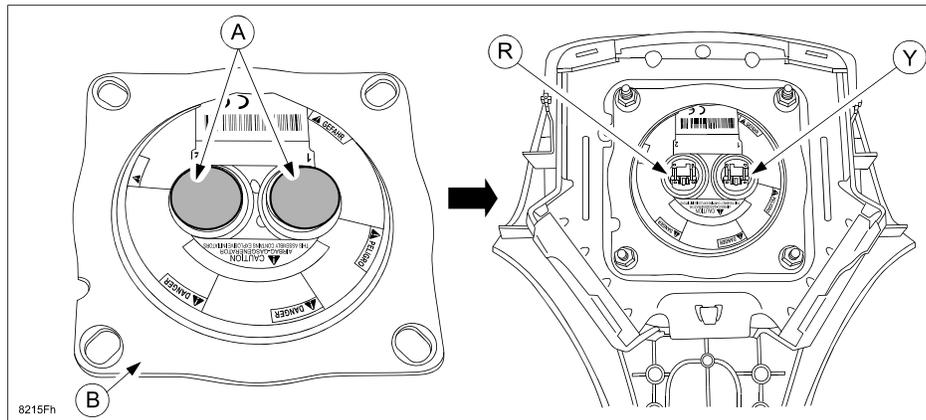
3. Peel off the dust-proof seal and confirm the two terminals of red (R) and yellow (Y) layouts correctly as shown.
