RECALL CAMPAIGN BULLETIN

NTB14-085a

VOLUNTARY SAFETY RECALL CAMPAIGN 2014 FRONTIER CREW CAB REAR SEATBELT ANCHOR WELD NUT

CAMPAIGN ID #: PC309
NHTSA #: 14V-418
APPLIED VEHICLES: 2014 Frontier Crew Cab (D40)

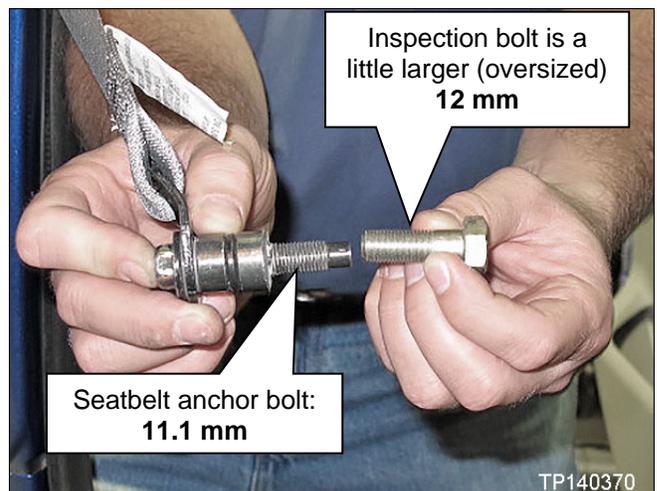
Figure 4

3. Insert the inspection bolt into the seatbelt lower anchor bolt hole.
4. **By hand only** – attempt to thread the inspection bolt into the weld nut.
 - Make at least three attempts to thread the bolt into the nut.
 - The left side (driver side) is shown.
 - **Make sure to perform this inspection on both sides (the passenger side and the driver side).**

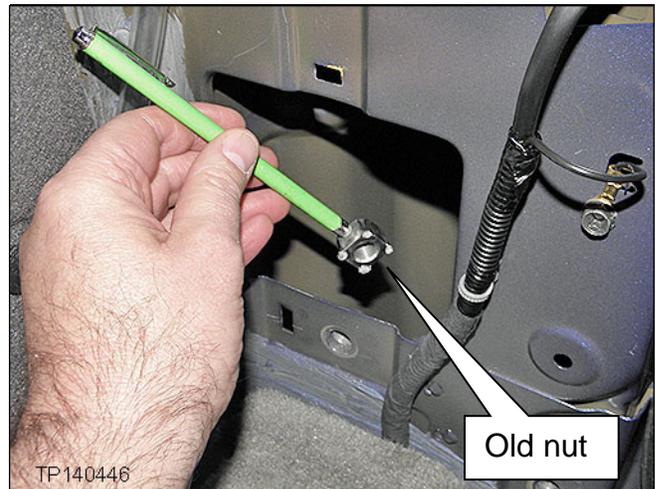
Figure 39

- Only the nut should break loose from the plate. The original plate should remain attached to the panel.
- It is possible that the original plate will fall loose when the bolt is removed. It is OK for the plate to come loose. If it does come loose, make sure it is also removed from the vehicle.

22. Remove the old nut.
