Technical Service Bulletin

16-01-011

Elantra (MD/UD)

**YAW RATE/"G" SENSOR INSPECTION AND HECU UPDATE
(RECALL CAMPAIGN 137)**

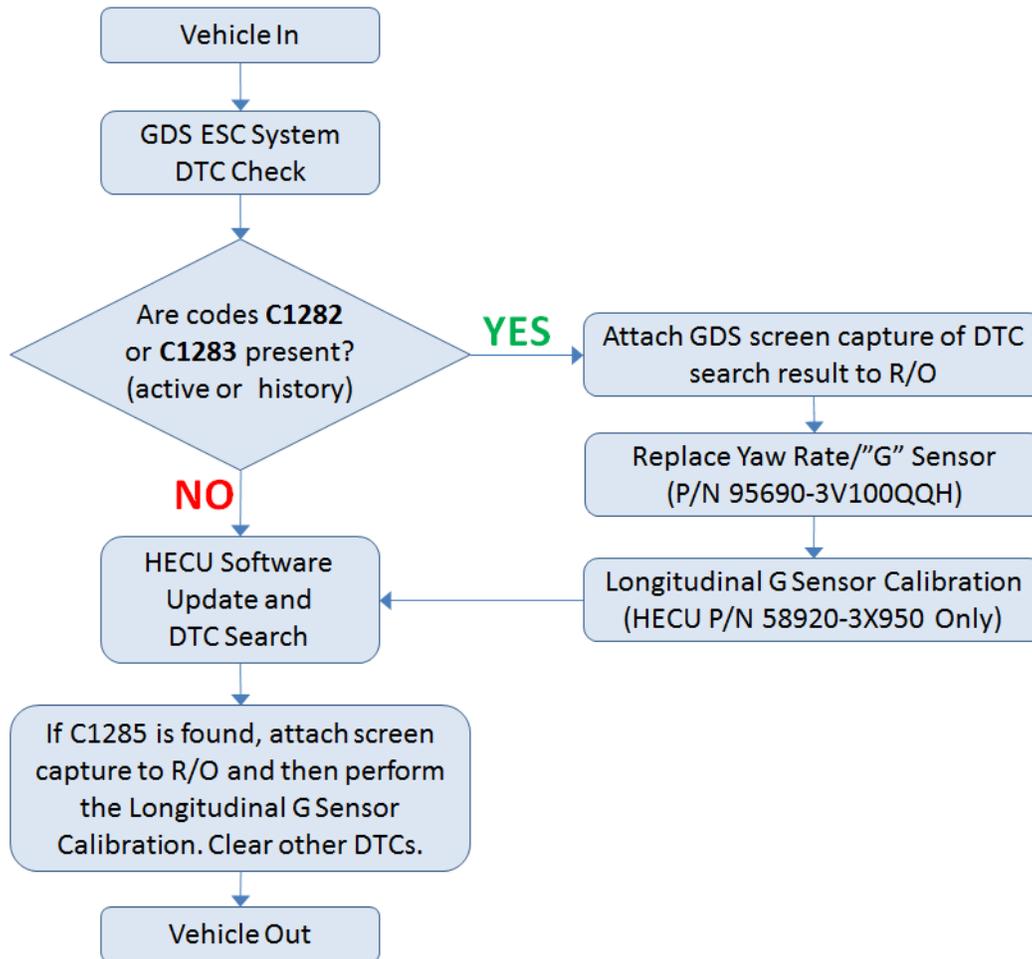
1. Inadvertent ESC system intervention,
2. Illumination of the "ESC" indicator lamp in the instrument cluster.
3. Diagnostic codes C1282 and/or C1283 (for the yaw sensor) stored in the ESC Control Module.

Follow the flow chart below.

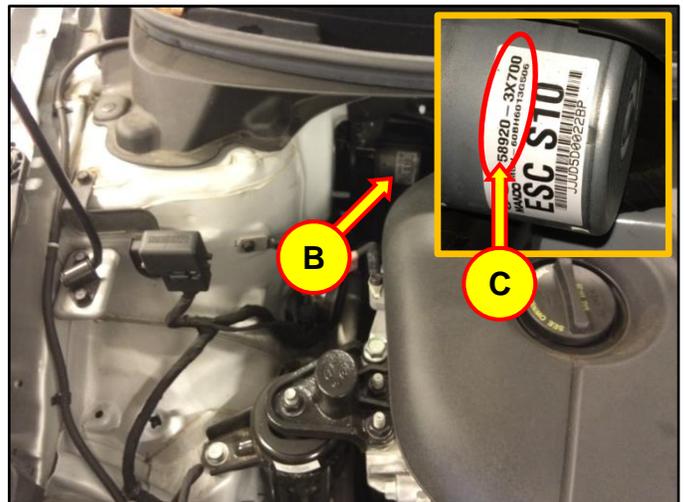
- 2a. If codes **C1282** or **C1283** are found either as active or history;
1. Attach a GDS screen capture of the Fault Code Search screen, clearly showing the VIN and the C1282 and/or C1283 DTCs found.

2. Replace the Yaw Rate/"G" Sensor (A) according to the applicable workshop manual.
 - a. Locate the HECU (B) on the passenger side of the engine compartment and note the part number (C).

- b. If the part number is **58920-3X950**, perform the Longitudinal G Sensor Calibration in the GDS.
 - c. If the part number is **58920-3X650** or **58920-3X700**, it is **not** necessary to perform the Longitudinal G Sensor Calibration.

Yaw Rate/"G" Sensor tightening torque:
 3.9 ~ 5.9 N.m (0.4 ~ 0.6 kgf.m, 2.9 ~ 4.3 ft-lb,
 34.8 ~ 51.6 in-lb)
