**SB-10054704-3330****FORD:**

2013 F-150

**ISSUE**

Some 2013 F-150 vehicles equipped with a 3.5L Gasoline Turbocharged Direct Injection (GTDI) engine and with an engine build date of 4/1/2013 and through 9/15/2013, may exhibit a shudder/runs rough concern at hot idle during stop-and-go driving and/or diagnostic trouble code (DTC) P0015 stored. The malfunction indicator lamp (MIL) may or may not be illuminated.

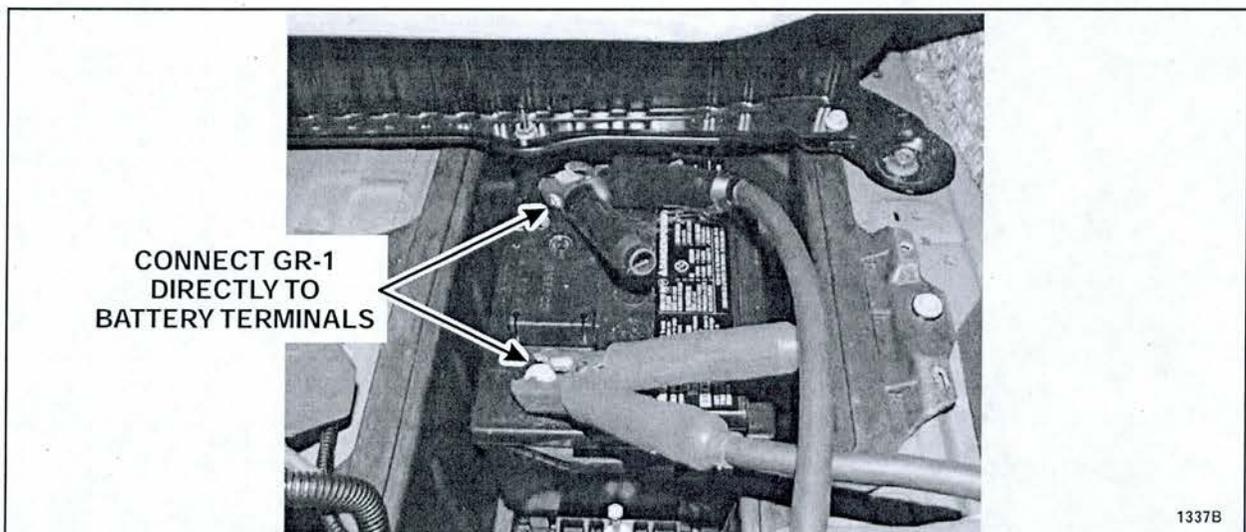
FIGURE 1

3. **NOTE:** The Rotunda GR-1 tester/charger **must be connected to battery terminals only**, cables must be removed and no other connections such as body ground can be in the circuit during testing. See Figure 1.
