Michael A. Berardi
 Director
 Service Engineering Operations
 Ford Customer Service Division

September 16, 2014

SUBJECT: **Regional Program 13R01 – Supplement #3**
 Certain 2005 through 2011 Model Year Crown Victoria, Grand Marquis, and Town Car
 Vehicles Not Covered Under Safety Recall 13S08
 Steering Column Shaft

REF: **Regional Program 13R01 – Supplement #2**
 Steering Column Shaft dated February 21, 2014

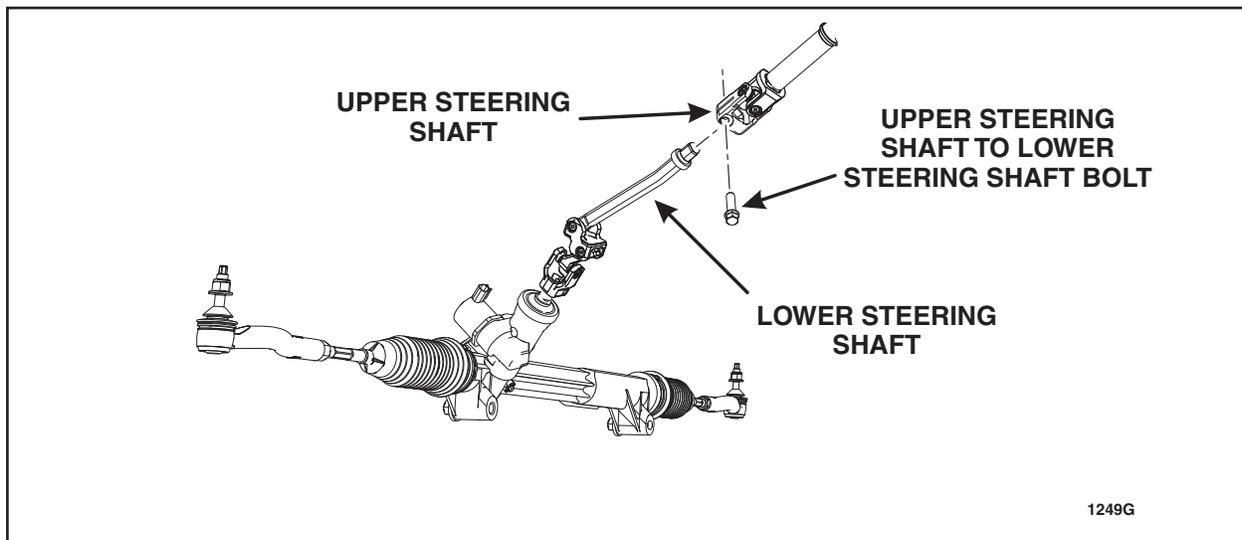
FIGURE 1

1. Inspect the lower steering shaft joints for binding or seizure, as follows:
 - a. Use a steering wheel holding device (such as Hunter® 28-75-1 or equivalent) to hold the steering wheel in the straight-ahead position.
 - b. Remove and discard the upper steering shaft to lower steering shaft bolt and disconnect the lower steering shaft. See Figure 1.

- c. Exercise the upper portion of the lower steering shaft throughout its range of motion. See Figure 2, on Page 2.
- d. If the lower steering shaft does not move freely and without binding, **it fails inspection.**
