# Program Bulletin

## SB-10058721-3804

### CUSTOMER SATISFACTION PROGRAM

**SUBJECT:** Brake and Fuel Pipe Bracket Contacting Fuel Feed Pipe  
**MODELS:** 2014 Chevrolet Caprice Police Patrol Vehicle (PPV)  
Equipped with 3.6L Engine (RPO LFX)

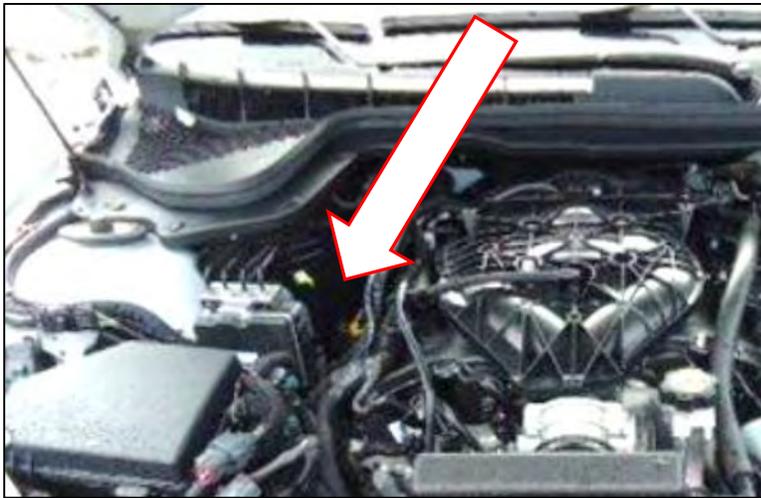
4225056

1. Open the hood and locate the brake and fuel line bundle on the passenger side of the engine bay just below the EBCM (Electronic Brake Control Module).

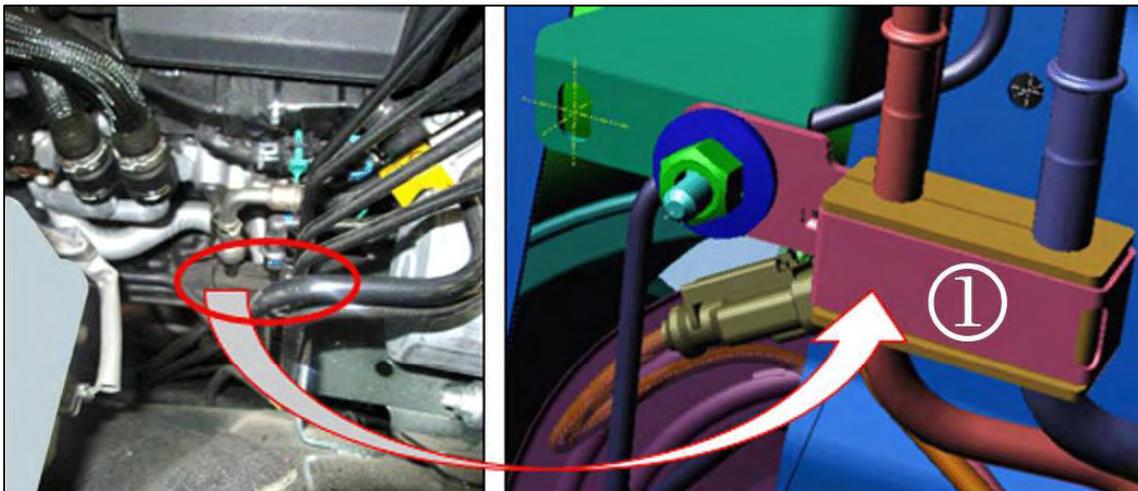
4225064

2. Identify the fuel line mounting bracket (1) located behind and below the EBCM.
