**SB-10056901-7043****FORD:**

2011-2015 Explorer

This article supersedes TSB 12-12-4 to update the vehicle model years and Service Procedure.

**ISSUE**

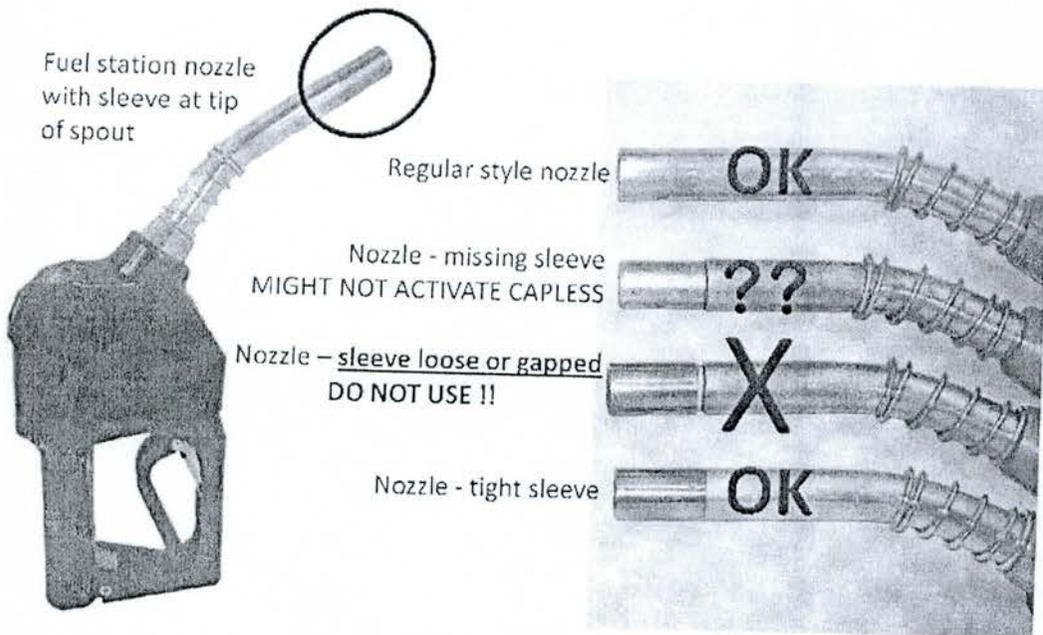
INSPECTING THE FUEL STATION FUEL FILLER NOZZLE BEFORE RE-FUELING

Before attempting to re-fuel your vehicle you should inspect the nozzle tip. If the nozzle sleeve is missing, the fuel station nozzle may not be able to activate the Easy Fuel capless flapper door. If the nozzle *sleeve is loose or gapped* out of place, *the nozzle may become trapped inside the capless device* after insertion.
