Michael A. Berardi
 Director
 Service Engineering Operations
 Ford Customer Service Division

April 5, 2016

SUBJECT: **Safety Recall 15S34 – Supplement #2**
 Certain 2010-2011 Model Year Fusion and Milan Vehicles Equipped with 2.5L or 3.0L Engines
 Fuel Tank and Canister Purge Valve Inspection and Repair

NEW ! CERTAIN 2010-2011 MODEL YEAR FUSION AND MILAN VEHICLES EQUIPPED WITH 2.5L OR 3.0L ENGINES — FUEL TANK INSPECTION AND REPAIR

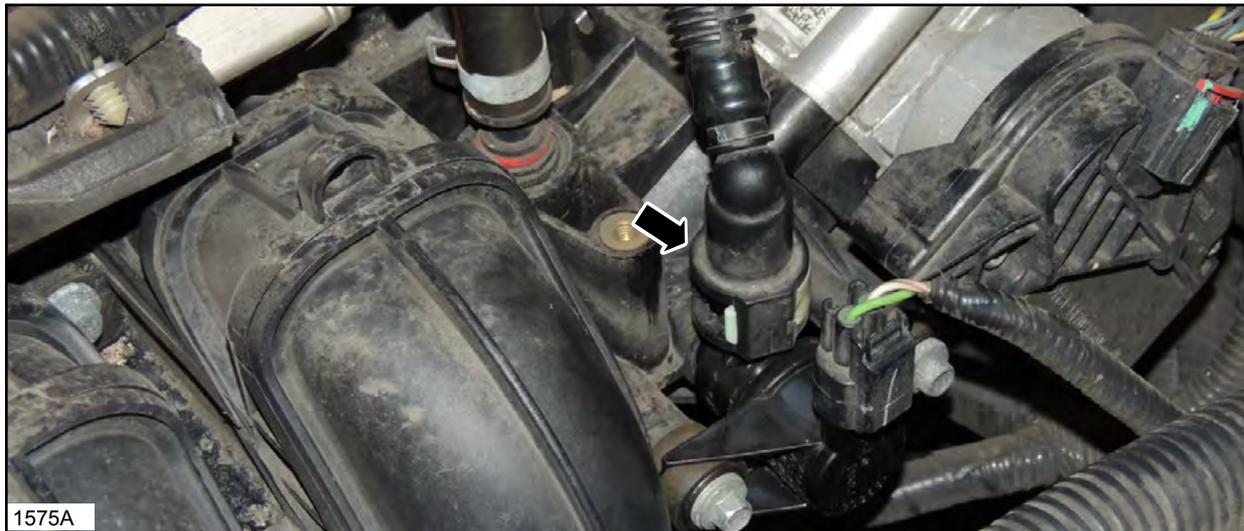
FIGURE 6

2. Disconnect the vapor tube-to-CPV quick connect coupling. Please follow the WSM procedures in Section 310-00. See Figure 6.

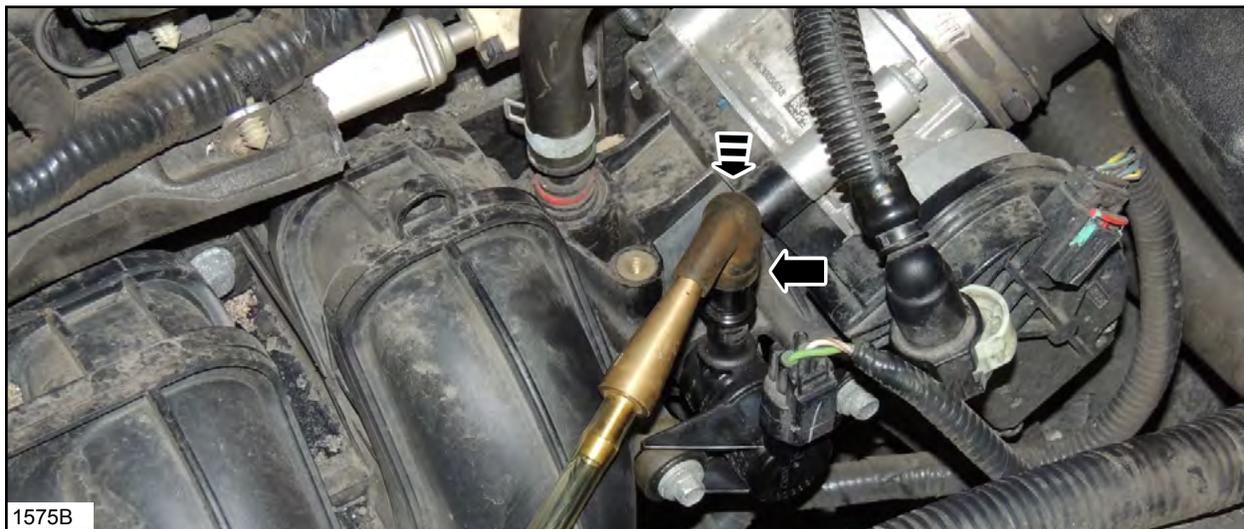
FIGURE 7

3. Using suitable adapters, connect the VACUTEC® Smoke Machine Fuel Evaporative Emission System Tester or equivalent to the port on the CPV. See Figure 7.

4. With the ignition in the "OFF" position, test the CPV for leaks by applying pressure from the tester and monitoring for air flow on the gauge. A good CPV will register a leak rate of less than 0.020".
