Recall Bulletin

PRODUCT SAFETY RECALL

SUBJECT: Heated Windshield Washer Module Short Circuit – Add Wire Harness

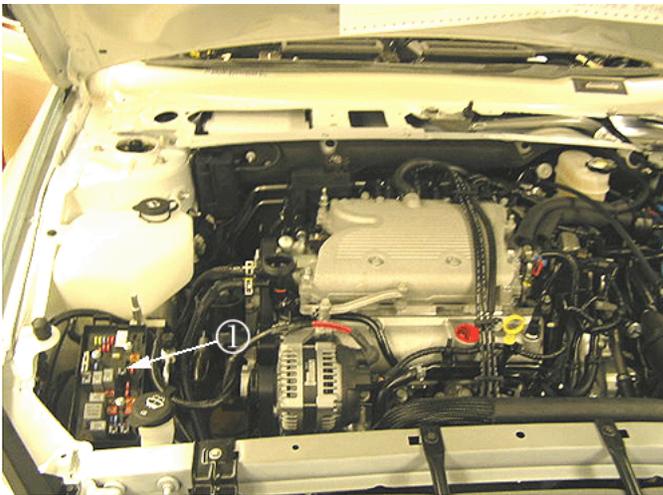
2182457

The underhood bussed electrical center is located in the vehicle's front passenger side of engine compartment between the engine coolant recovery bottle and rearward of the radiator support housing. The "Heated Windshield Washer" fuse is in location "F28", which is positioned in the rear inside quadrant of the UBEC.

2. Locate the underhood bussed electrical center (UBEC) (1).

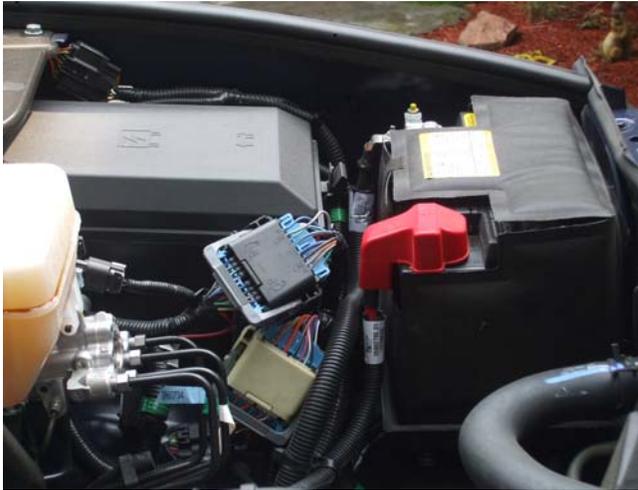
2182546

Important: The underhood fuse block in the engine compartment is located on the driver's side of the vehicle near the battery. Lift the cover for access to the fuse/relay block. Refer to *Underhood Fuse Block* in the Owner's Manual for fuse information.

2. Locate the under-hood bussed electrical center (UBEC).
3. Remove the UBEC cover and locate the 60 amp heated windshield washer Mega fuse.

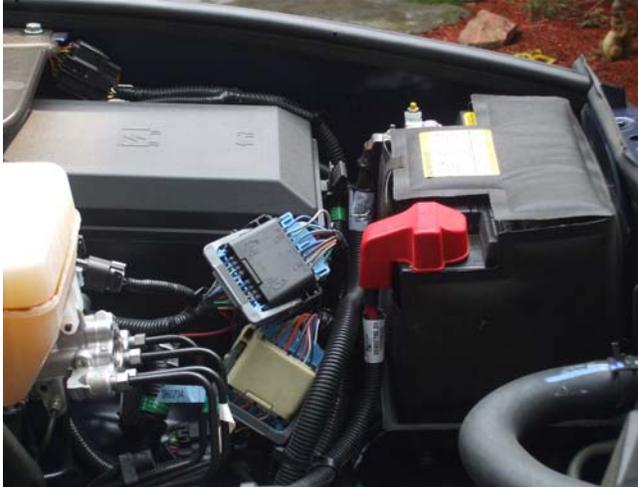
2182546

Important: The underhood fuse block in the engine compartment is located on the driver side of the vehicle near the battery. Lift the cover for access to the fuse/relay block. Refer to *Underhood Fuse Block* in the Owner's Manual for fuse information.

2. Locate the underhood bussed electrical center (UBEC).
3. Remove the UBEC cover and locate the 60 amp heated windshield washer fuse.
4. Remove the two relays next to the fuse to gain access to the fuse.
5. Remove the 60 amp heated windshield washer fuse using needle-nose pliers.
6. Store the 60 amp heated windshield washer fuse in the glove compartment.
7. Install the two relays removed in Step 4.
8. Connect the negative battery cable. Refer to *Battery Negative Cable Disconnection and Connection* in SI.
9. Test the operation of the windshield wiper system.
 - 9.1 Ensure the wiper system functions in low and high positions.
 - 9.2 Verify that the windshield wiper/washer switch functions. The windshield wiper system should provide wiper fluid to the windshield.

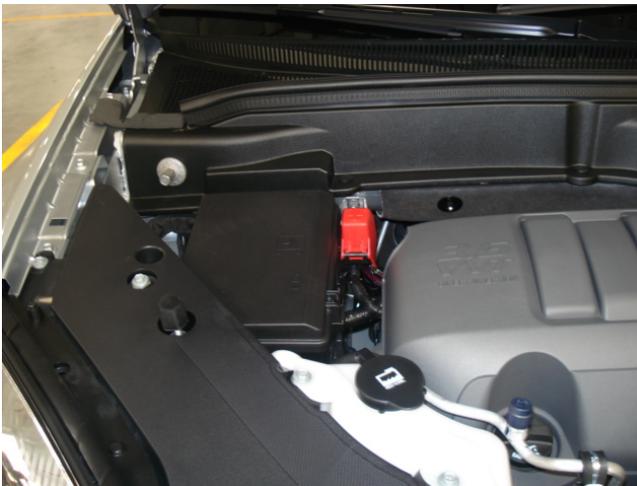
2182446

Important: The underhood bussed electrical center (UBEC) is located in the engine compartment on the passenger side of the vehicle. Refer to Underhood Fuse Block in the Owner's Manual for fuse information.

1. Disconnect the negative battery cable. Refer to *Battery Negative Cable Disconnection and Connection* in SI.
