SAFETY RECALL DSC

FRONT PASSENGER AIRBAG INFLATOR MODULE

CERTAIN 2002 – 2003 & 1 (one) 2004 MODEL YEAR SC430

SSC DLC is no longer valid and has been replaced by SSC DSC

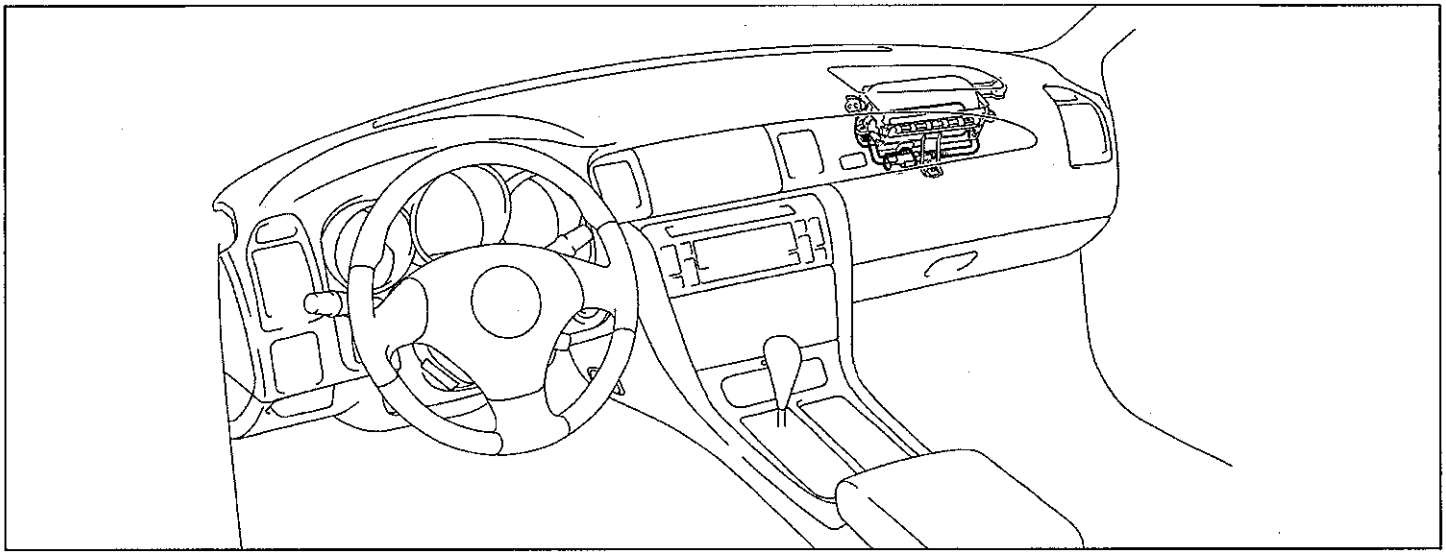
The subject vehicles are equipped with front passenger airbag inflators which could have been assembled with improperly manufactured propellant wafers. Improperly manufactured propellant wafers could cause the inflator to rupture and the front passenger airbag to deploy abnormally in the event of a crash, increasing the risk of injury to the occupant.

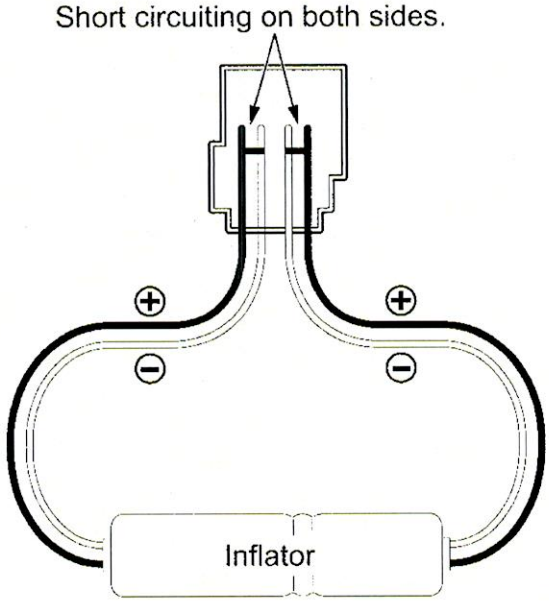
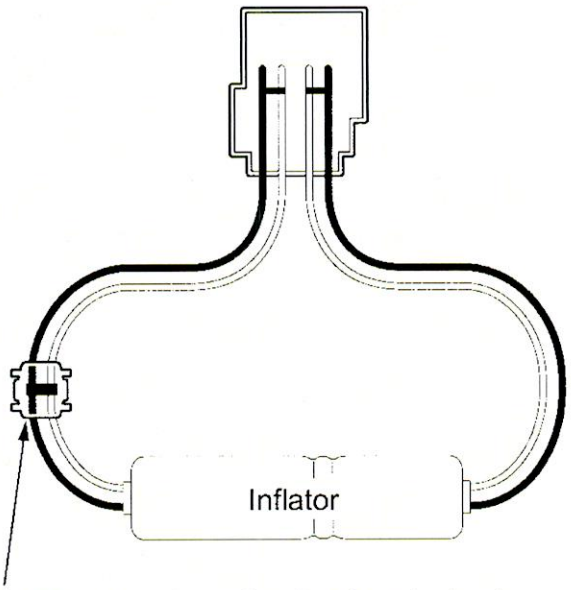
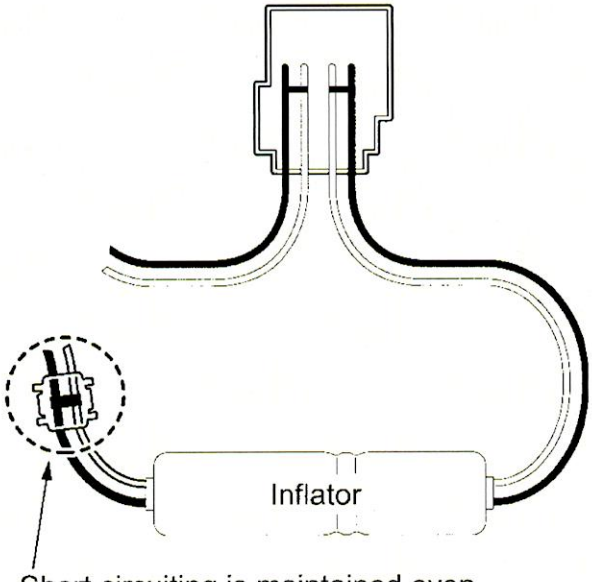
The connector of the inflator module contains a short circuiting mechanism to eliminate voltage variances when the connector(1) is disconnected. To allow for the replacement of the inflator module, a new short circuit(2) *MUST* be created before cutting the wires(3) and removing the inflator. The following steps *MUST* be followed exactly as described to ensure the work is completed correctly and safely.

Create new short circuit using electro tap.

Short circuiting is maintained even after cutting harness.

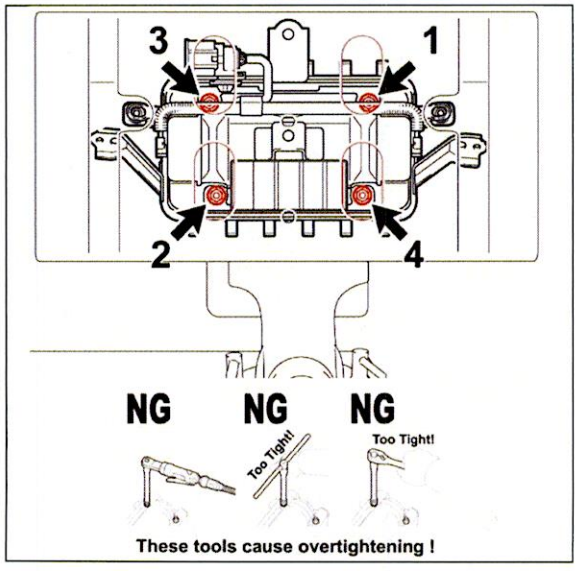
- **If the inflator is not positioned correctly in the position determining plate the airbag may not deploy correctly when activated.**
- **There will be some resistance when tightening the nuts because they are self-locking, confirm the nuts are tightened correctly.**
- ***DO NOT* use a power tool, T-handle, or ratchet when tightening the nuts to avoid overtorqueing.**

a) Push the inflator so that it contacts the position determining plate.

b) Tighten the nuts evenly in two increments following the sequence shown in the illustration. Use a socket driver or torque wrench to tighten the nuts.

Torque: 35in. lbf (3.9N·m)
