03V-028 ① of ①

5. Description of the defect:

In extremely low temperatures, ice can build up inside the engine throttle valve and cause the accelerator pedal to stick or not to return to idle after accelerating.

SUBJECT:		No: SR-03-001	
THROTTLE ICING CONDITION — SAFETY RECALL CAMPAIGN		DATE: January, 2003	
		MODEL: 2003 Outlander	
CIRCULATE TO:	<input checked="" type="checkbox"/> GENERAL MANAGER	<input checked="" type="checkbox"/> PARTS MANAGER	<input checked="" type="checkbox"/> TECHNICIAN
<input checked="" type="checkbox"/> SERVICE ADVISOR	<input checked="" type="checkbox"/> SERVICE MANAGER	<input checked="" type="checkbox"/> WARRANTY PROCESSOR	<input checked="" type="checkbox"/> SALES MANAGER

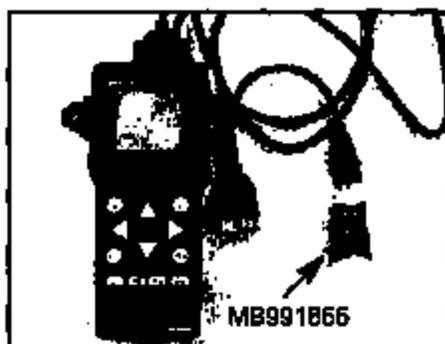
- 4. Connect adapter tool MB991855 to the MUT-II as shown. Install the red label interface cartridge to the MUT-II. Then install the 256 KBYTE red memory card and the red label ROM pack. **Use the ROM pack with the appropriate database number.**

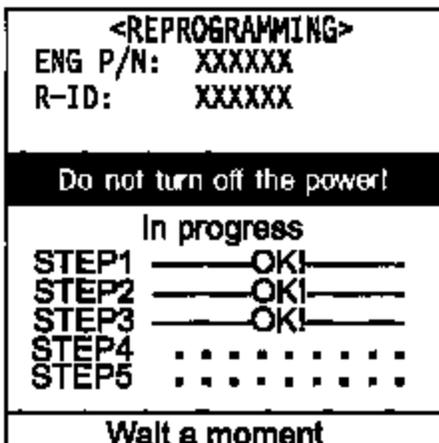
11. The MUT-II will display this screen as it reprograms the PCM. It will take approximately 18 minutes to complete.

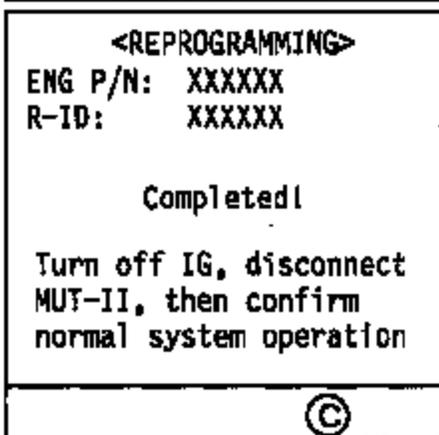
12. When the reprogramming process is finished, the MUT-II screen will display "Completed." Press "C".
