14513
OCTOBER 2014

SUBJECT: **NON COMPLIANCE RECALL**
Safety Triangle Kits sold as aftermarket parts only from 15 August 2012 through 25 July 2014 as International® part number FLTTRIKIT3.

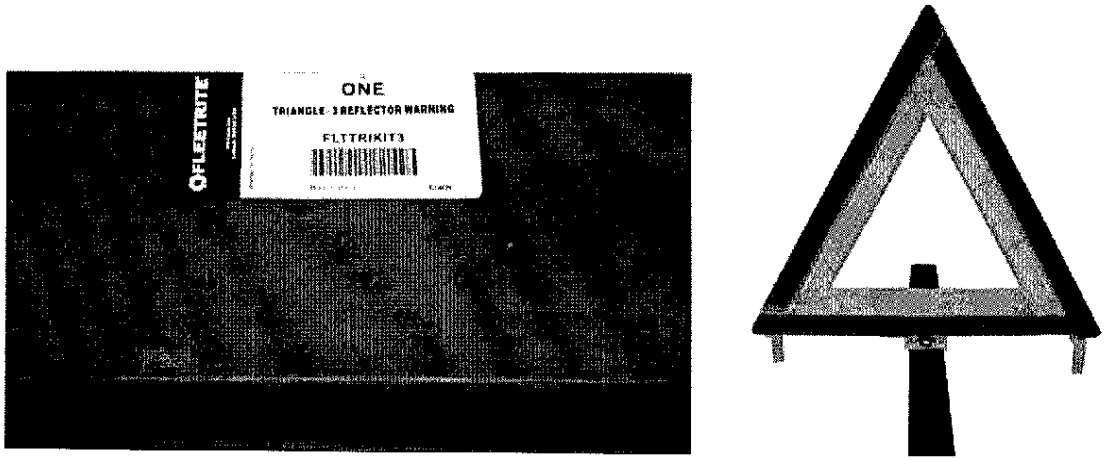
Figure 1. Safety Triangle Kit.

Safety triangle kits supplied by Torch Industries do not comply with Federal Motor Vehicle Safety Standard 125. The triangles fail to meet certain dimensional, red reflex color, and reflectivity requirements, and therefore may fail to warn other motorists of an impending hazard.

Request that your customer returns complete suspect safety triangle kits (P/N FLTTRIKIT3) to you for a new replacement triangle kit. Upon receipt, verify the returned kit is P/N FLTTRIKIT3 and the word FLEETRITE is molded into each triangle in the kit. Once verified, provide your customer with new triangle kit # 2204891C1.

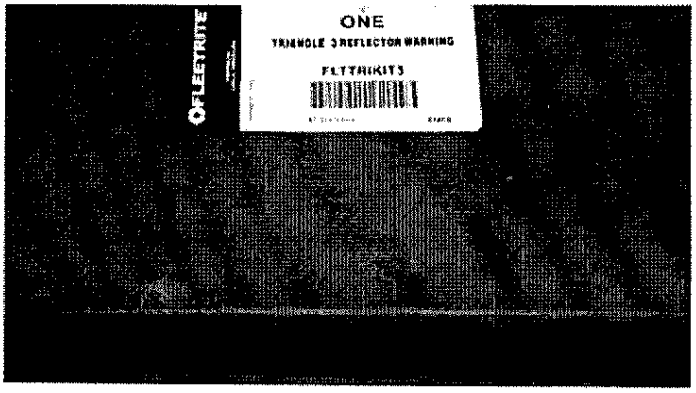
Safety Triangle Kits sold as aftermarket parts only from 08/15/2012 through 07/25/2014 as International® part number FLTTRIKIT3 do not comply with Federal Motor Vehicle Safety Standard 125. The triangles fail to meet certain dimensional, red reflex color, and reflectivity requirements, and therefore may fail to warn other motorists of an impending hazard.

If you purchased one of these kits, return the complete kit to any International® or IC Bus dealer and you will receive a free replacement kit.
