**May 20, 2015** 40918-01935 Version 11

# Safety Recall: Driver's Airbag Inflator Can Be Over-Pressurized

**Supersedes 08-093, dated April 14, 2014, to revise the information highlighted in yellow**

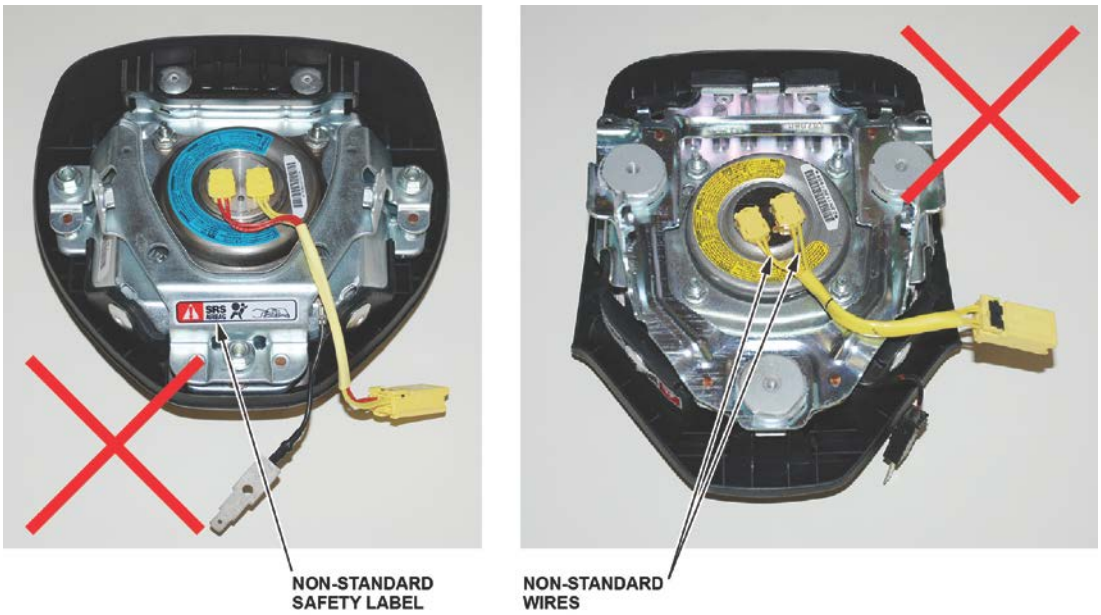
3. Place the airbag, face down, on a clean shop towel.
4. Visually inspect the airbag and the inflator for any unusual writing or markings.
   - If there is nothing unusual about the airbag or the inflator, go to step 5.
   - If there are any unusual markings, like an incorrect label or a model year written in marker, the airbag and inflator may not be the correct airbag and/or inflator for the vehicle or it may be a counterfeit part. For more information about counterfeit airbags, you can refer to *safercar.gov*, enter keywords **MANAGING COUNTERFEIT**, and select **Recommended Dealer Guidance for Managing Counterfeit Air Bags** from the list. **If you suspect that the airbag or inflator is counterfeit, do not continue this procedure**. Contact your DPSM for assistance.

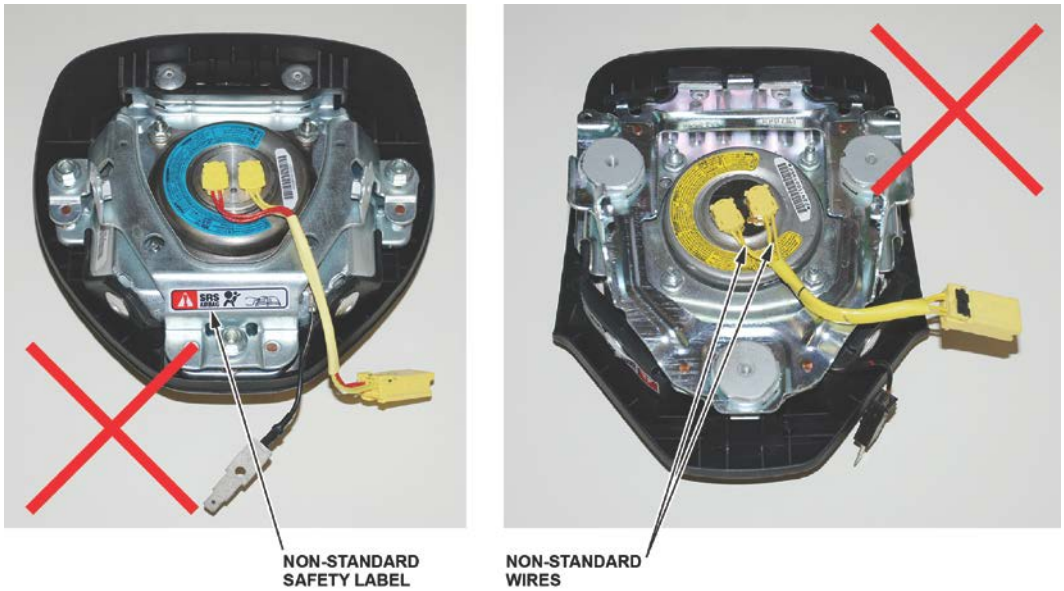
4. Visually inspect the airbag and the inflator for any unusual writing or markings.
   - If there is nothing unusual about the airbag or the inflator, go to step 5.
   - If there are any unusual markings, like an incorrect label or a model year written in marker, the airbag and inflator may not be the correct airbag and/or inflator for the vehicle or it may be a counterfeit part. For more information about counterfeit airbags, you can refer to *safercar.gov*, enter keywords **MANAGING COUNTERFEIT**, and select **Recommended Dealer Guidance for Managing Counterfeit Air Bags** from the list. **If you suspect that the airbag or inflator is counterfeit, do not continue this procedure**. Contact your DPSM for assistance.

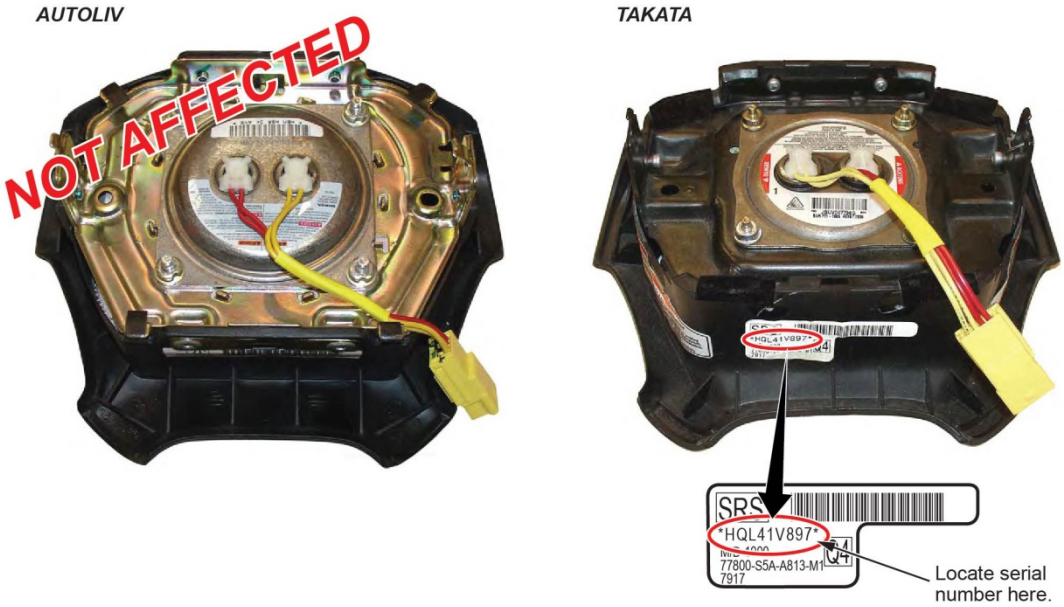
5. ***Civic only*** - Determine if the airbag is made by Autoliv or Takata by comparing the inflators to those in the images below.

NOTE: The Autoliv serial number label is different from the Takata label; the Autoliv has 11 characters, the Takata has 9.
   - If the airbag is made by Autoliv, the airbag is OK. Reinstall the airbag using new Torx bolts. Torque the bolts to **9.8 N·m (7.2 lb-ft)**. If you already received a replacement inflator, return the unopened kit to American Honda.
   - If the airbag is made by Takata, go to step 6.
