June 16, 2015 ATB 51811-01884 Version 9

Safety Recall: Front Passenger's Airbag Inflator Can Be Over-Pressurized

Supersedes 14-040, dated April 24, 2015; see Revision Summary

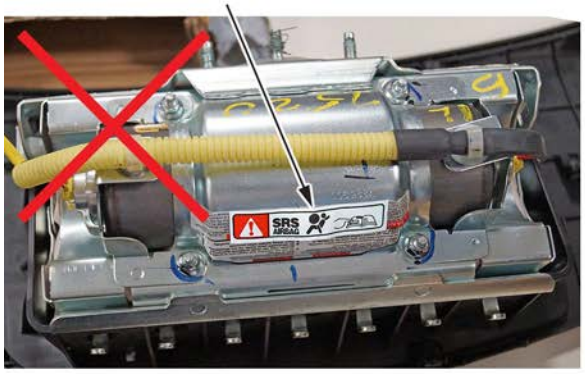
NON-STANDARD SAFETY LABEL

4. Visually inspect the airbag and the inflator for any unusual writing or markings.
   - If there is nothing unusual about the airbag or the inflator, go to step 5.
   - If there are any unusual markings, like an incorrect label or a model year written in marker, the airbag and inflator may not be the correct airbag and/or inflator for the vehicle or it may be a counterfeit part. For more information about counterfeit airbags, you can refer to *safercar.gov*, enter keywords **MANAGING COUNTERFEIT**, and select **Recommended Dealer Guidance for Managing Counterfeit Air Bags** from the list. **If you suspect that the airbag or inflator is counterfeit, do not continue this procedure**. Contact your DPSM for assistance.

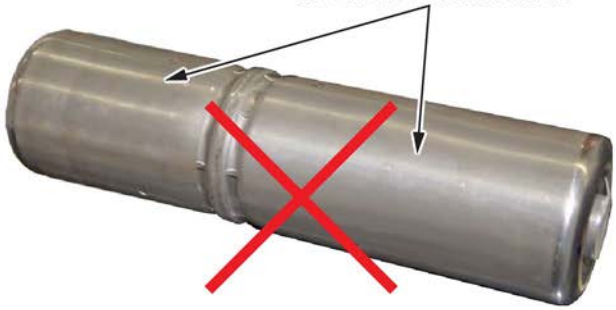
NO LABELS ON INFLATOR

HAND ENGRAVING
