SI B65 19 08
Audio, Navigation, Monitors, Alarms, SRS

Recall Campaign 08V-384: Modify Seat Occupancy Detection Mat

MODEL

E83 with base seats

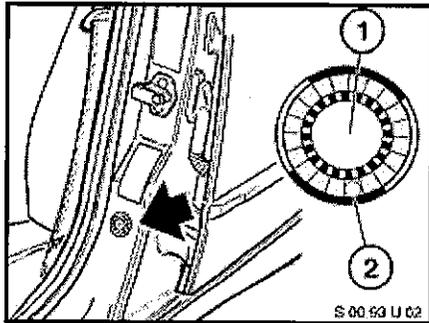
- A. Emboss your BMW center warranty number in the middle of the label (1);
- B. Punch out code number **530** (2) printed on the

label; and

- C. Affix the label to the **B**-pillar as shown.

This Recall Campaign has been assigned code number **530**. After the vehicle has been checked and corrected, if necessary, obtain a label (SD 92-352) and:
