June 30, 2015 49387-01883 Version 10

Safety Recall: Front Passenger's Airbag Inflator Can Be Over-Pressurized

AFFECTED VEHICLES

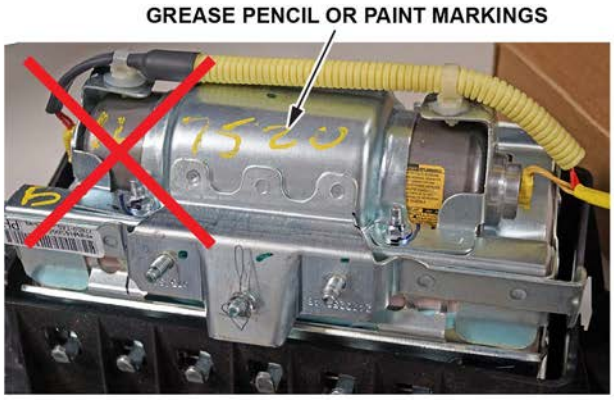
5. Visually inspect the airbag and the inflator for any unusual writing or markings.
   - If there is nothing unusual about the airbag or the inflator, go to step 6.
   - If there are any unusual markings, like an incorrect label or a model year written in marker, the airbag and inflator may not be the correct airbag and/or inflator for the vehicle or it may be a counterfeit part. For more information about counterfeit airbags, you can refer to *safercar.gov*, enter keywords **MANAGING COUNTERFEIT**, and select **Recommended Dealer Guidance for Managing Counterfeit Air Bags** from the list. **If you suspect that the airbag or inflator is counterfeit, do not continue this procedure**. Contact your DPSM for assistance.

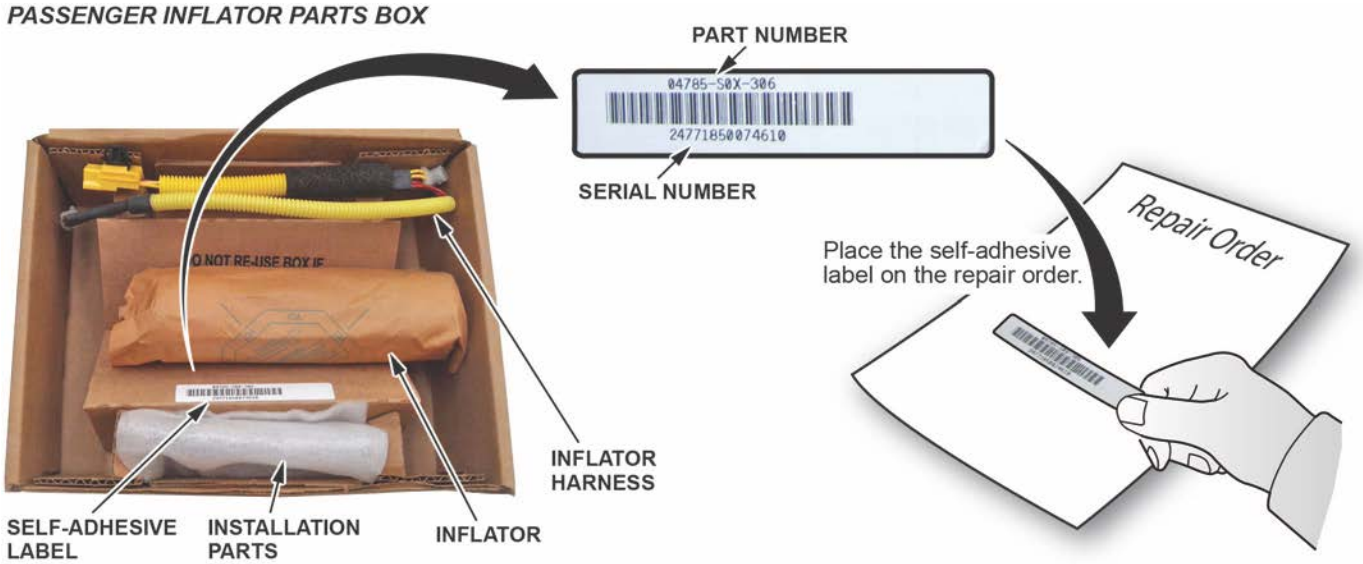
7. Peel the label located inside the inflator box from its backing and attach it to the RO. For the warranty claim to be paid, the **replacement inflator part number that you received** must be on the warranty claim and your warranty clerk must enter the serial number in the Diagnostic Trouble Codes field.

- The replacement part number is printed on the top part of the label and the serial number is printed on the bottom. **Make sure you attach the label to the RO and give it to the warranty clerk**.
   - There may also be a colored sticker located in the kit, ignore it because it is not used.
   - Not all inflator kits have a label included. In those cases, write the serial number and part number from the side of the inflator box on the RO. The part number always starts with 047.
