Subject: Recall Campaign 07V-334 (55E5/JV)

Safety Recall Circular

Code: 55E5/JV00

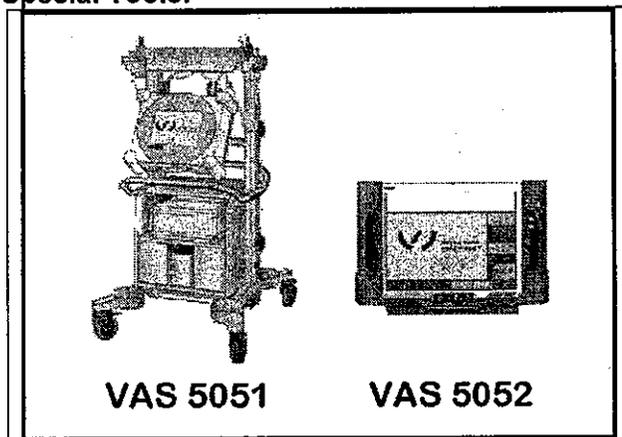
Special Tools:

- Approved battery charger
- ⇐ VAS 5051B or VAS 5052 (equipped with Ethernet card and security certificate)
- Adapter cable
- Network connection cable
- Brand CD V. 11.55.00 or later installed

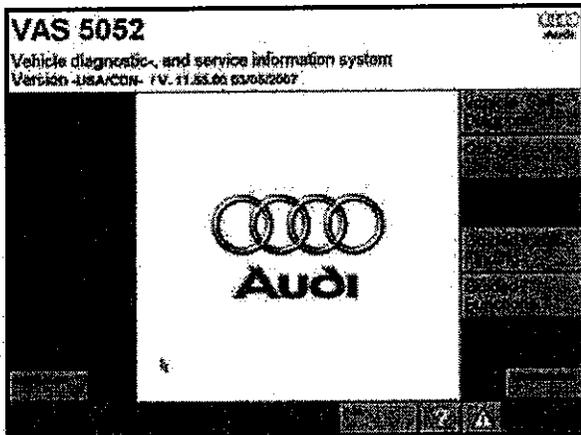
- Connect vehicle diagnostic, testing and information system -VAS 5051B- or -VAS 5052- (with online capability) to the vehicle
- Insert the Update CD (Part No. 4L0 906 961 G for VAS 5052) or Update CD (Part No. 4E0 906 961 AD for VAS 5051B) in the CD drive of the appropriate tester

- Connect tester to your workshop network (CPN) using network connection cable
- Insert memory stick so *Diagnosis Log* can be recorded following SVM update

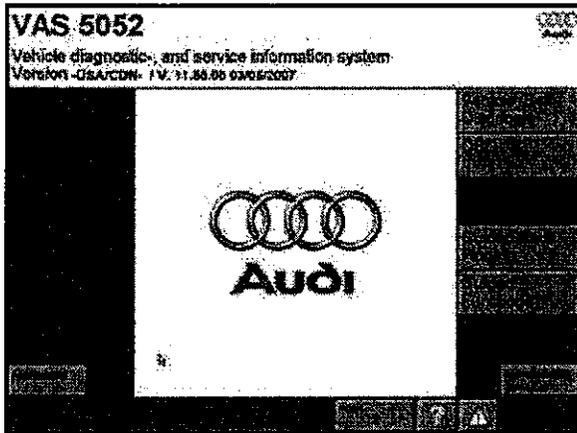
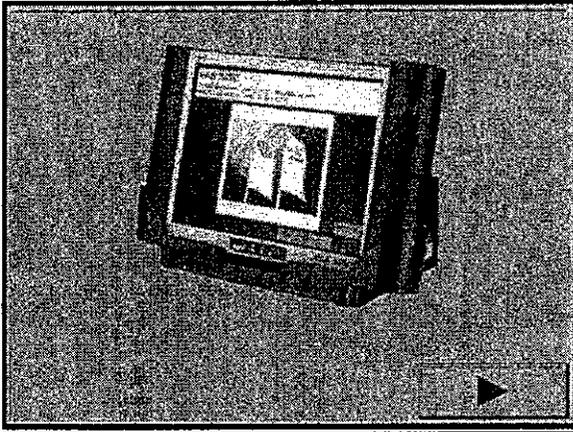
- ← With vehicle diagnostic, testing and information system -VAS 5051B- or -VAS 5052- (with online capability) connected to the vehicle
- Select:
Applications>>Start application from CD ROM

- ← The start screen shows the tester
- Press the 'Next' button (▶)

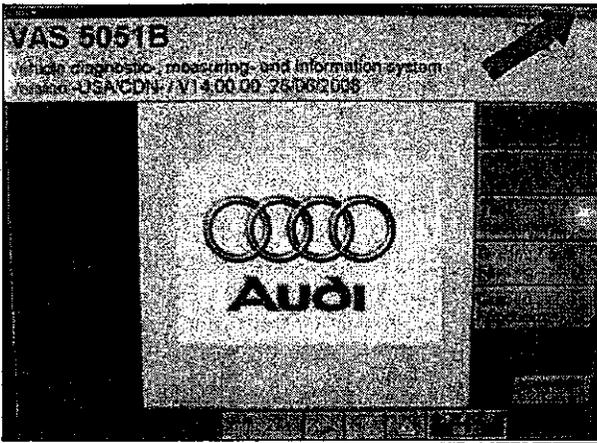
- Minimize the VAS-PC screen by selecting the minimize icon –arrow-

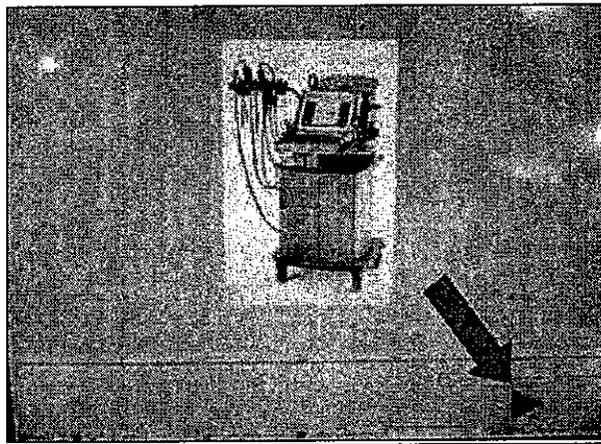
- ← The start screen shows the tester
- Press the 'Next' button (▶)

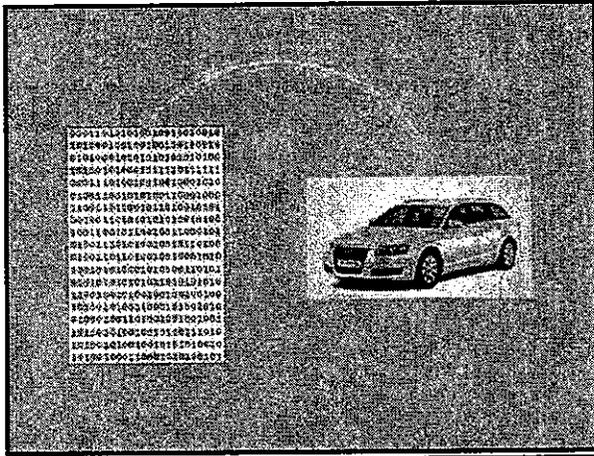
← When this screen is displayed, both tailgate drives will then be flashed. Wait until the software update is completed

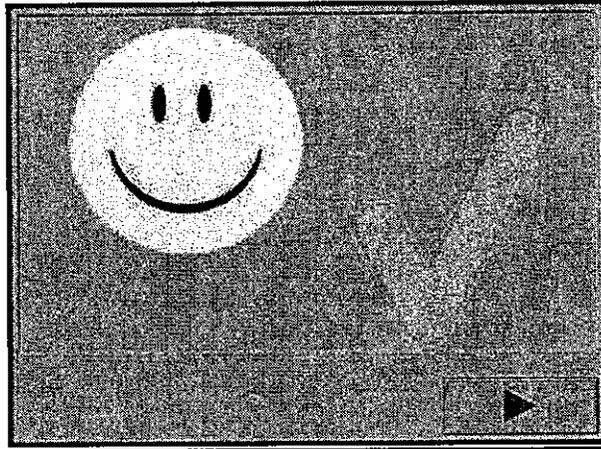
← If this screen display appears, the software update was successful

- Press the 'Next' button (▶)

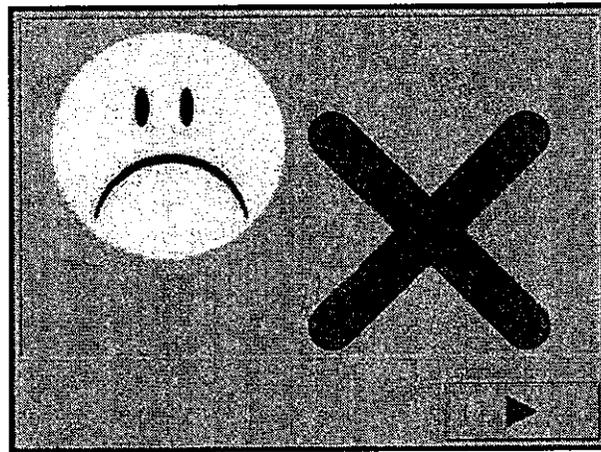
← If this screen display appears, the software update was not successful

- Make a note of the error number displayed on the screen
- Press the 'Next' button (▶)
- If the update was unsuccessful – **do not continue to Section C**

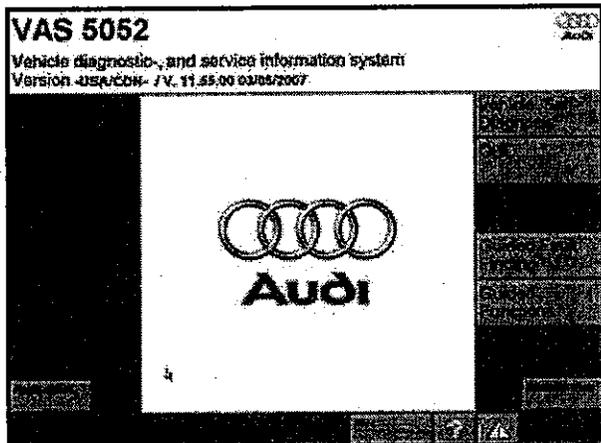
← With tester still connected to the vehicle, enter the SVM update into the User Test Plan by selecting the following inside *Guided Fault Finding*:

Go to >> *Function/Component Selection*
>> *Problem Related Hardware and Software Update* >> *Direct Input: SVM code for problem related update*

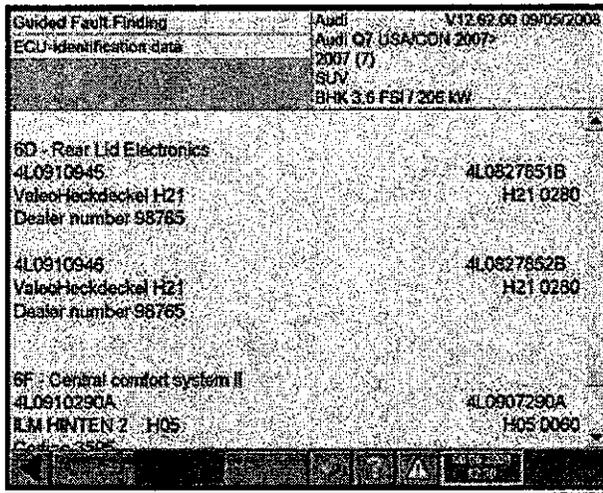
⇐ While still within the *Guided Fault Finding* menu, select *Go to >> ECU-identification Data*, and scroll down until you locate address 6D

⇐ Verify that software level for address 6D has been updated to software 280 or higher
