RE: 99V-069

Applies To: 1997-98 Accord
1996-98 Prelude
1997-98 Odyssey

Safety Recall: Lower Ball Joints

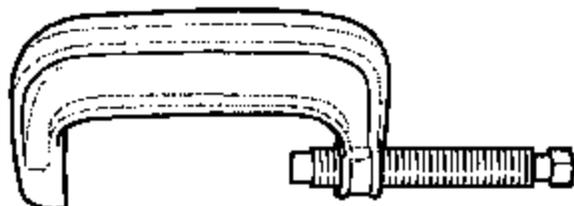
C-FRAME TOOL
OTC P/N 7248

C-Frame Tool: OTC P/N 7248

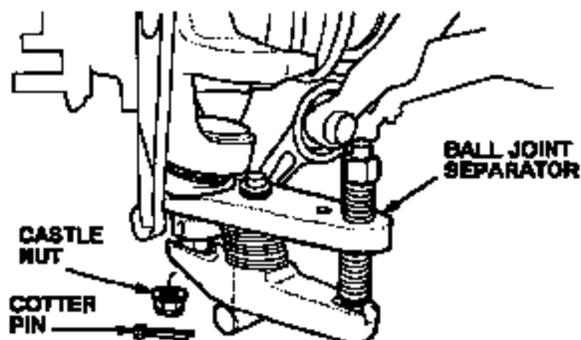
1. Raise the vehicle on a hoist. Remove the front wheels.
2. Remove and discard the spindle nut.
3. Remove the cotter pin and castle nut from the lower ball joint. Discard the cotter pin.
4. Separate the lower control arm from the ball joint with the special tool.

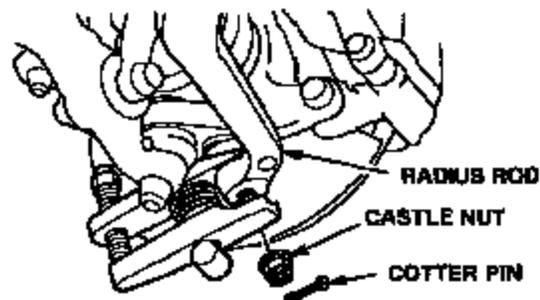
5. *Prelude Type SH only:* Separate the radius rod from the ball joint with the special tool.

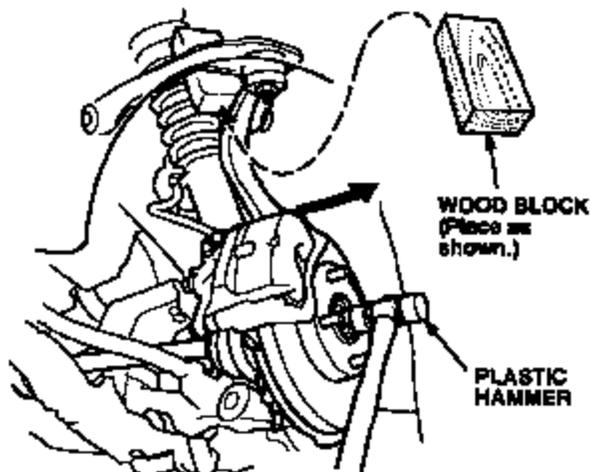
6. Remove the axle from the front wheel hub.

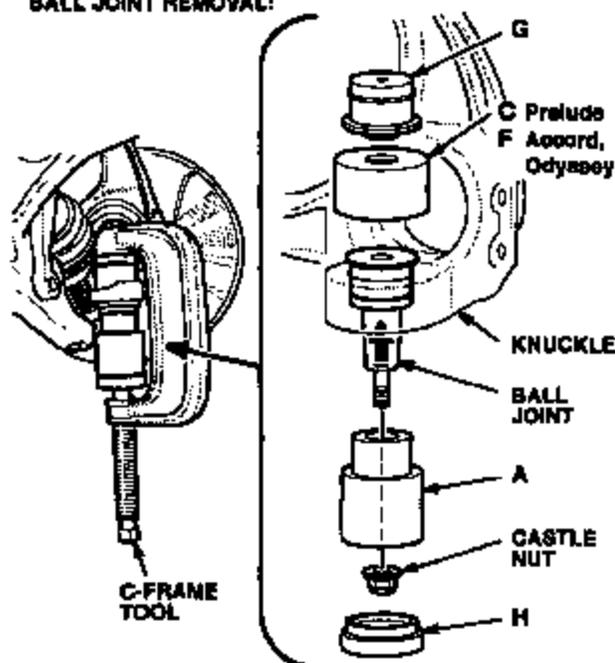
BALL JOINT REMOVAL:

7. Lift the knuckle, then place a block of wood (approximately 2-3/4" x 1-1/2" x 5") between the upper control arm and the damper assembly.
8. Remove the boot from the lower ball joint.
9. *1997 Accord and all Odyssey only:* Remove the brake caliper mounting bolts and the caliper. Remove the four flange bolts, then remove the brake rotor/hub assembly.
10. Install the special tools on the lower ball joint and the knuckle.

11. Tighten the C-frame and press the lower ball joint out of the knuckle.
12. Position the new ball joint in the knuckle.

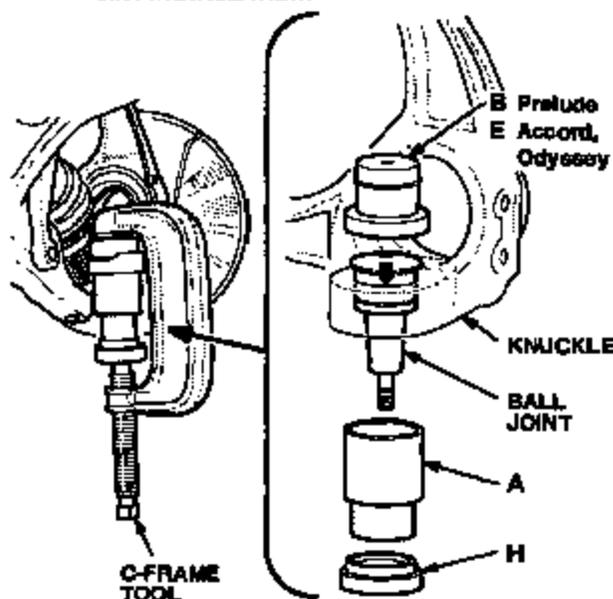
BALL JOINT INSTALLATION:

13. Install the special tools on the ball joint and the knuckle.

14. Tighten the C-frame and press the ball joint into the knuckle.
15. *1997 Accord and all Odyssey only:* Reinstall the brake rotor/hub assembly. Torque the flange bolts to 44 N-m (33 lb-ft). Reinstall the brake caliper. Torque the mounting bolts to 108 N-m (80 lb-ft).

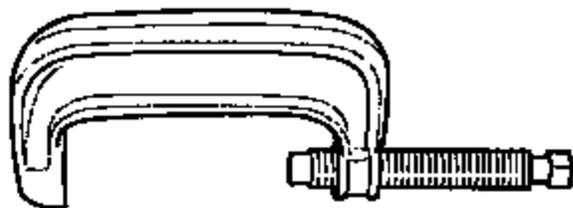
C-FRAME TOOL
OTC P/N 7248

C-Frame Tool: OTC P/N 7248

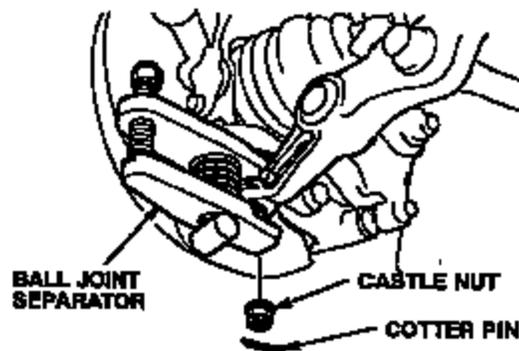
1. Raise the vehicle on a hoist. Remove the front wheels.
2. Remove and discard the spindle nut.
3. Remove the cotter pin and castle nut from the lower ball joint. Discard the cotter pin.

4. Separate the lower control arm from the ball joint with the special tool.

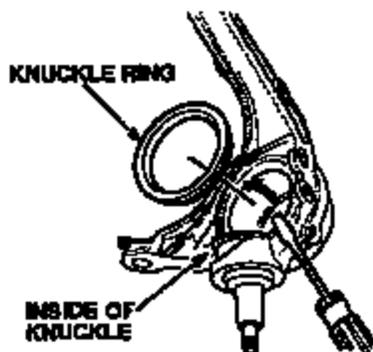
- Remove the boot from the lower ball joint.
- 3.5FL and 3.2TL only:* Carefully remove and retain the knuckle ring.

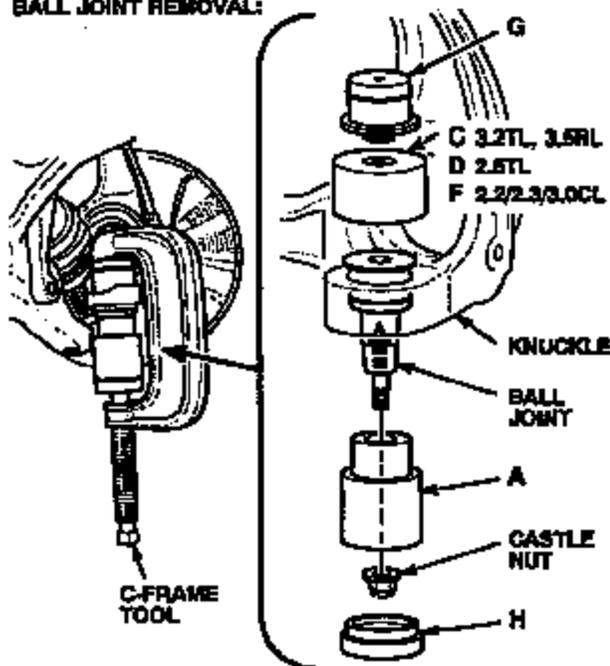
BALL JOINT REMOVAL:

- 2.5TL and CL only:* Remove the brake caliper mounting bolts and the brake caliper. Remove the four flange bolts, then remove the brake rotor/hub assembly.
- Install the special tools on the lower ball joint and the knuckle.

- Tighten the C-frame and press the lower ball joint out of the knuckle.
- Position the new ball joint in the knuckle.

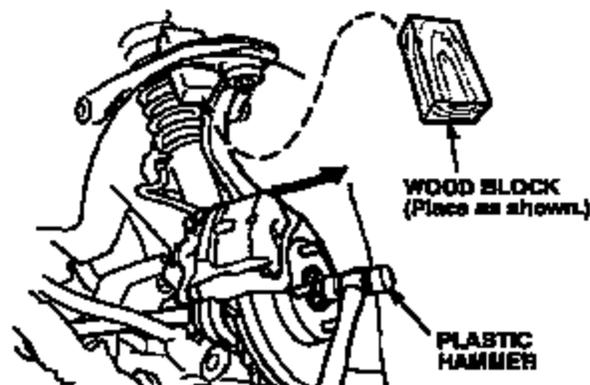
- Remove the axle from the front wheel hub.

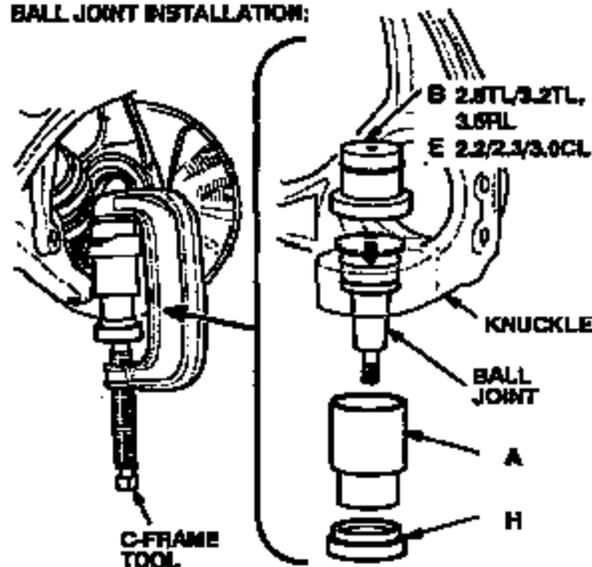
BALL JOINT INSTALLATION:

- Lift the knuckle, then place a block of wood (approximately 2-3/4" x 1-1/2" x 5") between the upper control arm and the damper assembly.
- Install the special tools on the ball joint and the knuckle.

- Tighten the C-frame and press the ball joint into the knuckle.

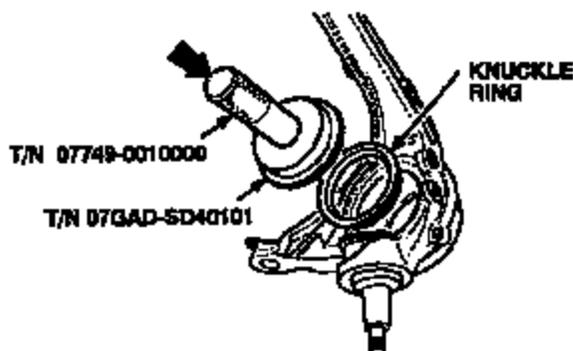
15. **3.5RL and 3.2TL only:** Examine the knuckle ring for damage. If it is not severely kinked, distorted, or broken, reinstall it. If the original knuckle ring is not reusable, install a new one.

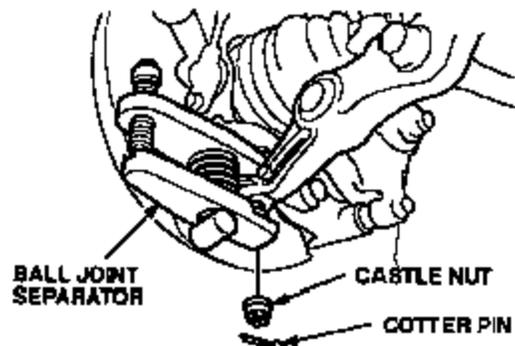
1. Raise the vehicle on a hoist. Remove the front wheels.
2. Remove and discard the spindle nut.
3. Remove the cotter pin and castle nut from the lower ball joint. Discard the cotter pin.

4. Separate the lower control arm from the ball joint with the special tool. To avoid damaging the ABS sensor harness, do not let the knuckle hang by its weight.
5. Remove the axle from the front wheel hub. If the axle is stuck to the hub, go to step 6. If the axle comes out easily, go to step 9.

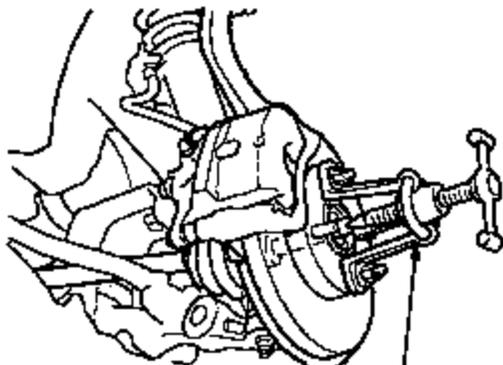
6. Reinstall the knuckle on to the lower control arm, and loosely install the castle nut.

Use Snap-on P/N CJ-129,
Old Forge P/N 2518, or equivalent.

7. Using a heavy-duty hub puller, free the axle from the hub. Do not press it all the way out.
8. Remove the castle nut, lift and support the knuckle (to prevent damaging the ABS sensor wire harness), and press the axle out of the hub.
9. Lift the knuckle, then place a block of wood (approximately 2-3/4" x 1-1/2" x 5") between the upper control arm and the damper assembly.

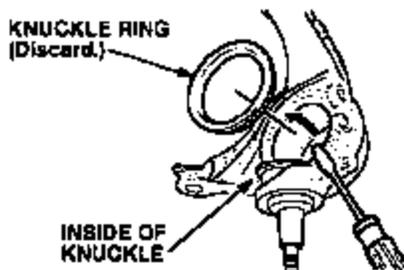
KNUCKLE RING
(Discard.)

10. Remove the boot from the lower ball joint.
11. 3.5RL and 3.2TL only: Remove and discard the knuckle ring.

INSIDE OF
KNUCKLE

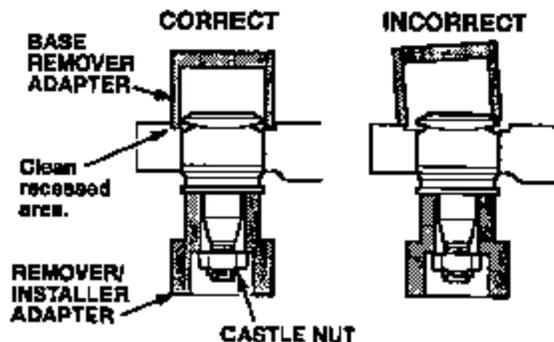
13. Clean the recessed area around the ball joint with solvent and compressed air, then install the seat base remover adapter (Tool C, D, or F).

CORRECT

INCORRECT

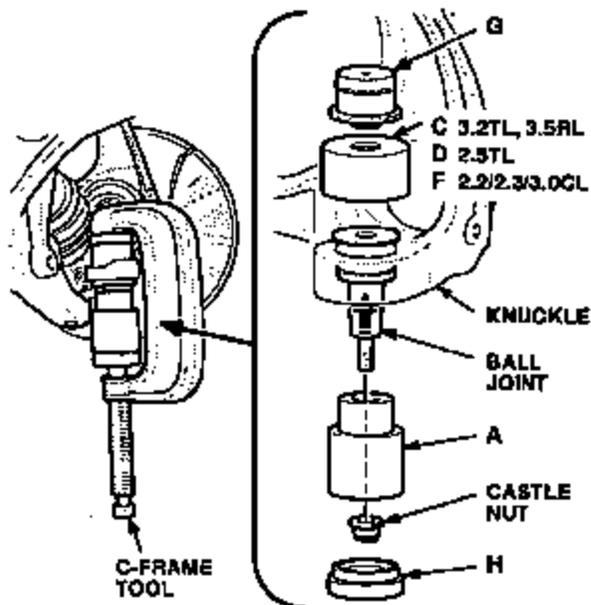
C-FRAME
TOOL

14. Hold the remover/installer adapter (Tool A) up to the ball joint, then install the castle nut to hold it in place. Install the remaining special tools on the lower ball joint and the knuckle. To avoid damaging the special tools, verify that they are correct for the vehicle you are working on and are aligned properly.

KNUCKLE

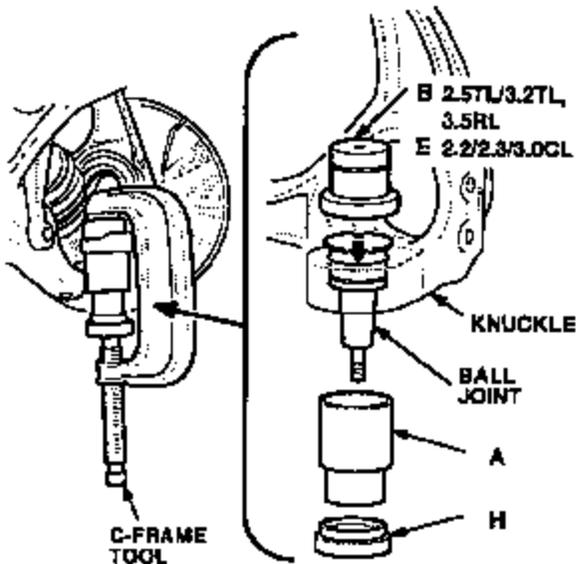
16. Position the new ball joint in the knuckle. Do not remove the boot from the ball joint.
17. Install the special tools on the ball joint and the knuckle.

18. Tighten the C-frame and press the ball joint into the knuckle.
19. *3.5RL and 3.2TL only:* Install a new knuckle ring.

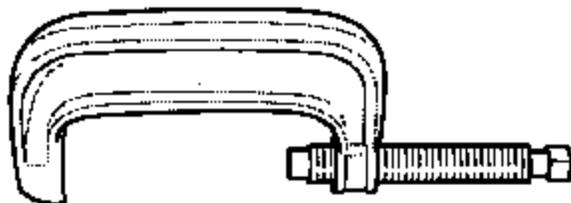
C-Frame Tool: OTC P/N 7248

Apply high-pressure grease to the threads before use.

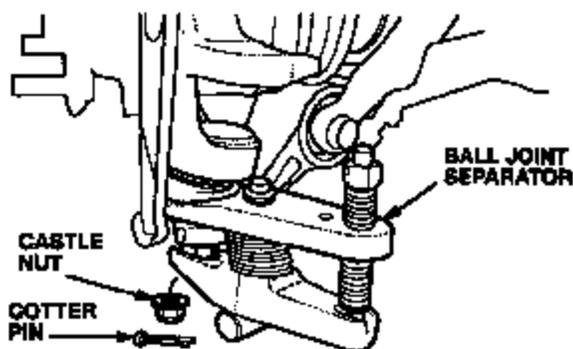
4. Separate the lower control arm from the ball joint with the special tool. To avoid damaging the ABS sensor harness, do not let the knuckle hang by its weight.

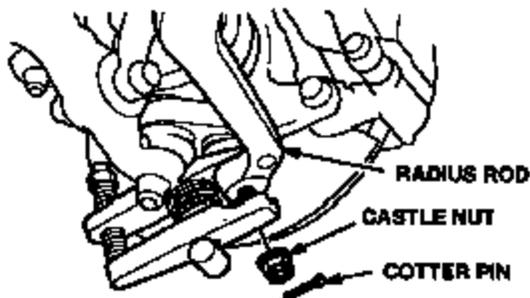
5. *Prelude Type SH only:* Separate the radius rod from the ball joint with the special tool. Take care not to damage the boot. Replace the boot if it is damaged during separation.

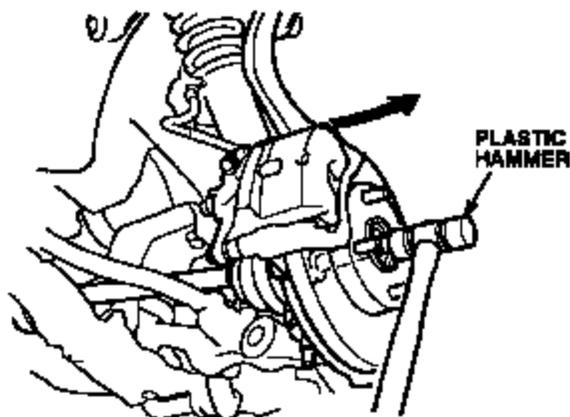
6. Remove the axle from the front wheel hub. If the axle is stuck to the hub, go to step 7. If the axle comes out easily, go to step 10.

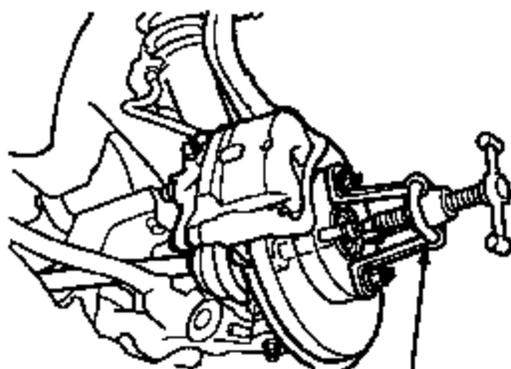
7. Reinstall the knuckle on the lower control arm and loosely install the castle nut.
8. Using a heavy-duty hub puller, free the axle from the hub. Do not press it all the way out.

Use Snap-on P/N CJ-126,
Old Forge P/N 2618, or equivalent.

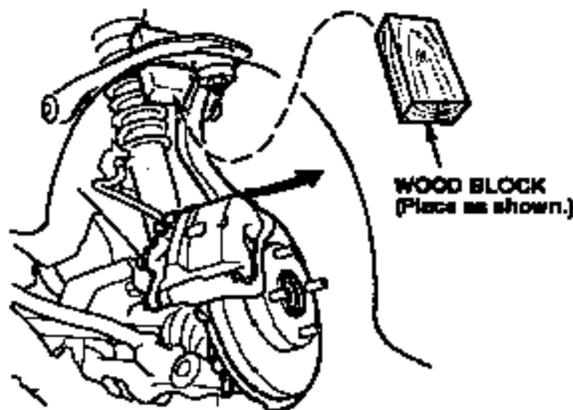
9. Remove the castle nut, lift and support the knuckle (to prevent damaging the ABS sensor wire harness), and press the axle out of the hub.

10. Lift the knuckle, then place a block of wood (approximately 2-3/4" x 1-1/2" x 5") between the upper control arm and the damper assembly.
11. Remove the boot from the lower ball joint.
12. *1997 Accord and all Odyssey only:* Remove the brake caliper mounting bolts and the caliper. Remove the four flange bolts, then remove the brake rotor/hub assembly.

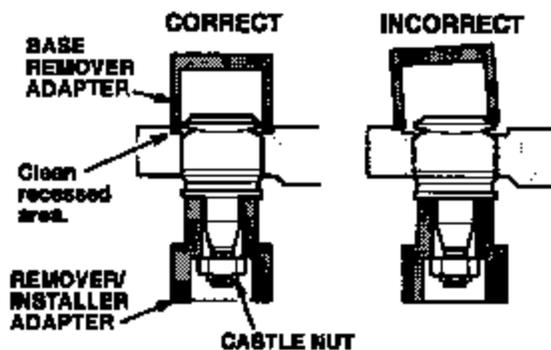
13. Clean the recessed area around the ball joint with solvent and compressed air, then install the base remover adapter (Tool C or F).

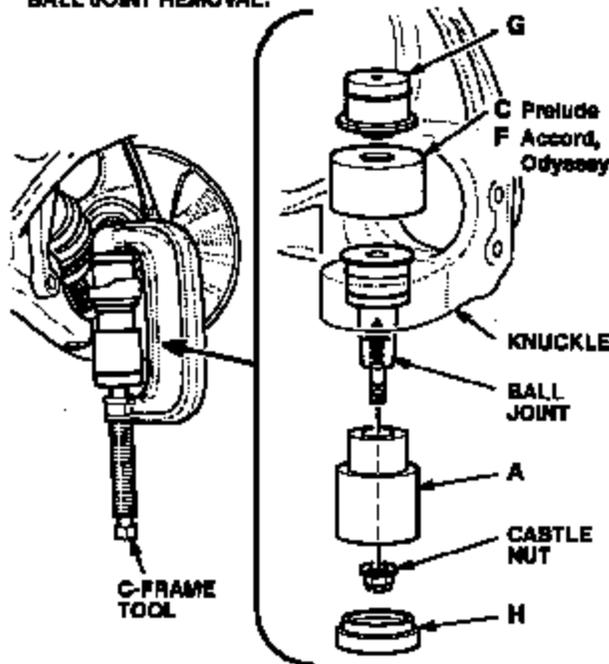
BALL JOINT REMOVAL:

14. Hold the remover/installer adapter (Tool A) up to the ball joint, then install the castle nut to hold it in place. Install the remaining special tools on the lower ball joint and the knuckle. To avoid damaging the special tools, verify that they are correct for the vehicle you are working on and are aligned properly.

NOTE: On the Prelude Type SH, make sure you are removing the ball joint that connects to the lower control arm. Do not remove the ball joint that connects to the radius rod.

15. Tighten the C-frame and press the lower ball joint out of the knuckle.

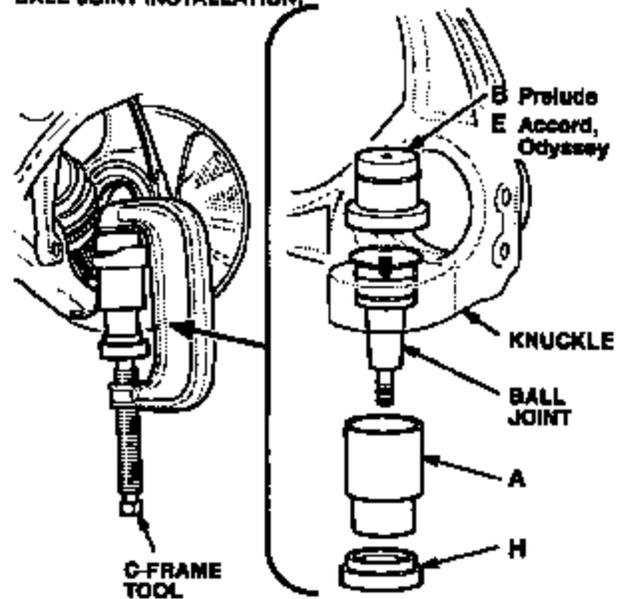
BALL JOINT INSTALLATION:

17. Install the special tools on the ball joint and the knuckle.

18. Tighten the C-frame and press the ball joint into the knuckle.
19. 1997 Accord and all Odyssey only: Reinstall the brake rotor/hub assembly. Torque the flange bolts to 44 N·m (33 lb-ft). Reinstall the brake caliper. Torque the mounting bolts to 108 N·m (80 lb-ft).

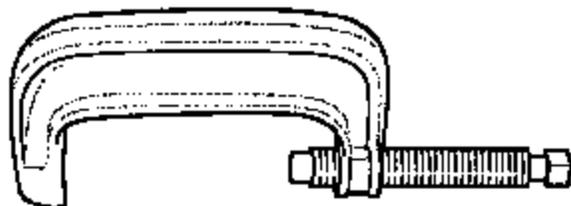
C-FRAME TOOL
OTC P/N 7248

C-Frame Tool: OTC P/N 7248

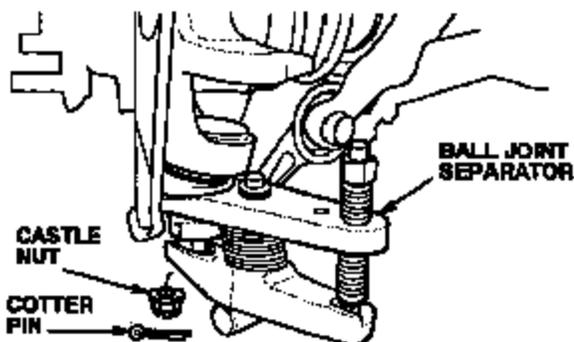
1. Raise the vehicle on a hoist. Remove the front wheels.
2. Remove and discard the spindle nut.
3. Remove the cotter pin and castle nut from the lower ball joint. Discard the cotter pin.
4. Separate the lower control arm from the ball joint with the special tool.

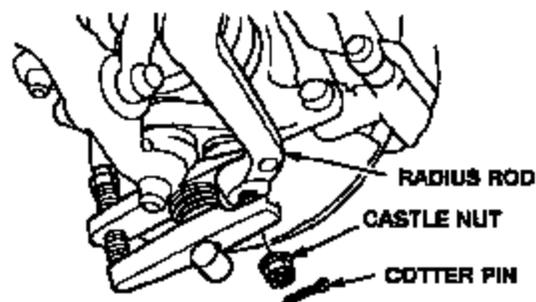
5. *Prelude Type SH only:* Separate the radius rod from the ball joint with the special tool.

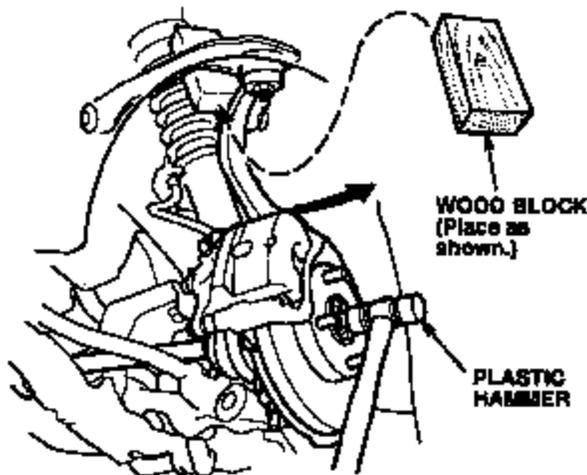
6. Remove the axle from the front wheel hub.

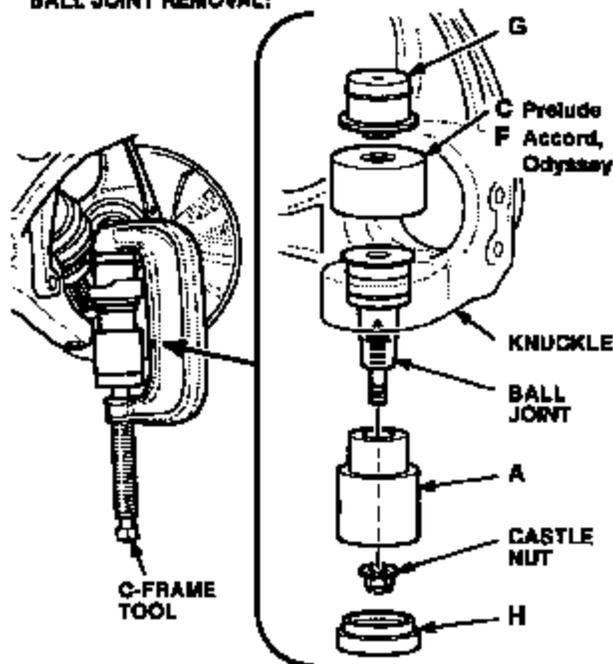
BALL JOINT REMOVAL:

7. Lift the knuckle, then place a block of wood (approximately 2-3/4" x 1-1/2" x 5") between the upper control arm and the damper assembly.
8. Remove the boot from the lower ball joint.
9. *1997 Accord and all Odyssey only:* Remove the brake caliper mounting bolts and the caliper. Remove the four flange bolts, then remove the brake rotor/hub assembly.
10. Install the special tools on the lower ball joint and the knuckle.

11. Tighten the C-frame and press the lower ball joint out of the knuckle.
12. Position the new ball joint in the knuckle.

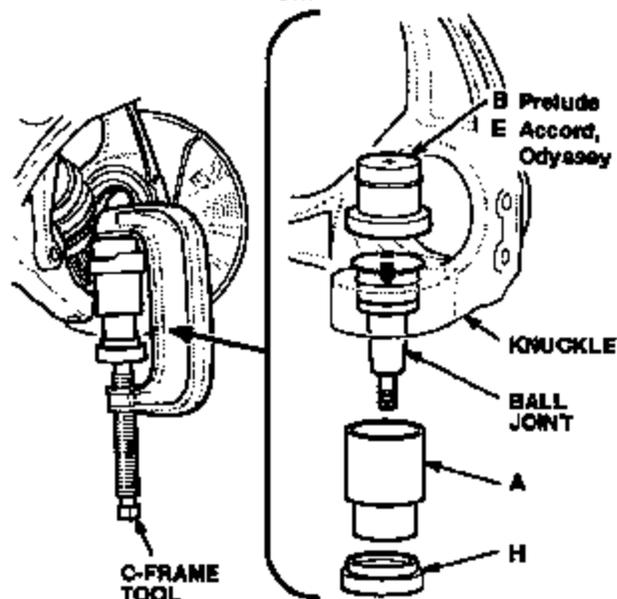
BALL JOINT INSTALLATION:

13. Install the special tools on the ball joint and the knuckle.

14. Tighten the C-frame and press the ball joint into the knuckle.
15. *1997 Accord and all Odyssey only:* Reinstall the brake rotor/hub assembly. Torque the flange bolts to 44 N-m (33 lb-ft). Reinstall the brake caliper. Torque the mounting bolts to 108 N-m (80 lb-ft).

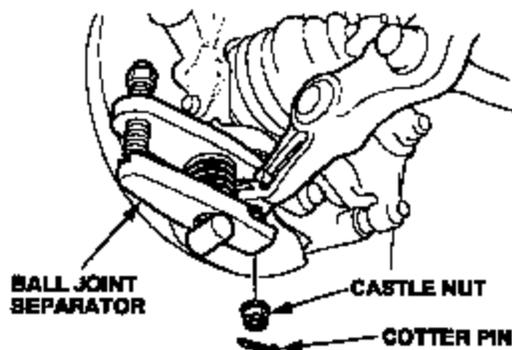
1. Raise the vehicle on a hoist. Remove the front wheels.
2. Remove and discard the spindle nut.
3. Remove the cotter pin and castle nut from the lower ball joint. Discard the cotter pin.

4. Separate the lower control arm from the ball joint with the special tool. To avoid damaging the ABS sensor harness, do not let the knuckle hang by its weight.
5. Remove the axle from the front wheel hub. If the axle is stuck to the hub, go to step 6. If the axle comes out easily, go to step 9.

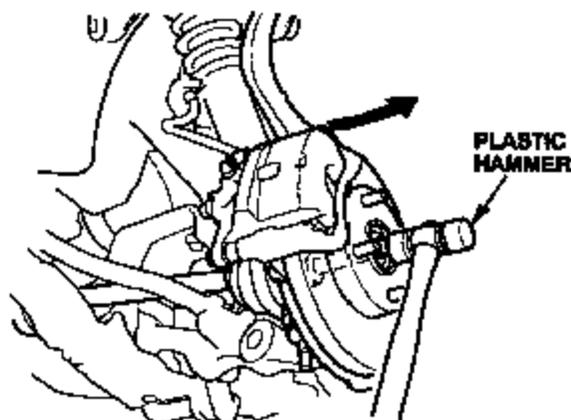
6. Reinstall the knuckle on the lower control arm and loosely install the castle nut.

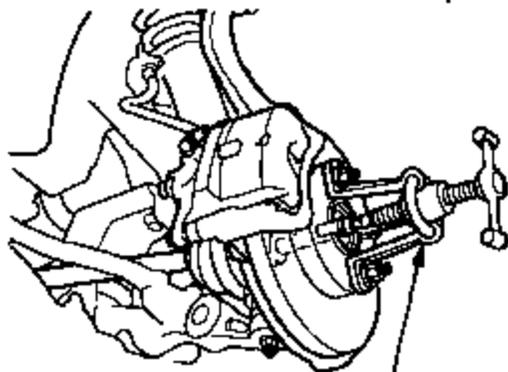
7. Using a heavy-duty hub puller, free the axle from the hub. Do not press it all the way out.

Use Snap-on P/N CJ-129,
Old Forge P/N 2518, or equivalent.

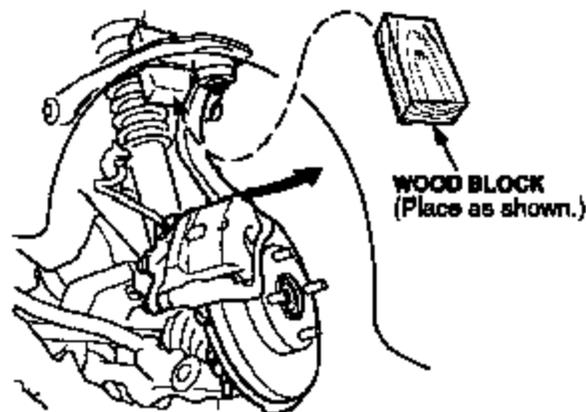
8. Remove the castle nut, lift and support the knuckle (to prevent damaging the ABS sensor wire harness), and press the axle out of the hub.
9. Lift the knuckle, then place a block of wood (about 2-3/4" x 1-1/2" x 5") between the upper control arm and the damper assembly.

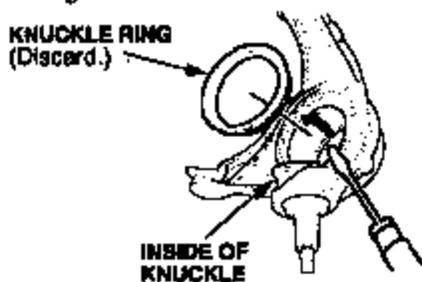
10. Remove the boot from the lower ball joint.
11. 3.5RL and 3.2TL only: Remove and discard the knuckle ring.

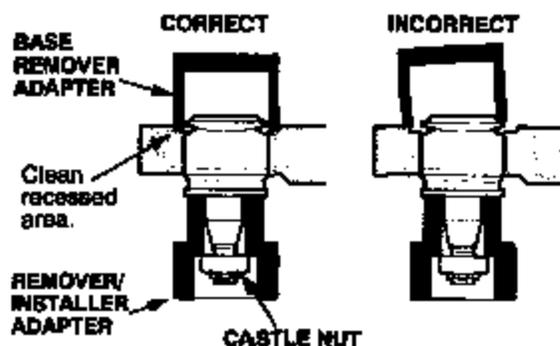
13. Clean the recessed area around the ball joint with solvent and compressed air, then install the base remover adapter (Tool C, D, or F).

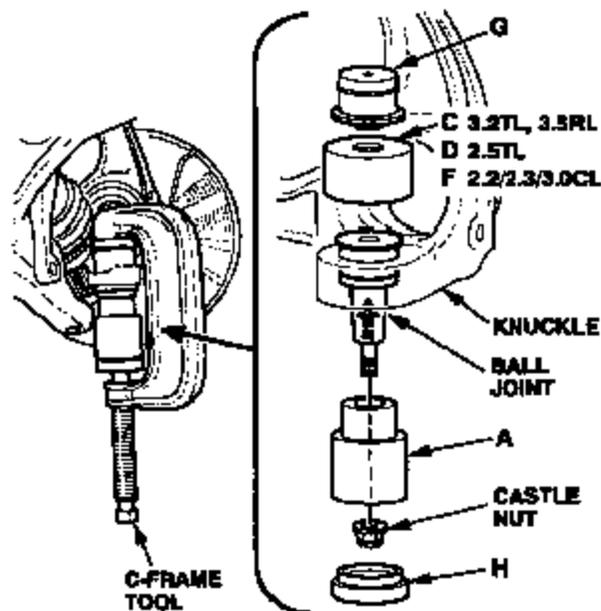
14. Hold the remover installer adapter (Tool A) up to the ball joint, then install the castle nut to hold it in place. Install the remaining special tools on the lower ball joint and the knuckle. To avoid damaging the special tools, verify that they are correct for the vehicle you are working on and are aligned properly.

15. Tighten the C-frame and press the lower ball joint out of the knuckle.

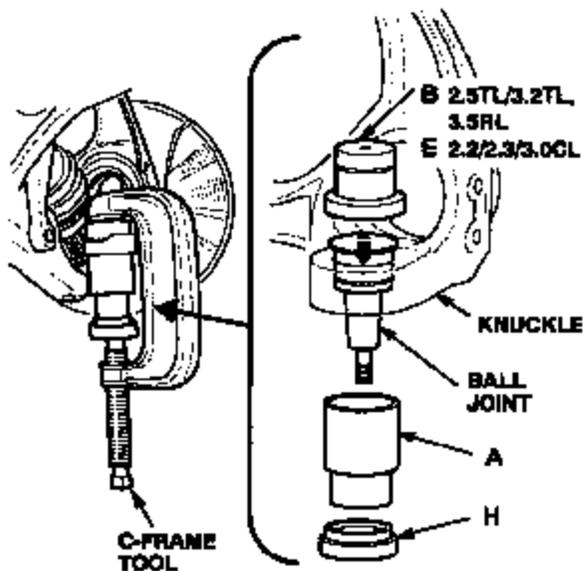
- Position the new ball joint in the knuckle. Do not remove the boot from the ball joint.
- Install the special tools on the ball joint and the knuckle.

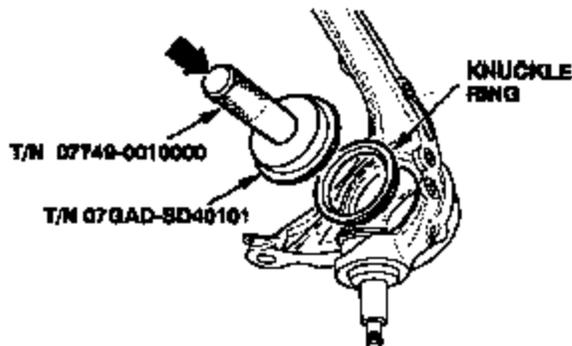
- Tighten the C-frame and press the ball joint into the knuckle.
- 3.5RL and 3.2TL only:* Install a new knuckle ring.

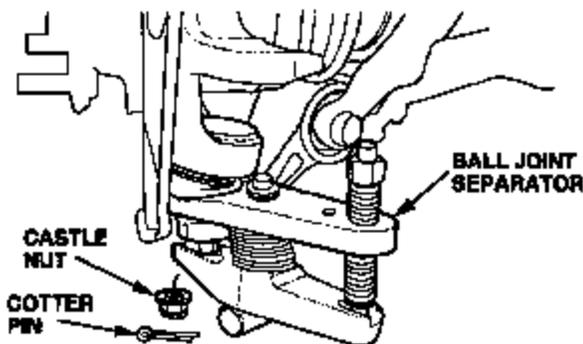
1. Raise the vehicle on a hoist. Remove the front wheels.
2. Remove and discard the spindle nut.
3. Remove the cotter pin and castle nut from the lower ball joint. Discard the cotter pin.

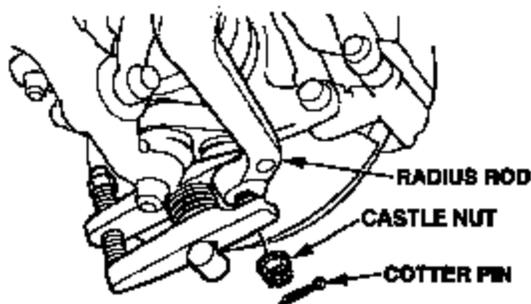
4. Separate the lower control arm from the ball joint with the special tool. To avoid damaging the ABS sensor harness, do not let the knuckle hang by its weight.
5. *Prelude Type SH only:* Separate the radius rod from the ball joint with the special tool. Take care not to damage the boot. Replace the boot if it is damaged during separation.

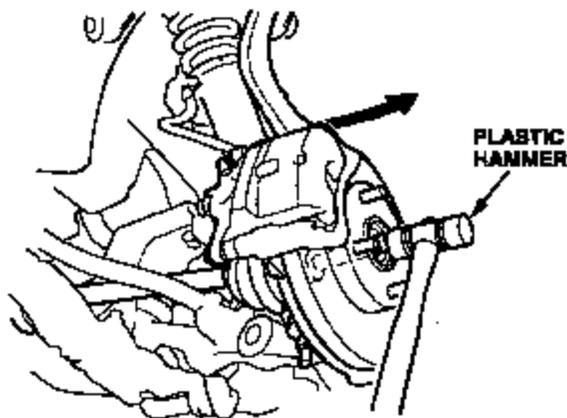
6. Remove the axle from the front wheel hub. If the axle is stuck to the hub, go to step 7. If the axle comes out easily, go to step 10.

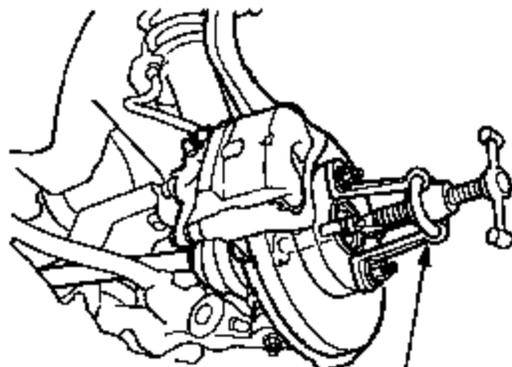
7. Reinstall the knuckle on the lower control arm and loosely install the castle nut.
8. Using a heavy-duty hub puller, free the axle from the hub. Do not press it all the way out.

Use Snap-on P/N CJ-128, Old Forge P/N 2518, or equivalent.

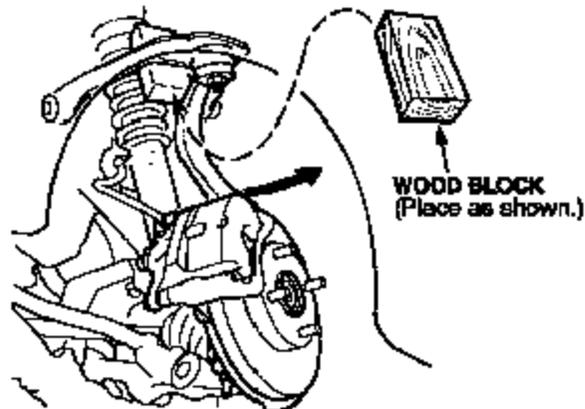
9. Remove the castle nut, lift and support the knuckle (to prevent damaging the ABS sensor wire harness), and press the axle out of the hub.
10. Lift the knuckle, then place a block of wood (about 2-3/4" x 1-1/2" by 5") between the upper control arm and the damper assembly.

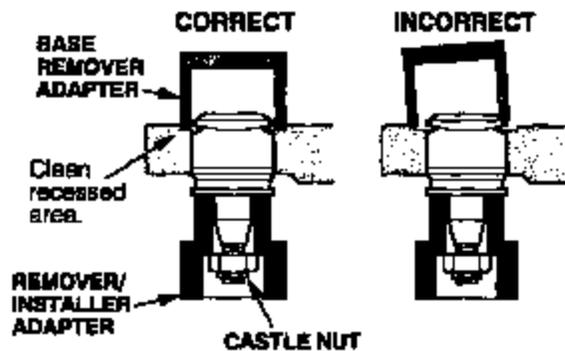
13. Clean the recessed area around the ball joint with solvent and compressed air, then install the base remover adapter (Tool C or F).

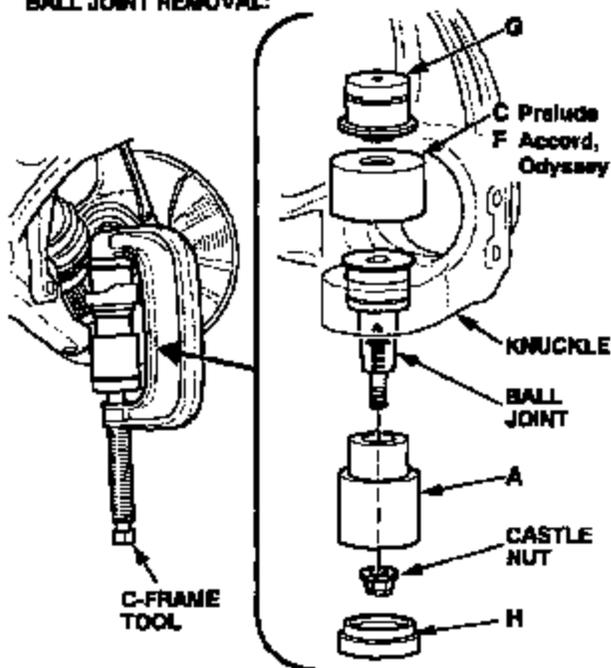
BALL JOINT REMOVAL:

14. Hold the remover installer adapter (Tool A) up to the ball joint, then install the castle nut to hold it in place. Install the remaining special tools on the lower ball joint and the knuckle. To avoid damaging the special tools, verify that they are correct for the vehicle you are working on and are aligned properly.

NOTE: On the Prelude Type SH, make sure you are removing the ball joint that connects to the lower control arm. Do not remove the ball joint that connects to the radius rod.

15. Tighten the C-frame and press the lower ball joint out of the knuckle.

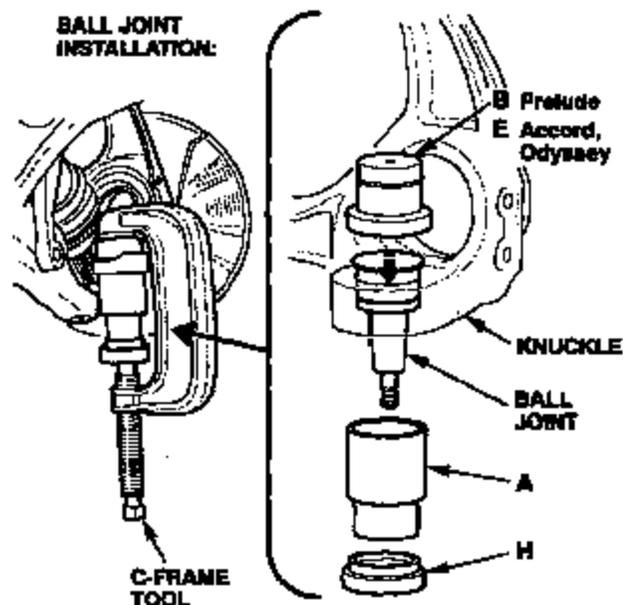
BALL JOINT INSTALLATION:

16. Position the new ball joint in the knuckle. Do not remove the boot from the ball joint.
17. Install the special tools on the ball joint and the knuckle.

18. Tighten the C-frame and press the ball joint into the knuckle.
19. *1997 Accord and all Odyssey only:* Reinstall the brake rotor/hub assembly. Torque the flange bolts to 44 N-m (33 lb-ft). Reinstall the brake caliper. Torque the mounting bolts to 108 N-m (80 lb-ft).
