SAFETY RECALL DSC and ELG

FRONT PASSENGER AIRBAG INFLATOR MODULE

CERTAIN 2002 – 2007 MODEL YEAR SC 430

Updated 9-30-15

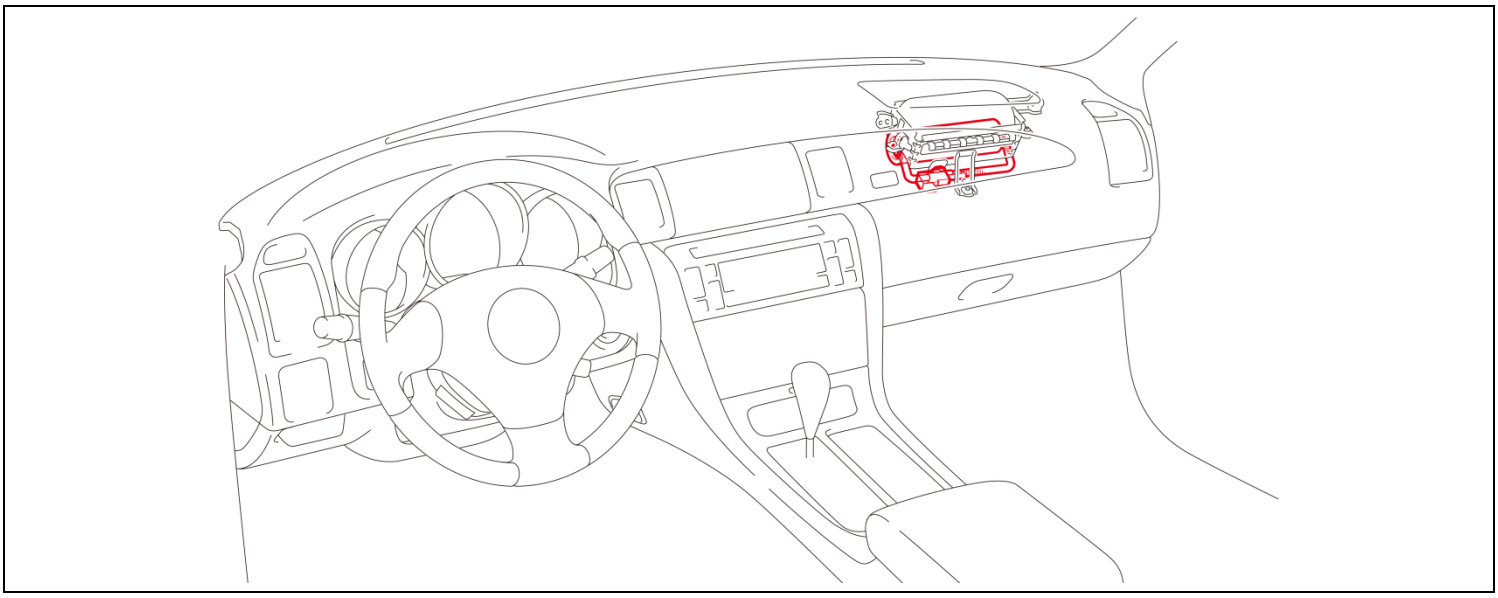
The subject vehicles are equipped with front passenger airbag assemblies. When located in areas with consistently high absolute humidity, the front passenger airbag inflator could be susceptible to rupture in a crash. An inflator rupture may result in metal fragments striking and potentially seriously injuring the vehicle occupants. The cause of the potential ruptured inflators and influence of high absolute humidity are under investigation.

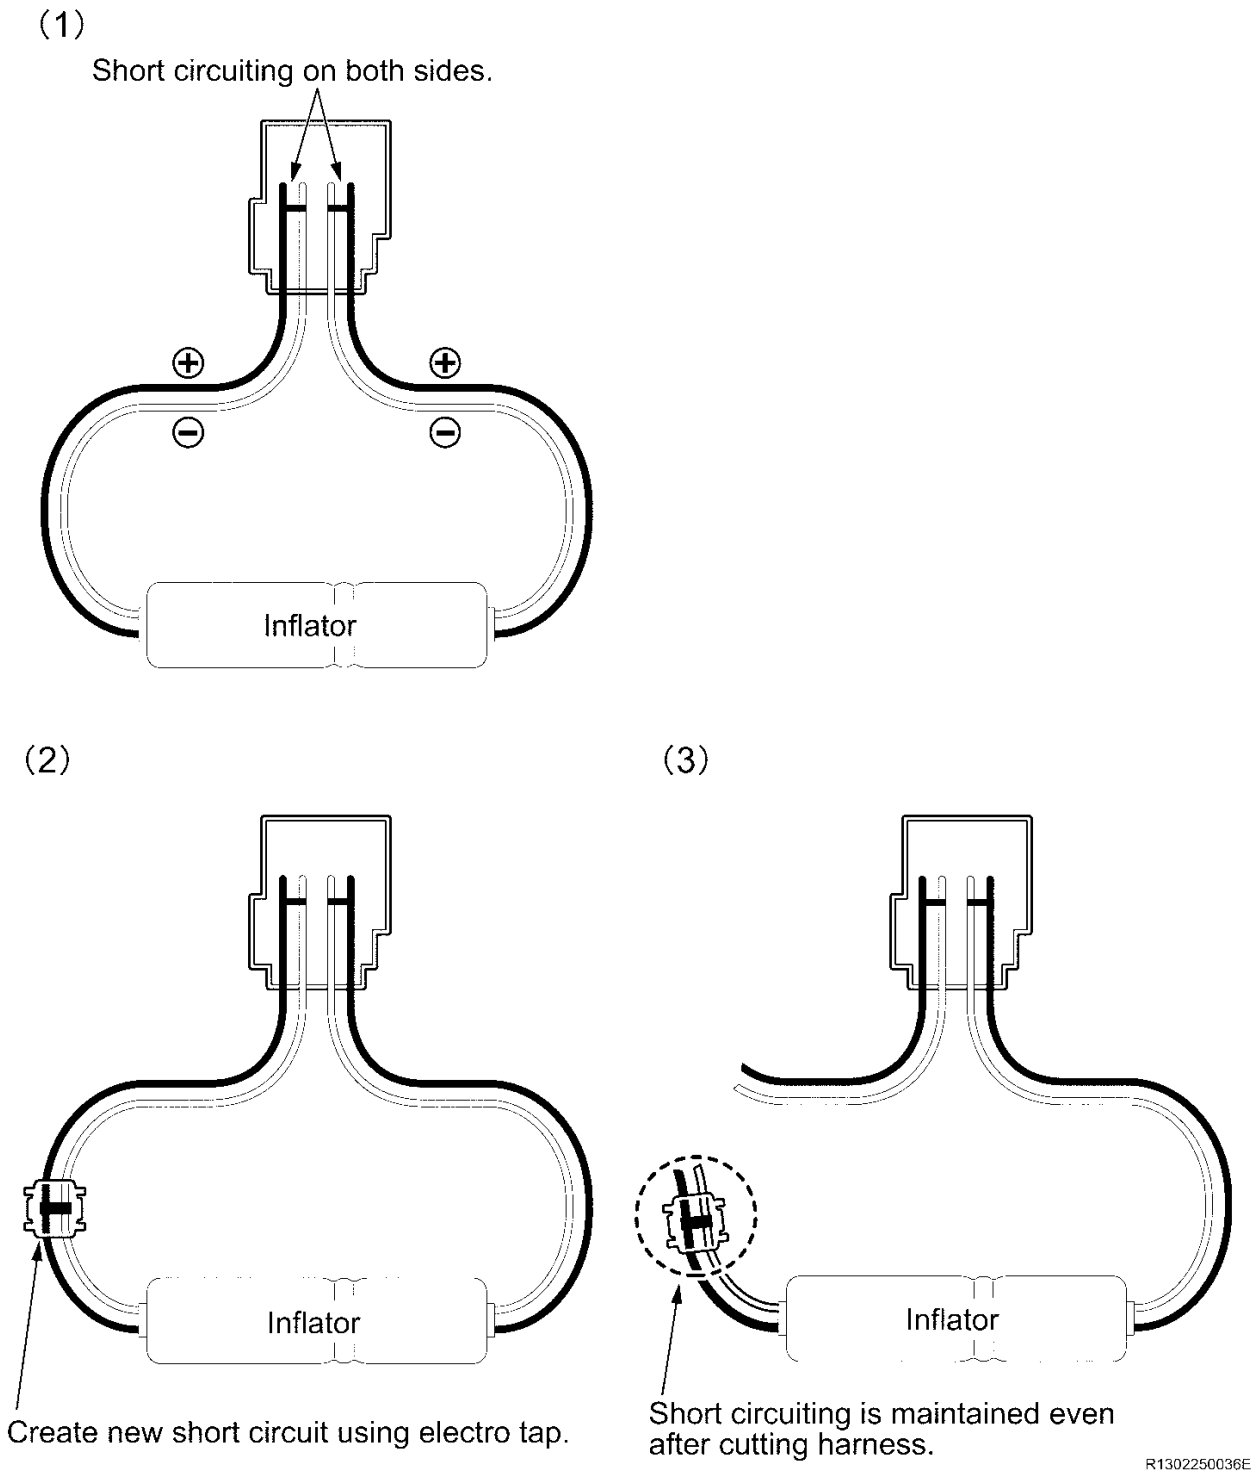
The connector of the inflator module contains a short circuiting mechanism to eliminate voltage variances when the connector (1) is disconnected. To allow for the replacement of the inflator module, a new short circuit (2) *MUST* be created before cutting the wires (3) and removing the inflator. The following steps *MUST* be followed exactly as described to ensure the work is completed correctly and safely.

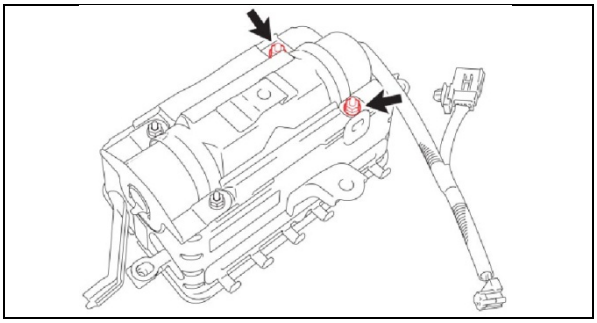
> **STOP** **The position determining plate can only be installed on one side in one position, confirm the plate is aligned correctly.**

b) Install the position determining plate and install the 2 ***NEW*** nuts by hand. They will be torqued on a later step.

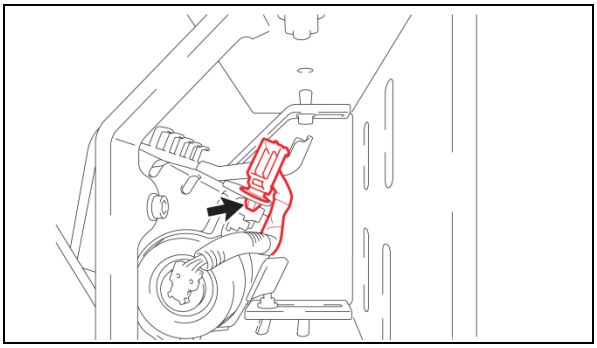
- **The connector should be connected *IMMEDIATELY* after removing the seal.**
- **The connector is one-way, once it is installed it *CANNOT* be removed.**
- **If the connector is installed in the incorrect orientation the terminals may be bent or the connector may not fully engage.**
