**Re: Defect Information Report – Supplemental Report No. 5  
08V-137, FL-527, 8K Thin Spindle Nut**

## Subject: Medium Duty Axle Spindle Nuts

**Models Affected:** Specific Freightliner Business Class and Business Class M2 vehicles; Sterling Acterra vehicles; and Freightliner Custom Chassis FS65 and B2 school bus chassis (Thomas Built Buses Saf-T-Liner C2) and FB65 shuttle bus chassis manufactured between January 26, 2000, and March 24, 2008, by ArvinMeritor or Axle Alliance Company with 6,000 or 8,000 pound front axles and a four-piece spindle nut set.

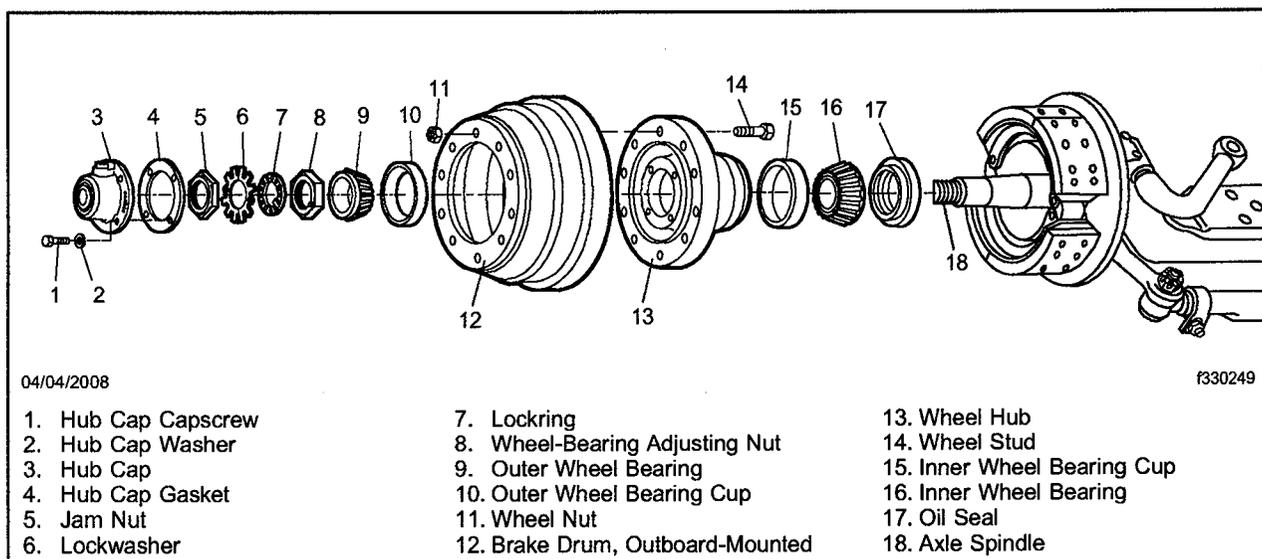
Fig. 1, Front Axle Assembly, Drum Brakes (New Spindle Nut Set Shown)

5. Remove the jam nut, lockwasher, lockring, and wheel-bearing adjusting nut. See **Fig. 1** and **Fig. 2** for assembly diagrams.
6. To hold the hub on the wheel bearings and protect the oil seal and spindle threads from damage, install and hand tighten the jam nut.
7. Inspect the back side (bearing contact side) of the adjusting nut for signs of scoring.

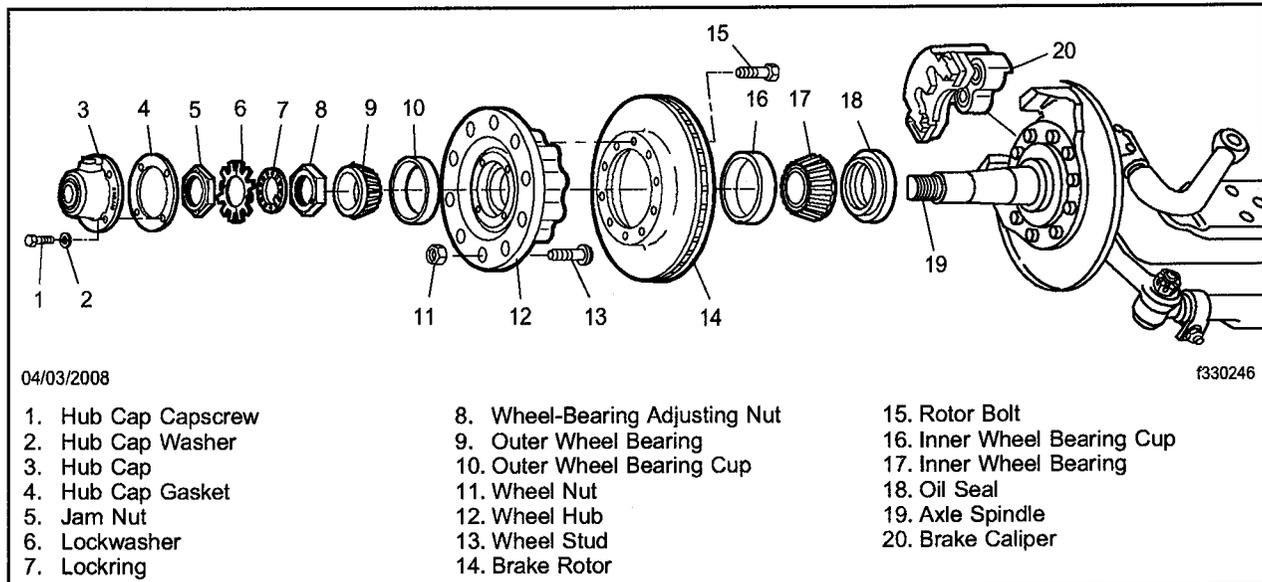
Fig. 2, Front Axle Assembly, Disc Brakes (New Spindle Nut Set Shown)

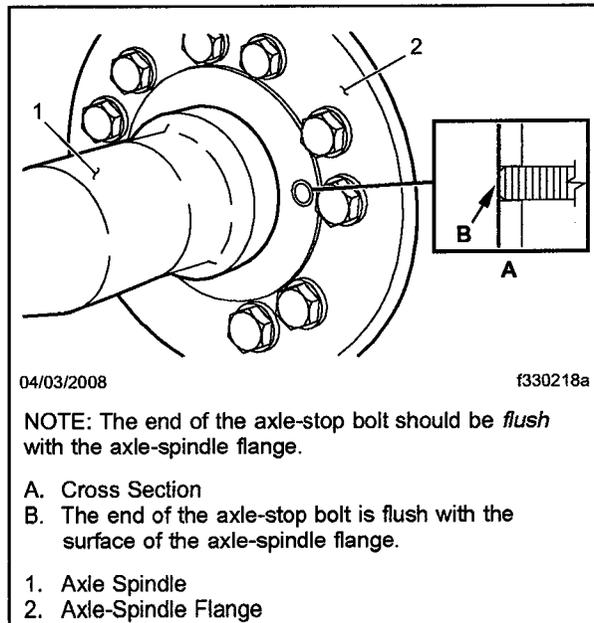
**Fig. 3, End of Axle-Stop Bolt Installed Flush with Axle-Spindle Flange**

If the bolt end is flush with the axle-spindle flange (see Fig. 3), go to the next step.

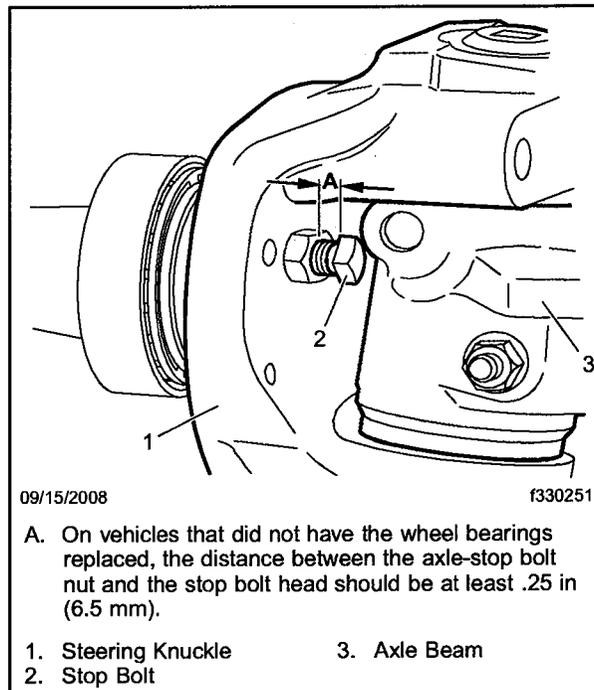
**Fig. 4, Stop Bolt, Gap Between the Nut and Head**

- 1.1 Measure the distance between the axle-stop bolt nut and the stop bolt head. See **Fig. 4**.

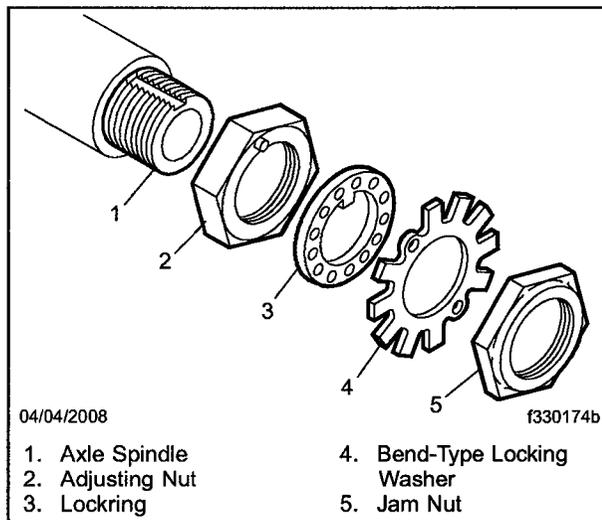
**Fig. 5, New Four-Piece Spindle Nut Set**

2. Install the new spindle nut set, which includes the thicker wheel-bearing adjusting nut. See **Fig. 5** and **Fig. 6**.

2.5 Install the lockring (as described in the note above), bend-type locking washer, and jam nut. See **Fig. 5**.

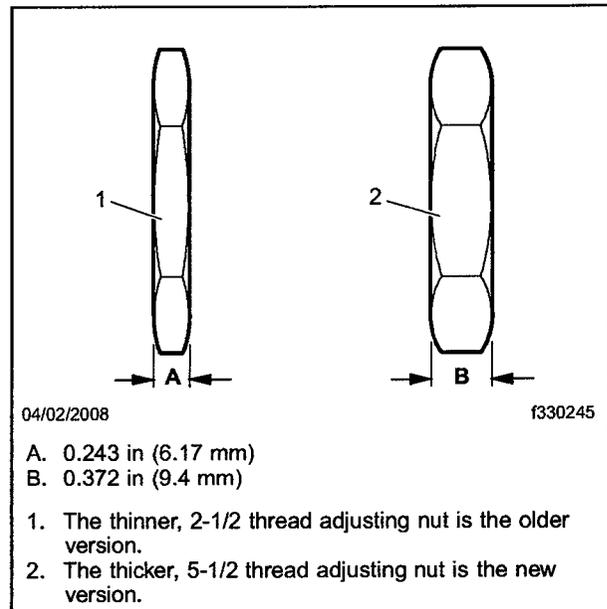
**Fig. 6, Wheel-Bearing Adjusting Nuts**

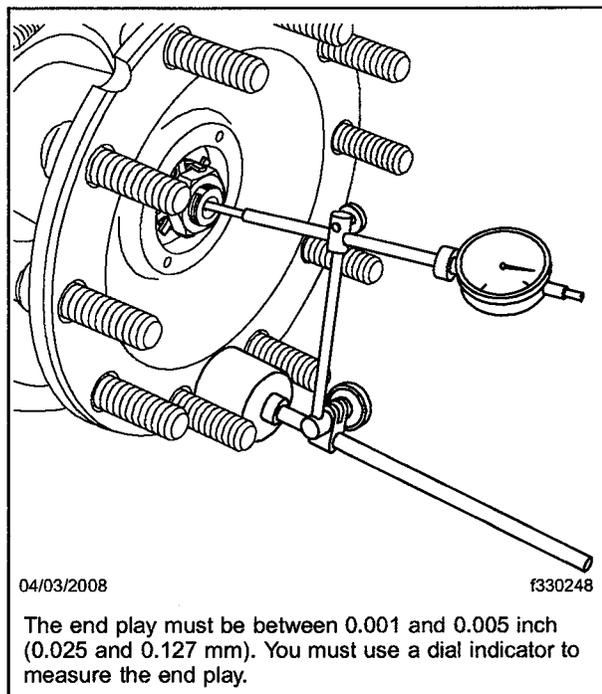
**Fig. 7, Using the Dial Indicator**

3. *Attach a dial indicator to the hub*, and set the point of the indicator in line with the end of the axle spindle. The point of the indicator should be parallel to the spindle axis. See **Fig. 7**.

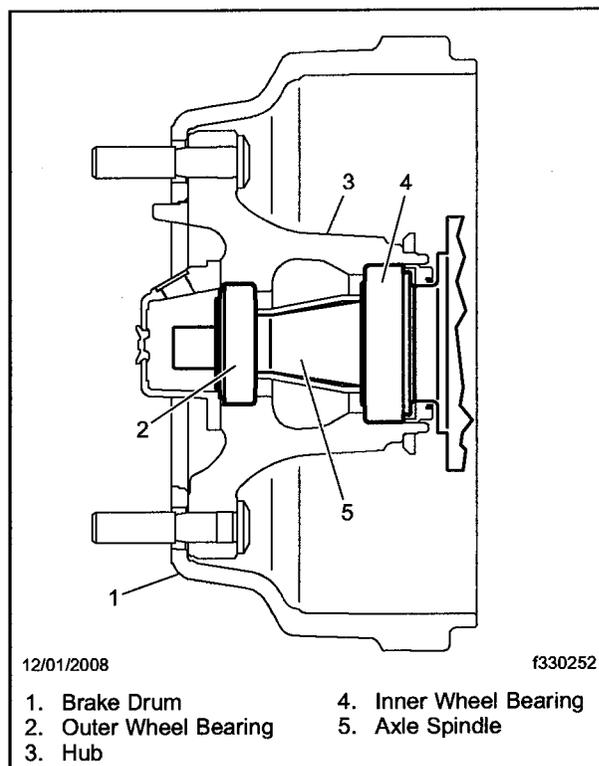
**Fig. 8, Bearings Between the Hub and Axle Spindle**

4. If the brakes were used to hold the drum during installation, release them.
5. Seat the bearings. There are two roller bearings between the hub and the axle spindle, each of which consists of four basic parts: the cone (inner race), cage, rollers, and cup (outer race). See **Fig. 8** and **Fig. 9**. To achieve the correct end play, the rollers must be rolled into position against the large rib of the cone as follows.

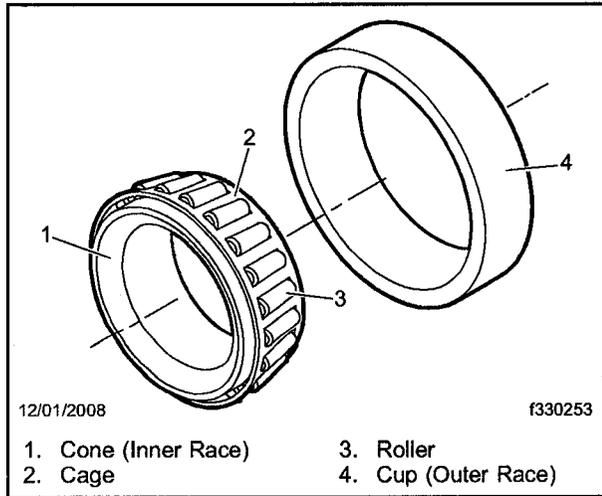
**Fig. 9, Wheel Bearing**

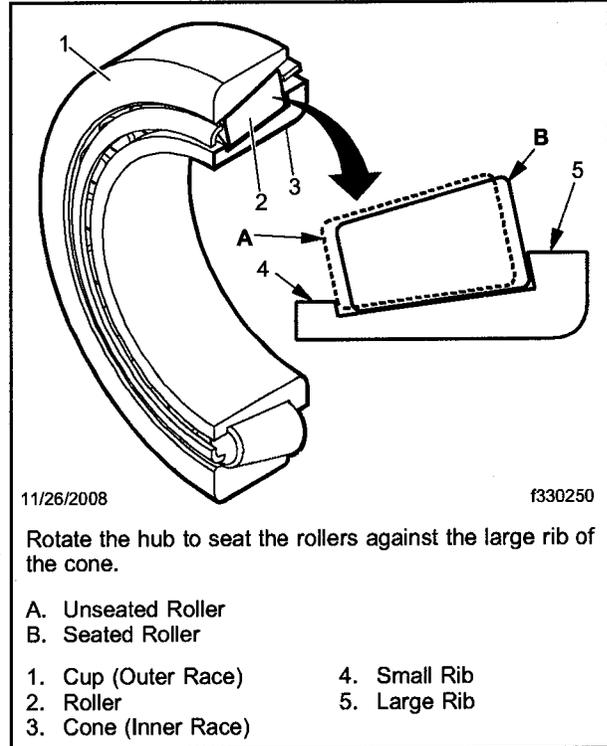
**Fig. 10, Seated Roller, Wheel Bearing**

Grasp the wheel hub at the 3 o'clock and 9 o'clock positions and push the hub toward the vehicle while rotating it 90 degrees back and forth. Rotating the hub in this manner forces the rollers into position against the large rib of the cone. See **Fig. 10**. *This is absolutely necessary to seat the bearings correctly.*

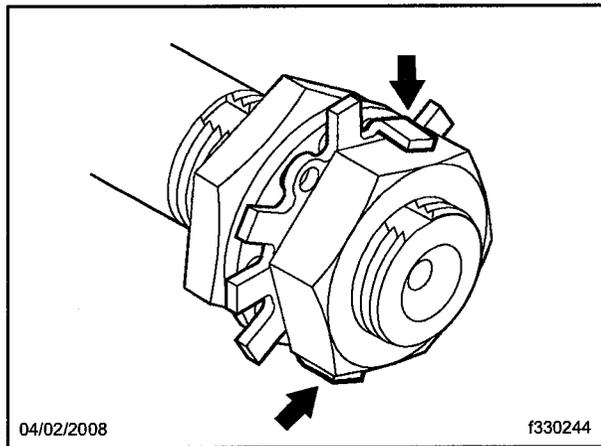
Fig. 11, Tabs Bent to Lock the Jam Nut

9. Bend the tabs on the locking washer at 6 o'clock and 12 o'clock to lock the jam nut in place. See **Fig. 11**.

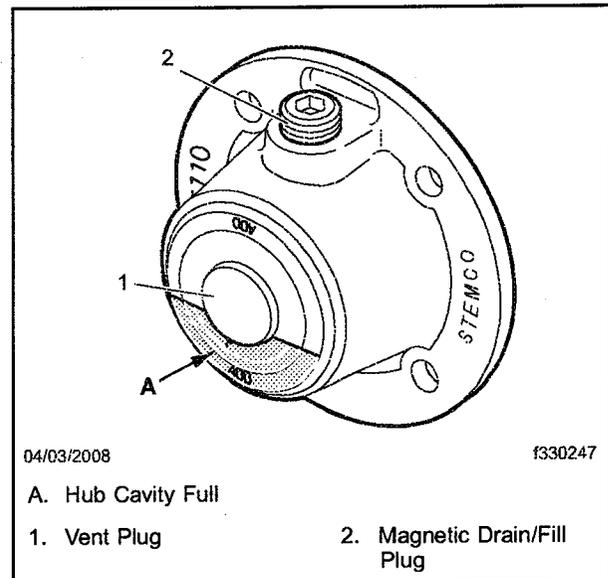
Fig. 12, Stemco Hub Cap

12.3 Add enough oil (about 2 oz or 60 mL) to the hub to bring the level up to the bottom of the vent cap. See **Fig. 12**.

12.5 Once the oil level has stabilized in the hub cap, check the level in the window and, if needed, add enough oil to bring the level up to the bottom of the vent plug. See **Fig. 12**.

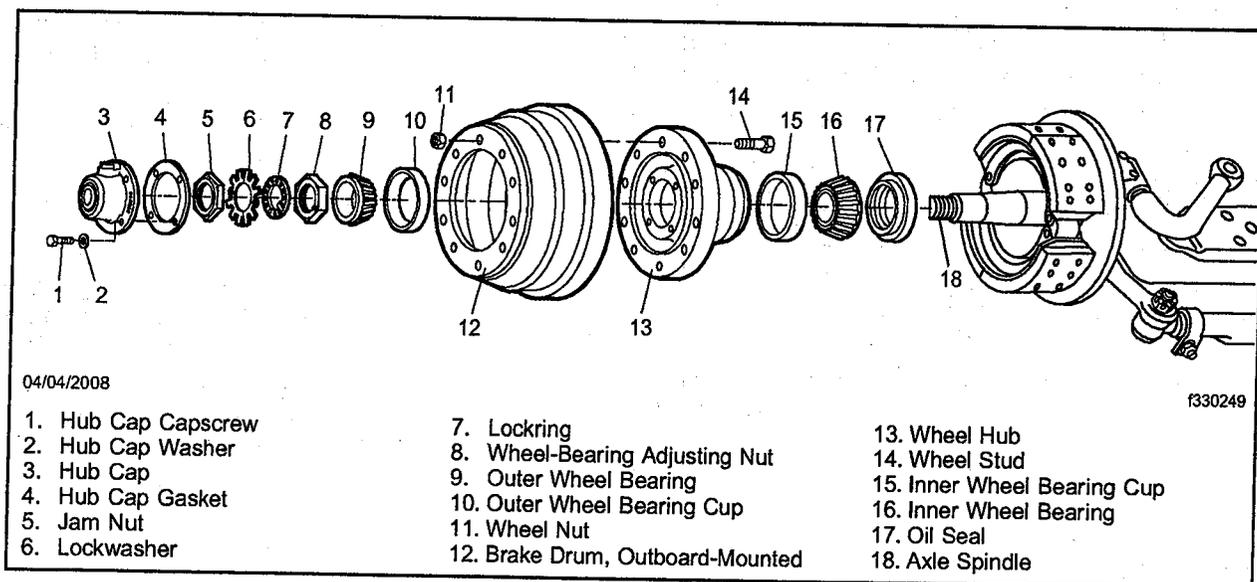
Fig. 1, Front Axle Assembly, Drum Brakes (New Spindle Nut Set Shown)

5. Remove the jam nut, lockwasher, lockring, and wheel-bearing adjusting nut. See **Fig. 1** and **Fig. 2** for assembly diagrams.
6. To hold the hub on the wheel bearings and protect the oil seal and spindle threads from damage, install and hand tighten the jam nut.
7. Inspect the back side (bearing contact side) of the adjusting nut for signs of scoring.

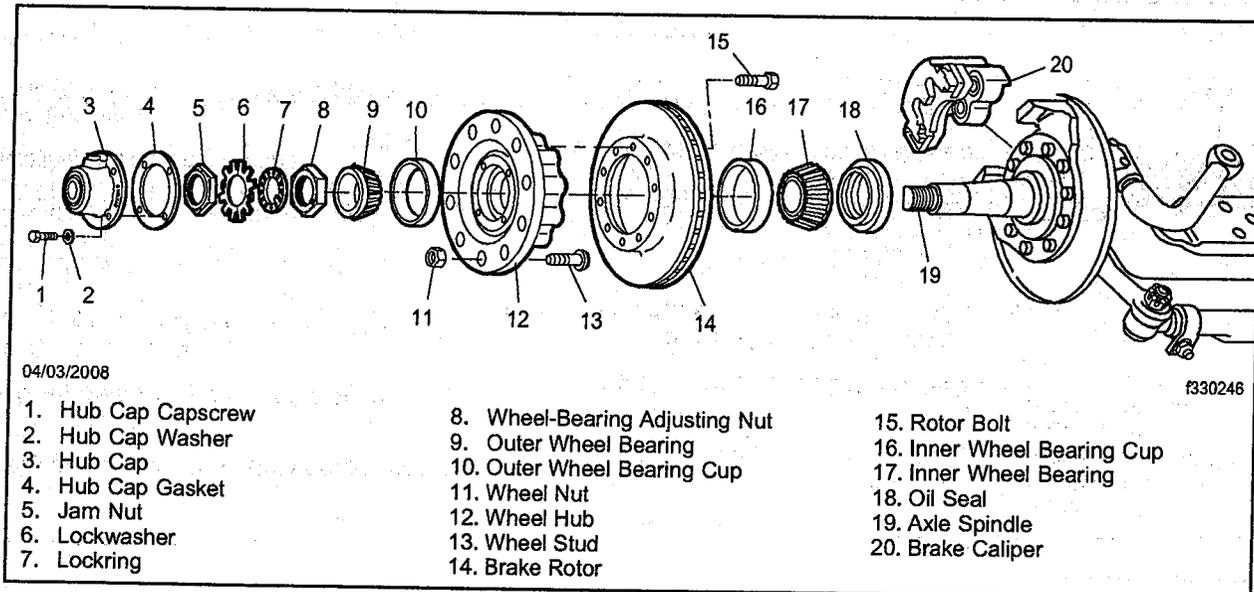
Fig. 2, Front Axle Assembly, Disc Brakes (New Spindle Nut Set Shown)

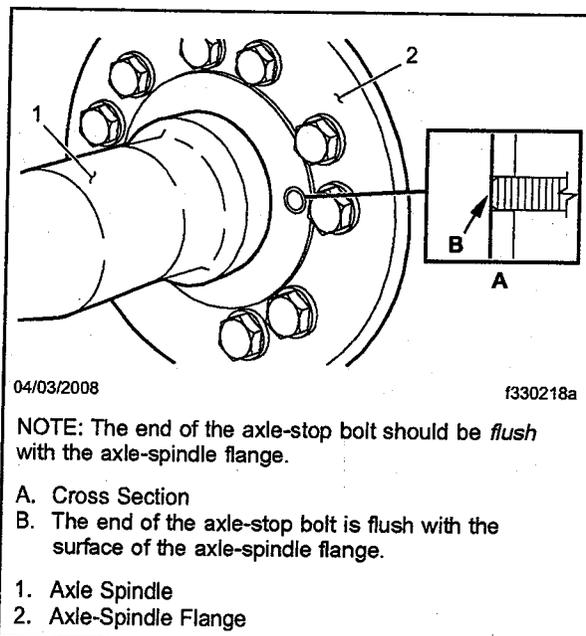
Fig. 3, End of Axle-Stop Bolt Installed Flush with Axle-Spindle Flange

If the bolt end is flush with the axle-spindle flange (see Fig. 3), go to the next step.

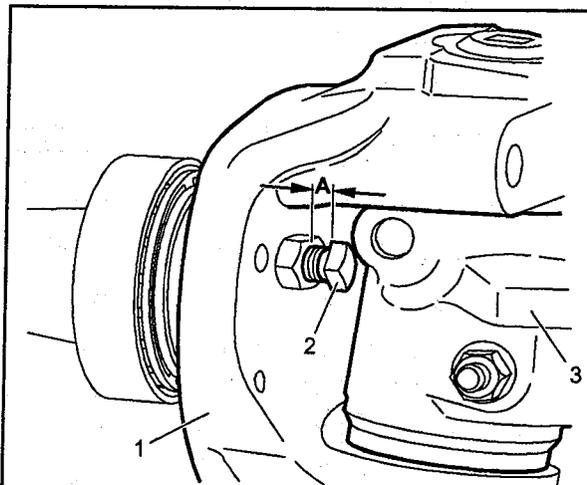
**Fig. 4, Stop Bolt, Gap Between the Nut and Head**

- 1.1 Measure the distance between the axle-stop bolt nut and the stop bolt head. See **Fig. 4**.

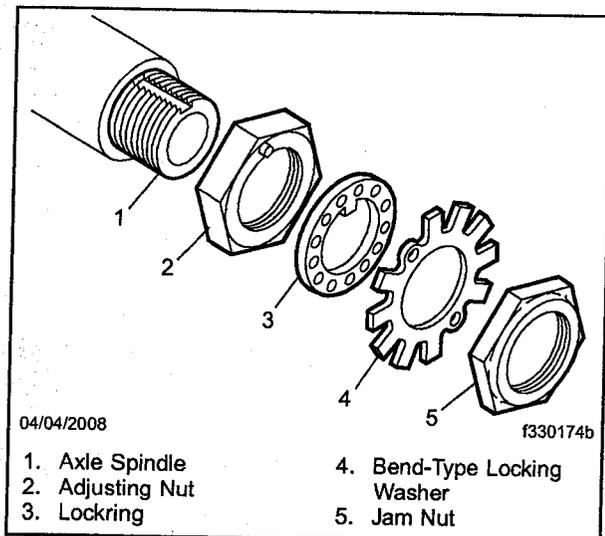
Fig. 5, New Four-Piece Spindle Nut Set

2. Install the new spindle nut set, which includes the thicker wheel-bearing adjusting nut. See Fig. 5 and Fig. 6.

- 2.5 Install the lockring (as described in the note above), bend-type locking washer, and jam nut. See Fig. 5.

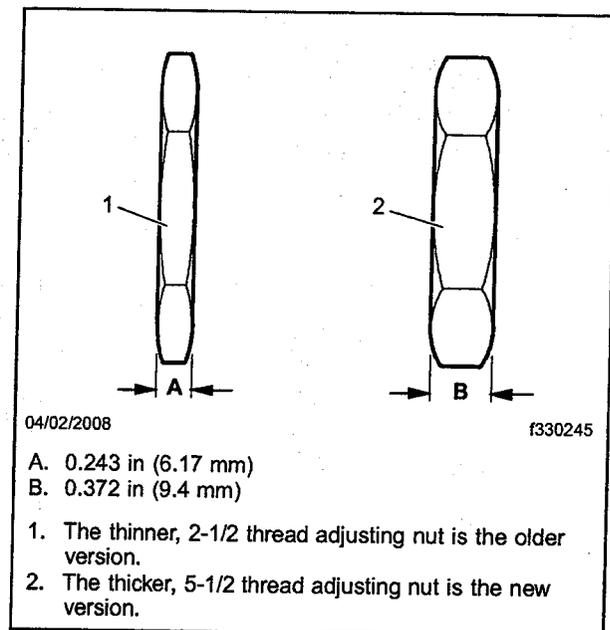
Fig. 6, Wheel-Bearing Adjusting Nuts

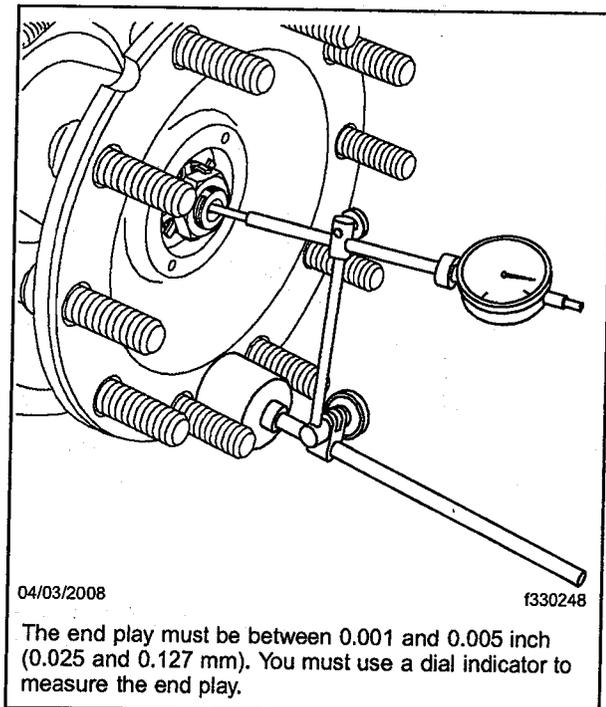
Fig. 7, Using the Dial Indicator

3. Attach a dial indicator to the hub, and set the point of the indicator in line with the end of the axle spindle. The point of the indicator should be parallel to the spindle axis. See Fig. 7.

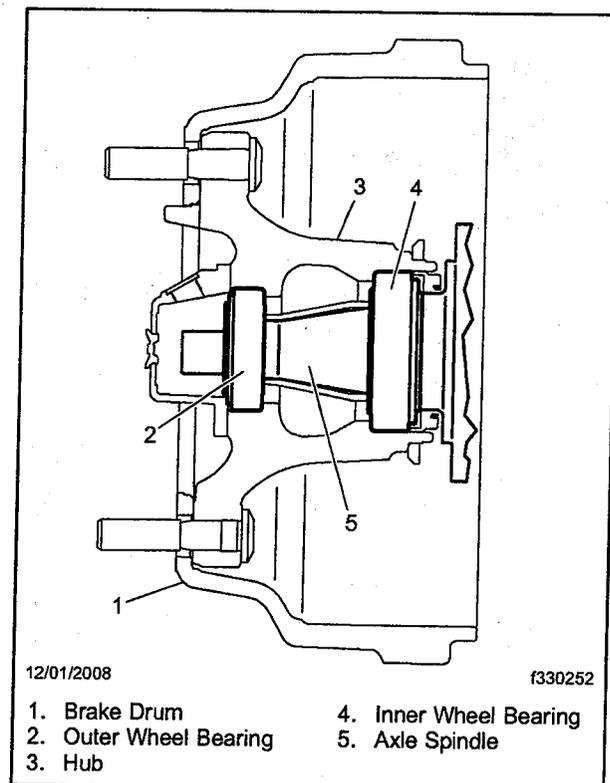
Fig. 8, Bearings Between the Hub and Axle Spindle

4. If the brakes were used to hold the drum during installation, release them.
5. Seat the bearings. There are two roller bearings between the hub and the axle spindle, each of which consists of four basic parts: the cone (inner race), cage, rollers, and cup (outer race). See Fig. 8 and Fig. 9. To achieve the correct end play, the rollers must be rolled into position against the large rib of the cone as follows.

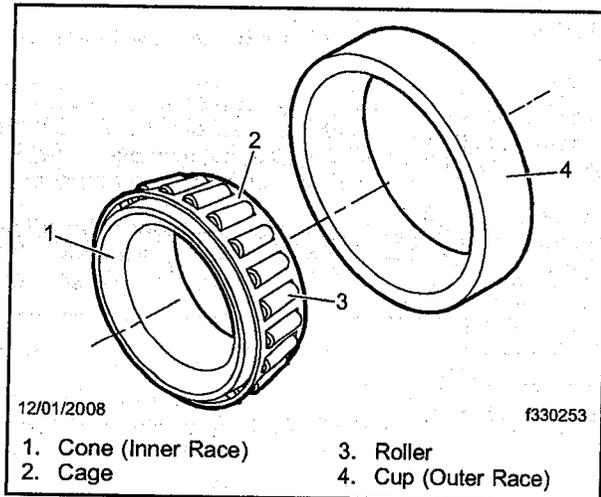
**Fig. 9, Wheel Bearing**

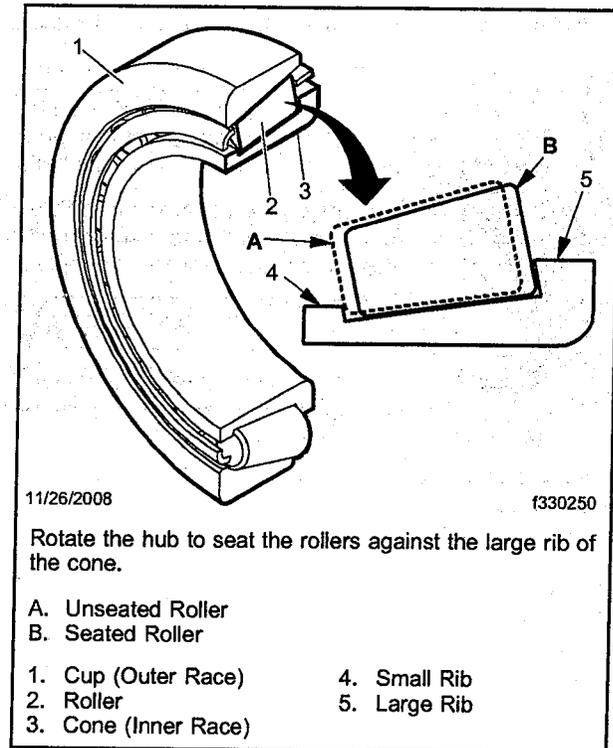
**Fig. 10, Seated Roller, Wheel Bearing**

Grasp the wheel hub at the 3 o'clock and 9 o'clock positions and push the hub toward the vehicle while rotating it 90 degrees back and forth. Rotating the hub in this manner forces the rollers into position against the large rib of the cone. See Fig. 10. *This is absolutely necessary to seat the bearings correctly.*

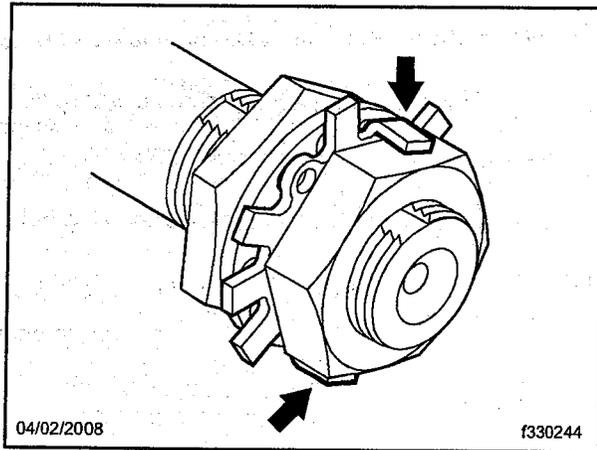
Fig. 11, Tabs Bent to Lock the Jam Nut

9. Bend the tabs on the locking washer at 6 o'clock and 12 o'clock to lock the jam nut in place. See Fig. 11.

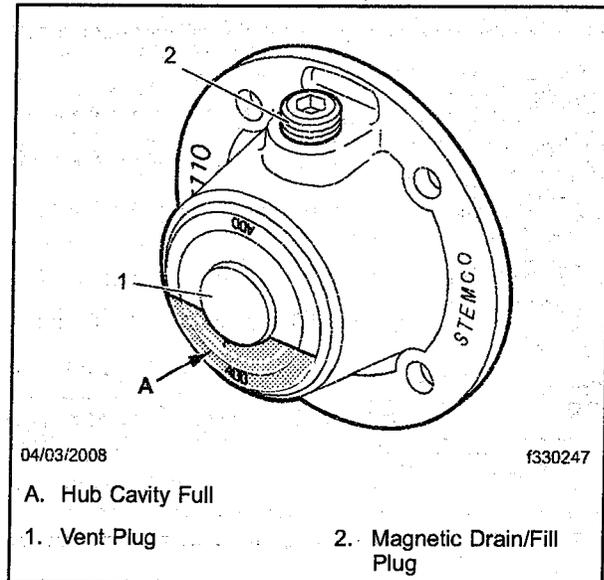
Fig. 12, Stemco Hub Cap

12.3 Add enough oil (about 2 oz or 60 mL) to the hub to bring the level up to the bottom of the vent cap. See Fig. 12.

12.5 Once the oil level has stabilized in the hub cap, check the level in the window and, if needed, add enough oil to bring the level up to the bottom of the vent plug. See Fig. 12.
