SAFETY RECALL DSF and E04

FRONT PASSENGER AIRBAG INFLATOR MODULE

CERTAIN 2003 – 2006 MODEL YEAR TUNDRA

Updated 11-12-15

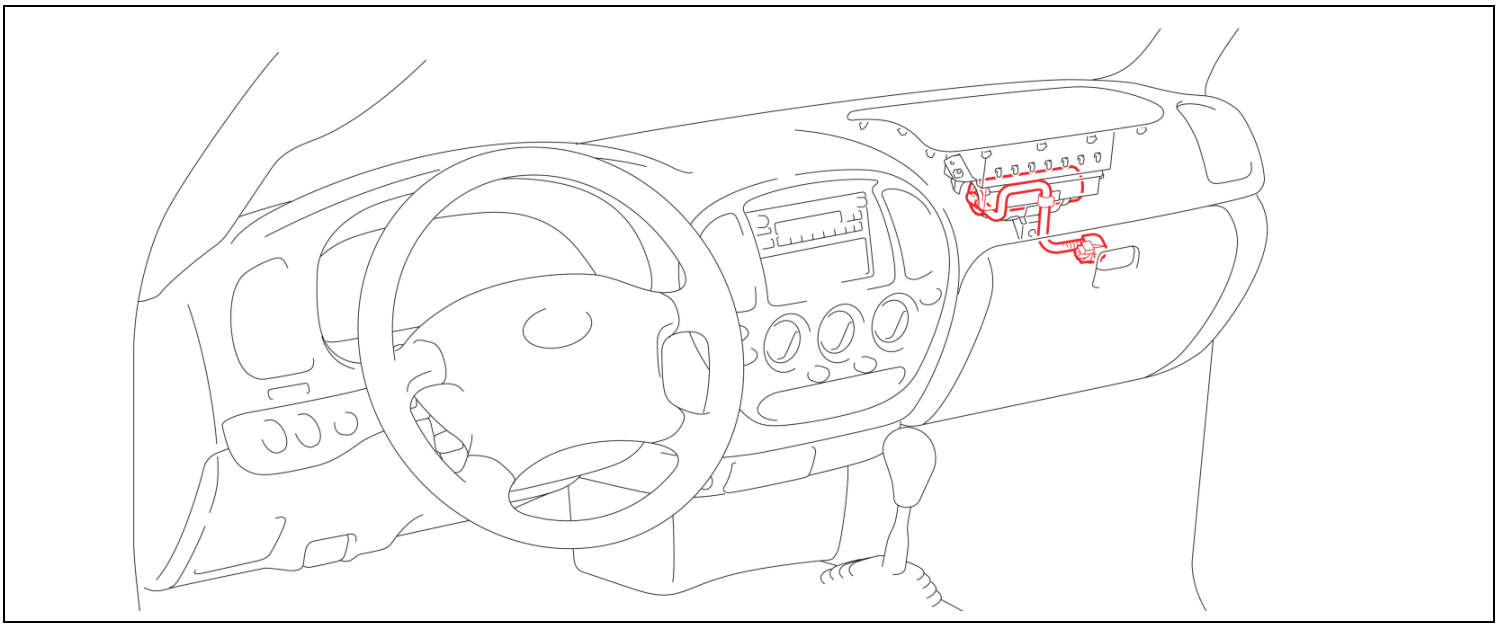
The subject vehicles are equipped with front passenger airbag assemblies. When located in areas with consistently high absolute humidity, the front passenger airbag inflator could be susceptible to rupture in a crash. An inflator rupture may result in metal fragments striking and potentially seriously injuring the vehicle occupants. The cause of the potential ruptured inflators and influence of high absolute humidity are under investigation.

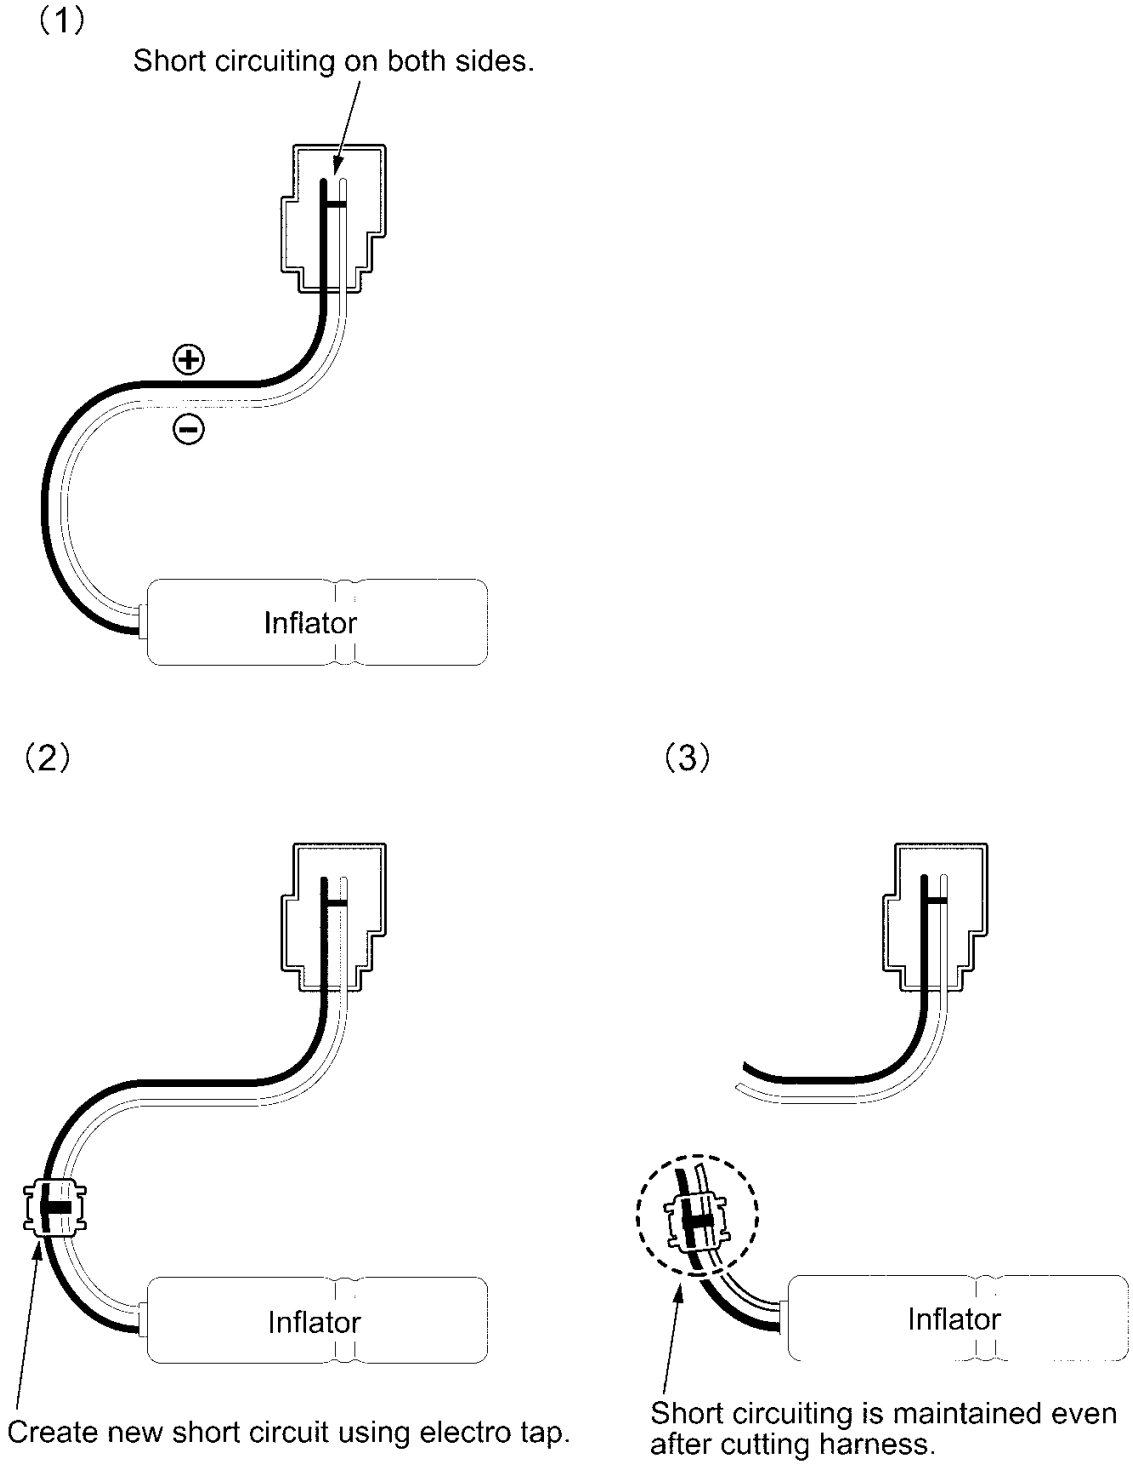
The connector of the inflator module contains a short circuiting mechanism to eliminate voltage variances when the connector(1) is disconnected. To allow for the replacement of the inflator module, a new short circuit(2) *MUST* be created before cutting the wires(3) and removing the inflator. The following steps *MUST* be followed exactly as described to ensure the work is completed correctly and safely.
