RE: NHTSA Recall Campaign Number: **03V-199**

SAFETY RECALL BULLETIN

SUBJECT: ArvinMeritor FF98x Series Unitized Steer Axle Bearings

Unitized Wheel-End Hub Replacement

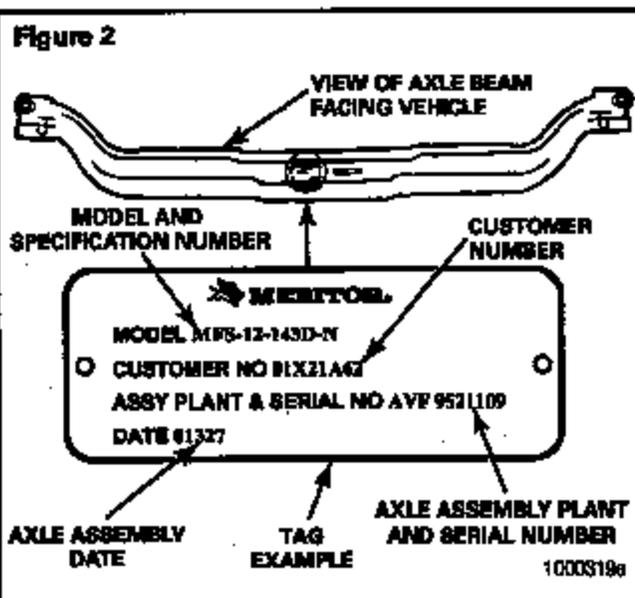
If the hubcaps are missing, you can use the axle model number to determine if the axle is equipped with unitized wheel ends. To identify the model number, refer to the axle identification plate on the front of the beam. Figure 2.

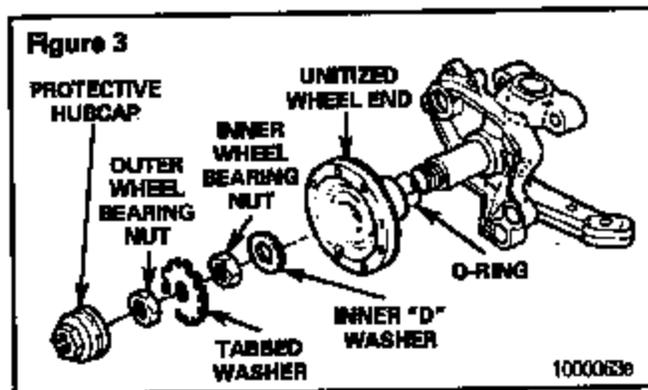
1. Park the vehicle on a level surface. Block the wheels to prevent the vehicle from moving. Set the parking brake.
2. Use the correct size socket to remove the threaded protective hubcap from the hub by turning the hubcap COUNTERCLOCKWISE. Figure 3.

8. Remove the uninitialized wheel end STRAIGHT from the spindle. Figure 3.

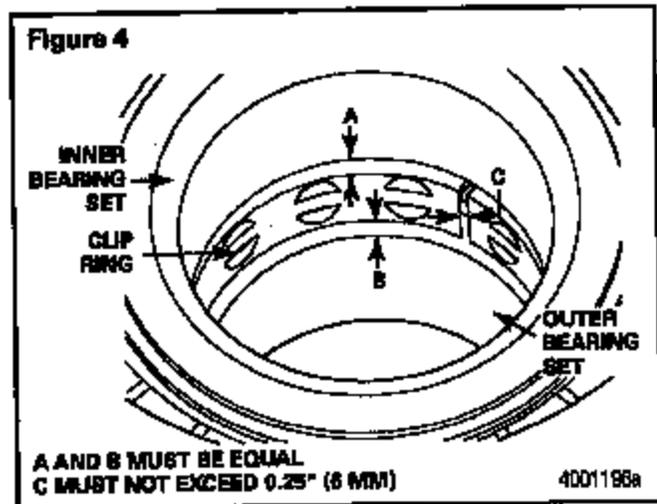
1. Remove the replacement hub from the box and place it on a clean surface.
2. Examine the interior of the hub to verify the following.
 - A. The inner clip ring has not become dislodged in shipment and is in correct alignment with the inner and outer bearings. The gap between the inner and outer bearing sets and the clip ring must be equal. Figure 4.
 - B. The gap between the ends of the clip ring must be equal and not exceed 0.25-inch (6 mm). If necessary, adjust by hand. Figure 4.
 - C. The bearing face must be clean with no seal coating, dirt or dust.

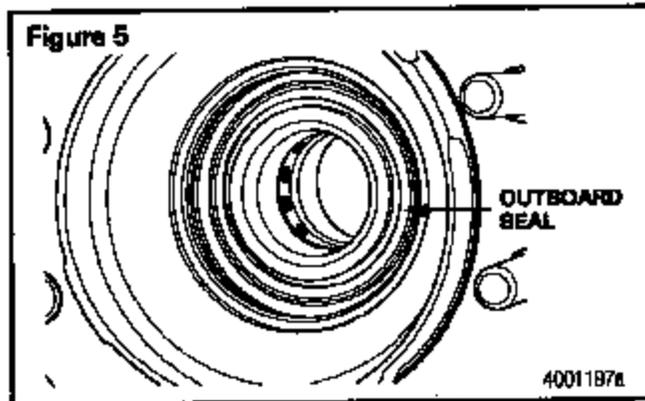
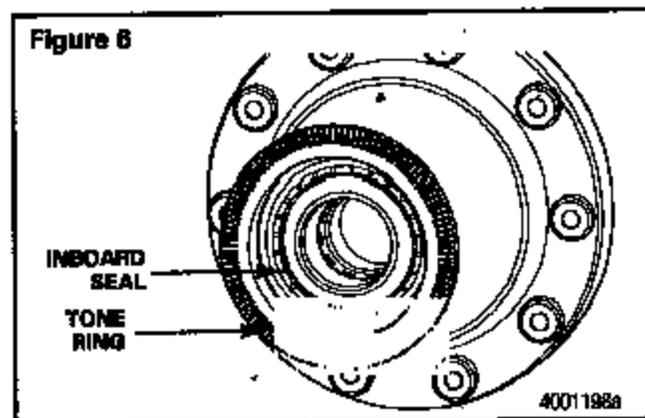
3. Examine the exterior of the hub to verify the following.
 - A. There is no visible damage to the inboard or outboard seals and the bearings have not become unseated. Figure 5 and Figure 6.
 - B. The tone ring teeth are not damaged and there are no broken or missing teeth on the tone ring. Figure 6.

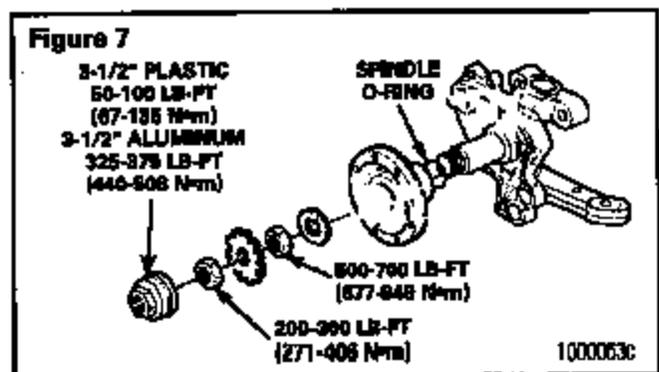
3. Coat the inside of the unitized wheel end with anti-seize compound. Make certain to cover the inner and outer bearing races. Do not apply anti-seize or anti-fretting compound onto the spindle or threads. Wipe away any anti-seize or anti-fretting compound that may have dripped onto the spindle threads.
4. Slide a new O-ring, Meritor part number 5X-1301, onto the spindle. The O-ring must be positioned against the knuckle journal. Figure 7.

6. Install the inner "D" washer and inner wheel bearing nut onto the spindle stud. Tighten the inner wheel bearing nut to 500-700 lb-ft (678-949 N·m) while rotating the unlubed wheel and a minimum of five rotations. **Figure 7.**

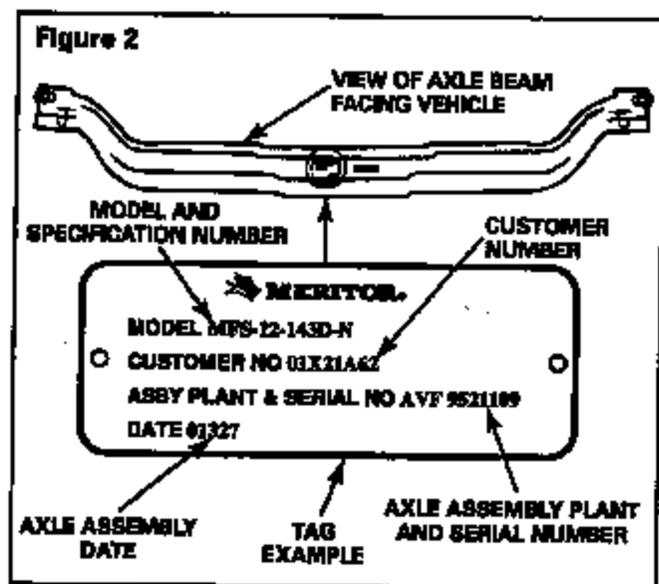
If the hubcaps are missing, you can use the axle model number to determine if the axle is equipped with unitized wheel ends. To identify the model number, refer to the axle identification plate on the front of the beam. Figure 2.

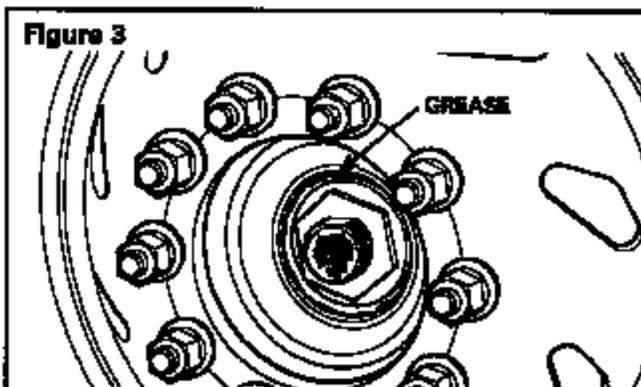
NOTE: The outboard and inboard seals may purge small amounts of grease that are visible during inspection. Figure 3. This is a normal occurrence.

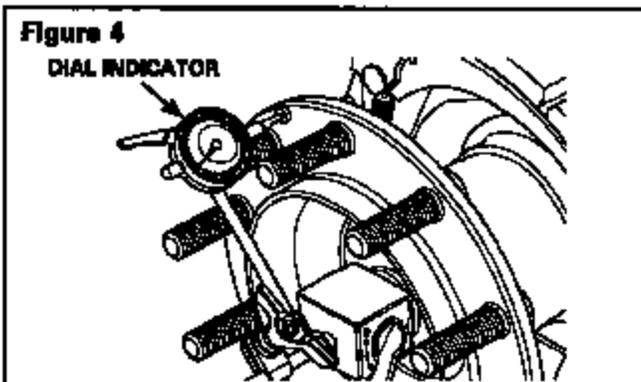
4. Remove the wheel and drum. Attach the magnetic base of a dial indicator to the end of the spindle. Figure 4. Touch the indicator stem perpendicular against the unitized wheel-end's mounting face.

5. Set the dial indicator to ZERO. Do not rotate the wheel end. Place your hands at the nine and three o'clock positions.

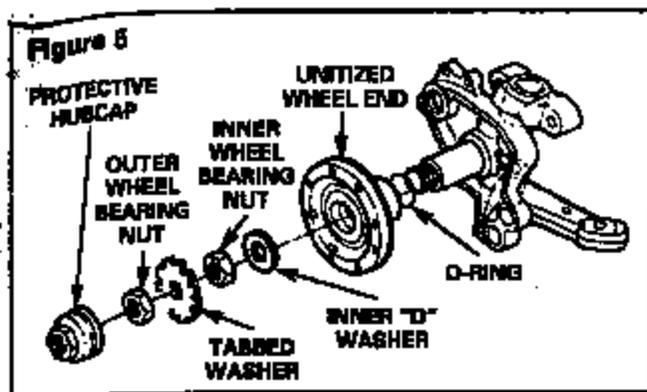
6. Push the unitized wheel end straight IN. Note the reading. Pull the unitized wheel end straight OUT. Note the reading.
- If the total movement of the dial indicator is less than 0.003-inch (0.08 mm): Inspection is complete. No adjustment is required.
 - If the total movement of the dial indicator is 0.003-inch (0.08 mm) or greater: Remove the OUTER bearing nut and tabbed washer. Tighten the INNER wheel bearing nut to 500-700 lb-ft (679-949 N·m) while rotating the unitized wheel end a minimum of five rotations. Figure 6. ①

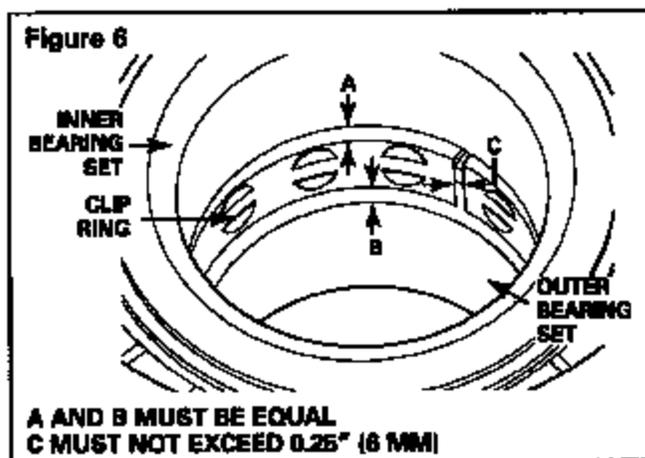
1. Remove the replacement hub from the box and place it on a clean surface.
2. Examine the interior of the hub to verify the following.
 - A. The inner clip ring has not become dislodged in shipment and is in correct alignment with the inner and outer bearings. The gap between the inner and outer bearing sets and the clip ring must be equal. Figure 8.
 - B. The gap between the ends of the clip ring must be equal and not exceed 0.26-inch (6 mm). If necessary, adjust by hand. Figure 8.
 - C. The bearing face must be clean with no seal coating, dirt or dust.

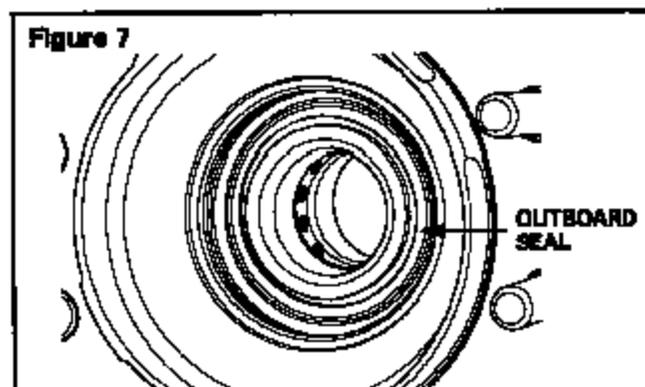
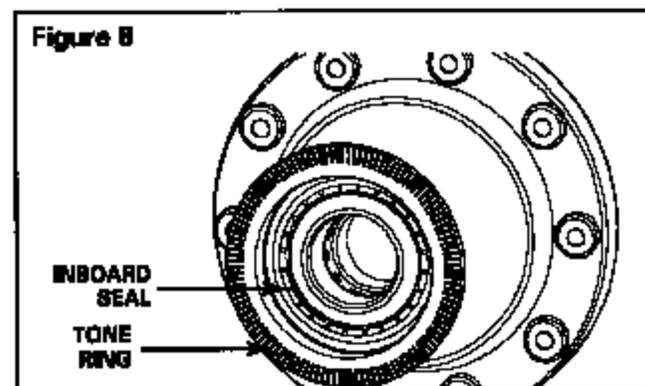
3. Examine the exterior of the hub to verify the following.
 - A. There is no visible damage to the inboard or outboard seals and the bearings have not become unseated. **Figures 7 and 8.**
 - B. The tone ring teeth are not damaged and there are no broken or missing teeth on the tone ring. **Figure 8.**

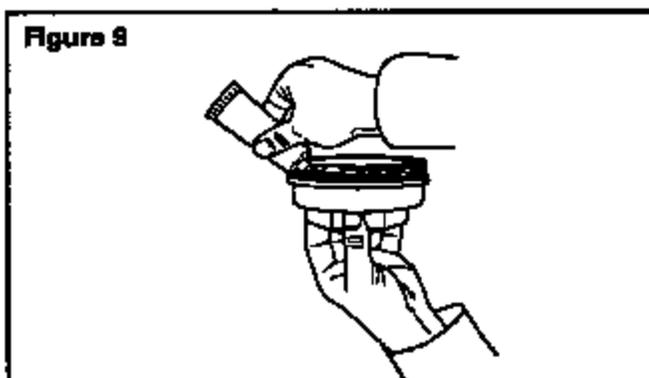
Figure 9

- Apply a continuous 1/8-3/16-inch (3-5 mm) bead of RTV sealant to the outside first thread around the entire circumference of the hubcap. You must use Meritor part number 2297-Z-7098 RTV sealant, Loctite® Adhesive Sealant number 5699.

- Install the plastic hubcap into the unitized wheel end by hand.
- Use a torque wrench with the correct size socket to tighten plastic hubcaps to 50-100 lb-ft (67-135 N•m). Disregard the torque value embossed on the hubcap.
