GENERAL MOTORS NORTH AMERICA
Safety Center

The following information is submitted pursuant to the requirements of 49 CFR 573.5 as it applies to a determination by General Motors of a defect which relates to motor vehicle safety involving certain 1998-99 Oldsmobile Intrigue model cars.

CONDITION

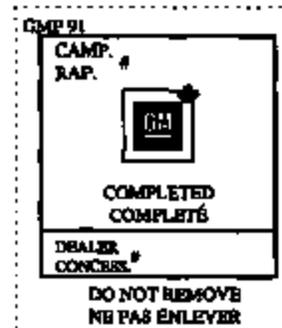
Place a Campaign Identification Label on each vehicle corrected in accordance with the instructions outlined in this Product Campaign Bulletin. Each label provides a space to include the campaign number and the five (5) digit dealer code of the dealer performing the campaign service. This information may be inserted with a typewriter or a ball point pen.

Put the Campaign Identification Label on a clean and dry surface of the radiator core support in an area that will be visible to people servicing the vehicle. Additional Campaign Identification Labels for Canadian dealers can be obtained from DGN by calling 1-800-568-5539 (Monday-Friday, 8:00 a.m. to 5:00 p.m. EST). Ask for Item Number GMP 91 when ordering.
