PART 573 Defect and Noncompliance Reporting

Defect Report

Blue Bird All American and TC/2000 school and transit buses, Q Bus and Commercial Series buses manufactured from February 02, 1999 through August 04, 2000 equipped with electronic engines and Felsted electronic accelerator pedals.

Throttle Pedal Spring Pack Replacement

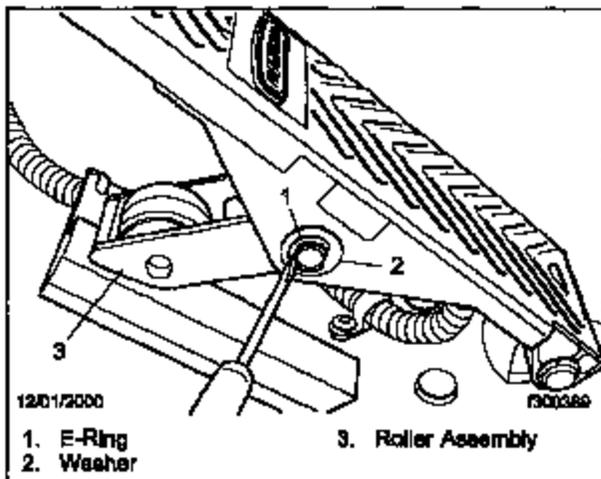
Fig. 1, Throttle Pedal, Left-Side View

3. Remove the E-ring and washer from the throttle pedal. See Fig. 1.
4. Remove the two sensor screws that attach the sensor to the throttle pedal. Remove the sensor. See Fig. 2.
5. Using a Phillips screwdriver, remove the sensor shaft by pushing it out from the E-ring side of the throttle pedal. Hold the roller and spring assembly with your hand while removing the sensor shaft.

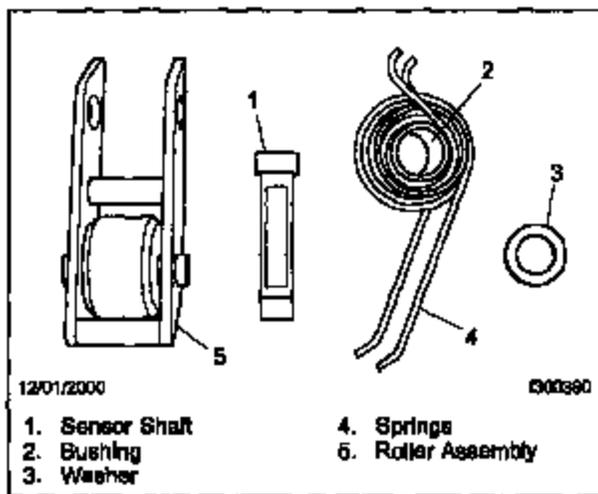
Fig. 3, Throttle Pedal Parts

6. Remove the bushing (Fig. 3) from the spring assembly that was just removed, and install it in the new spring pack (Fig. 4).

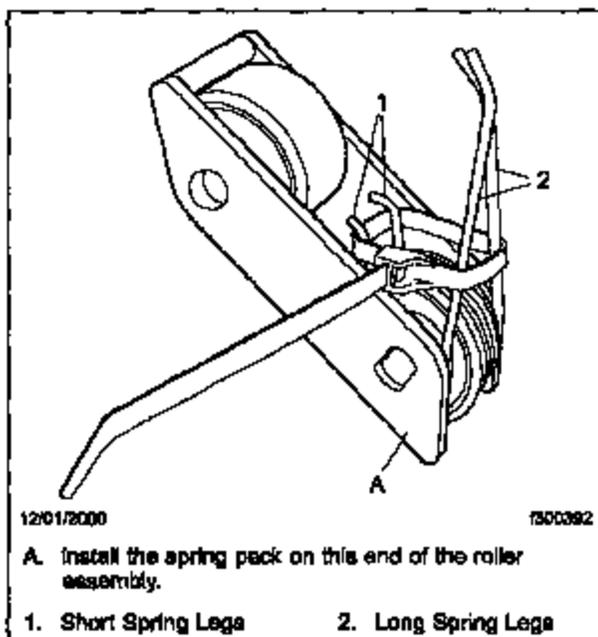
Fig. 5, Roller Assembly

7. Place the new spring pack into the roller assembly with the short spring legs hooked over the cross bar. See Fig. 5.
8. Install the roller assembly with the spring pack in the footpad. See Fig. 6. Make sure that the long spring legs are inside the wide, center space of the footpad. See Fig. 7.
9. Using a Phillips screwdriver, install the washer with the larger inside diameter between the roller assembly and the sensor side of the footpad. See Fig. 8. Align the roller assembly, washer, and bushing to gently align the parts for the sensor shaft installation. See Fig. 9.

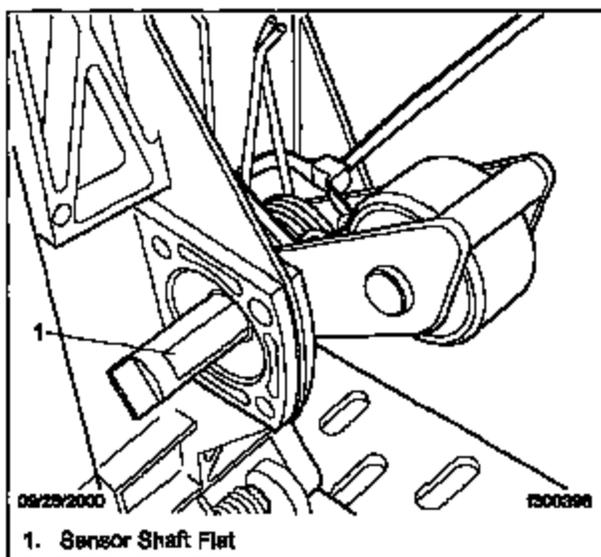
Fig. 10, Position Flats of Sensor Shaft

NOTE: The flats of the sensor shaft will be perpendicular to the roller arm assembly when aligned. See Fig. 10.

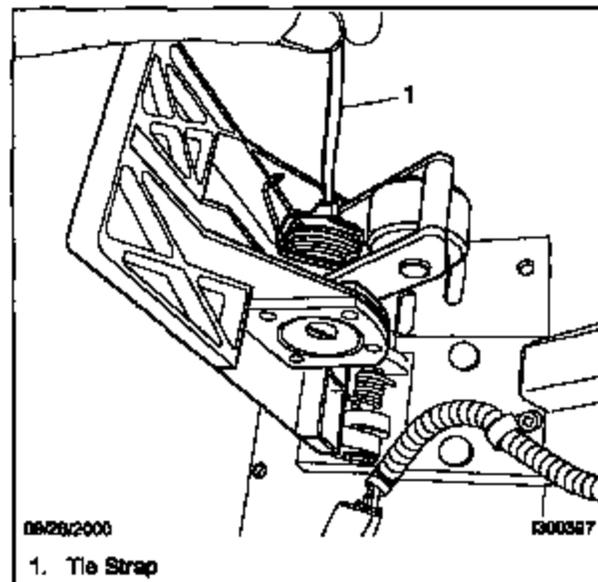
Fig. 11, Remove the Tie Strap

11. Place the washer with the smaller inside diameter over the the sensor shaft and snap the E-ring into the groove of the shaft. Pull the end of the tie strap forward (away from the pedal) to remove the tie strap. See Fig. 11.
