# VEHICLE RECALL

G-00513  
October, 2000

**SUBJECT: SAFETY RECALL (U.S., EXPORT)  
TRW Drag Links On Certain 1000, 2000, 3000, FE  
bus, RE bus, 4000 and 8000 model series built from  
7/5/1999 through 10/31/1999.**

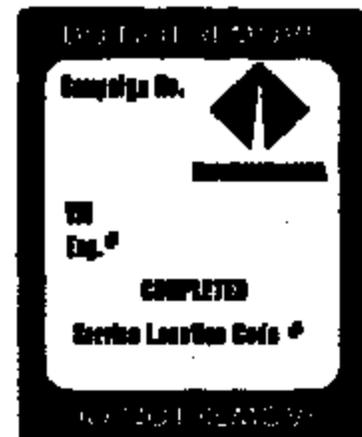
Each vehicle corrected in accordance with Campaign letter G-00513 will require a CTS-1075 Campaign Identification Label.

Attach the CTS-1075 label on a clean surface next to the vehicle identification number (VIN) plate.
