//ALL HMA8ST70 10/06/00 10/06/00 10/06/00
TO: ALL HYUNDAI SERVICE MANAGERS
FROM: CHUCK HALPER
SUBJECT: CAMPAIGN 039 - MASS AIR FLOW SENSOR CONNECTION RECALL
CAMPAIGN

Group	CAMPAIG
Number	00-01-005

**1999 - 2000 ELANTRA MASS AIR FLOW
SENSOR CONNECTOR REPLACEMENT
CAMPAIGN 040**

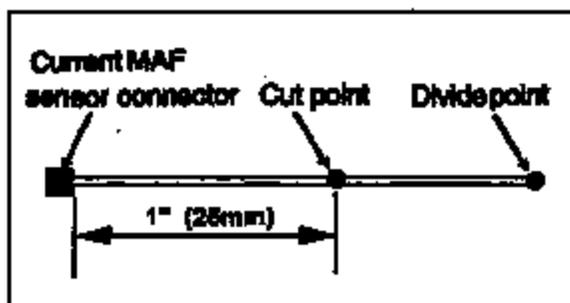
4. Remove the plastic protective tube from the MAF sensor connector wiring harness and set aside for later use. Cut the MAF sensor connector wiring at approximately 1" (25mm) from the end of the connector. Discard the removed connector.

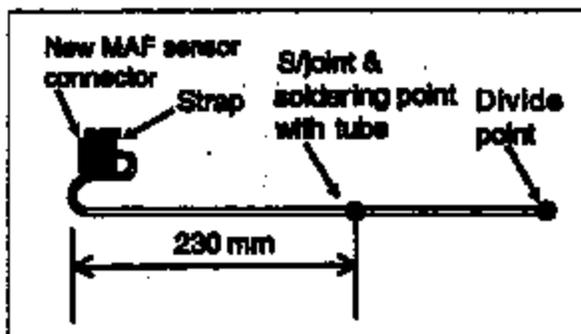
15. Slide the heat shrink tubes over the solder joints.
