**Subject: Recall Campaigns M7 and JL (07V-375) and
Recall Campaign JV (07V-334)**

**Subject: Safety Recall JV
2006-2008 Model Year Audi A6 Avant
and Model Year 2007-2008 Audi Q7
Automatic Rear Lid Software**

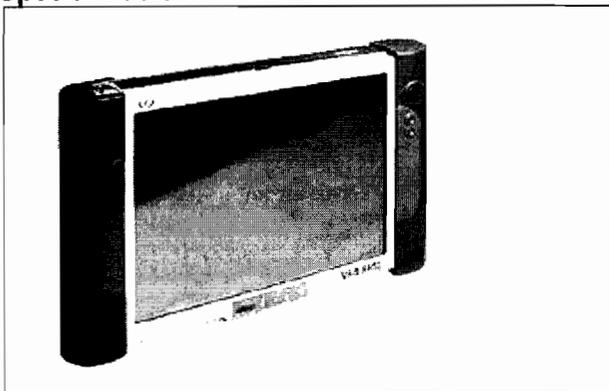
- Approved battery charger
- ← Vehicle diagnostic, measuring and information systems -VAS 5052-
- Adapter cable VAS 5052/3A
- Network connection cable VAS 5052/13
- Brand CD V. 11.55.00 or later installed

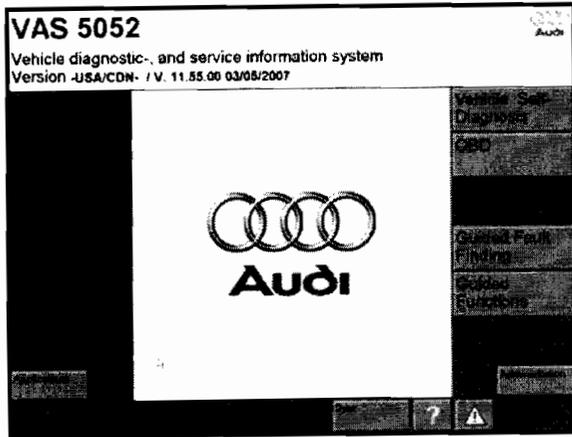
- Connect vehicle diagnostic, testing and information system -VAS 5052- (with online capability) to the vehicle
- Insert the Update CD, Part No. 4L0 906 961 G in the CD drive of the tester
- Connect -VAS 5052- to your workshop network (CPN) using network connection cable
- Insert memory stick so *Diagnosis Log* can be recorded following SVM update
- Enter the SVM update into the User Test Plan by selecting the following inside *Guided Fault Finding*:
 - Go to >> *Function/Component Selection* >> *Problem Related Hardware and Software Update* >> *Direct Input: SVM code for problem related update*
- Follow the SVM update procedure and enter the SVM Action Code **55E5A001** when prompted
- Enter your GeKo ID when requested and data will be transmitted to the SVM server, which will respond with instructions to continue

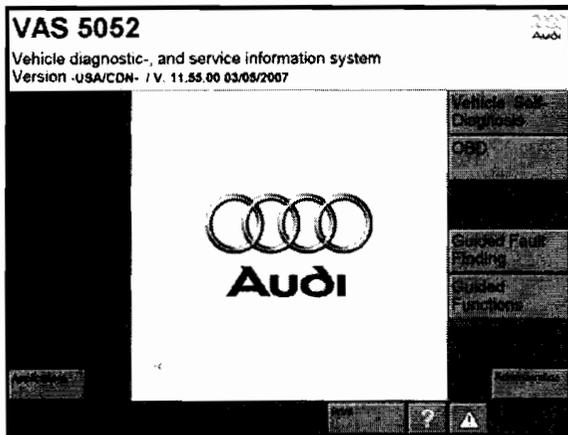
⇐ With vehicle diagnostic, testing and information system -VAS 5052- (with online capability) connected to the vehicle

Applications>>Start application from CD ROM

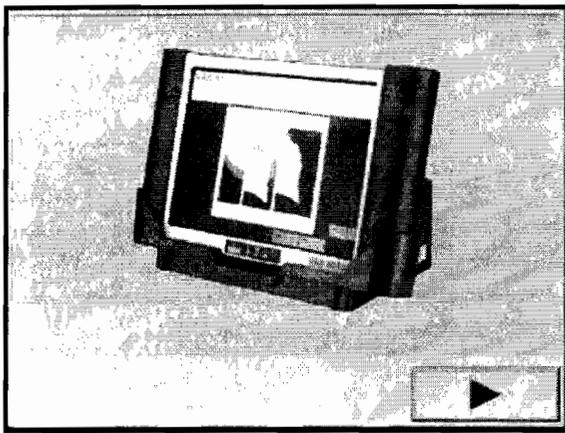
⇐ The start screen shows the -VAS 5052-

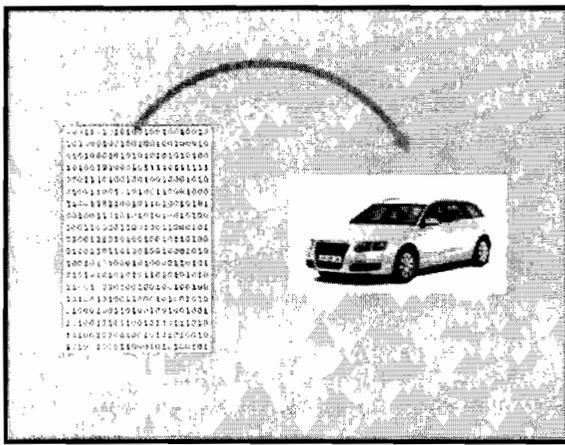
⇐ When this screen is displayed, both tailgate drives will then be flashed. Wait until the software update is completed

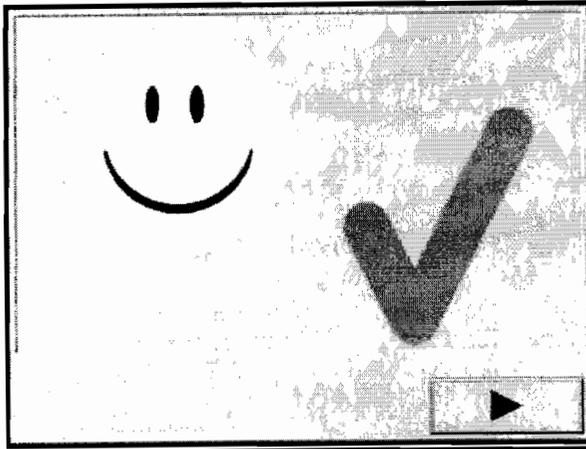
⇐ If this screen display appears, the software update was successful

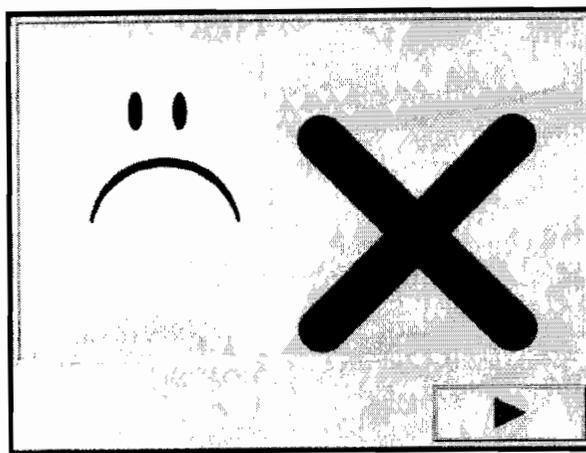
⇐ If this screen display appears, the software update was not successful

- Make a note of the error number displayed on the screen
- Press the 'Next' button (▶)
- If the update was unsuccessful – **do not continue to Section C**

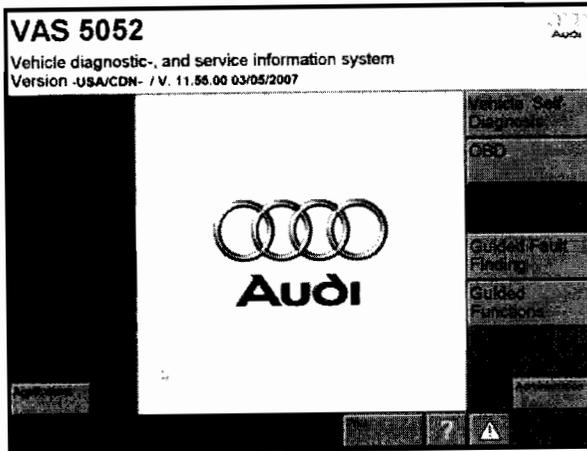
← With vehicle diagnostic, testing and information system -VAS 5052- still connected to the vehicle, enter the SVM update into the User Test Plan by selecting the following inside *Guided Fault Finding*:

Go to >> *Function/Component Selection*
>> *Problem Related Hardware and Software Update* >> *Direct Input: SVM code for problem related update*

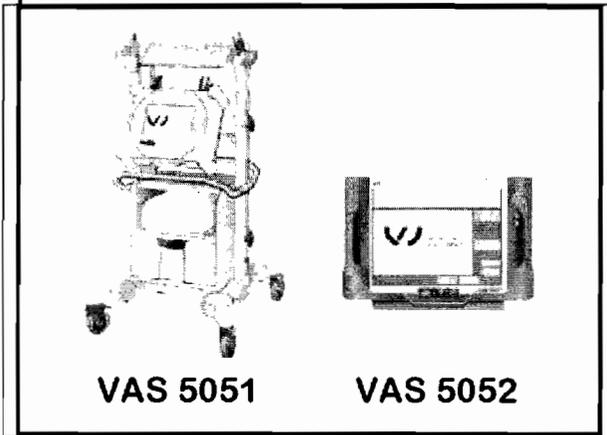
- Approved battery charger
- ← VAS 5051B or VAS 5052 (equipped with Ethernet card and security certificate)
- Adapter cable
- Network connection cable
- Brand CD V. 11.55.00 or later installed

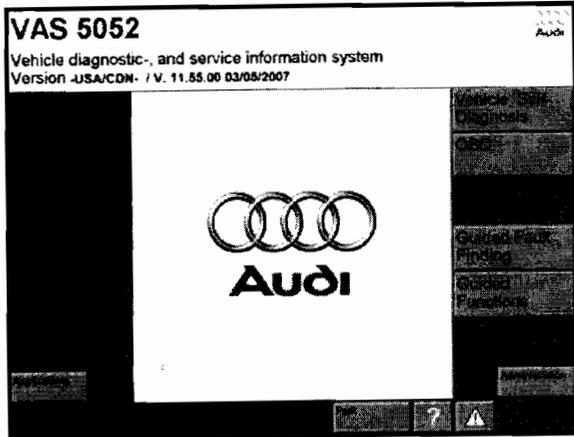
- Connect vehicle diagnostic, testing and information system -VAS 5051B- or -VAS 5052- (with online capability) to the vehicle
- Insert the Update CD (Part No. 4L0 906 961 G for VAS 5052) or Update CD (Part No. 4E0 906 961 AD for VAS 5051B) in the CD drive of the appropriate tester

- Connect tester to your workshop network (CPN) using network connection cable
- Insert memory stick so *Diagnosis Log* can be recorded following SVM update

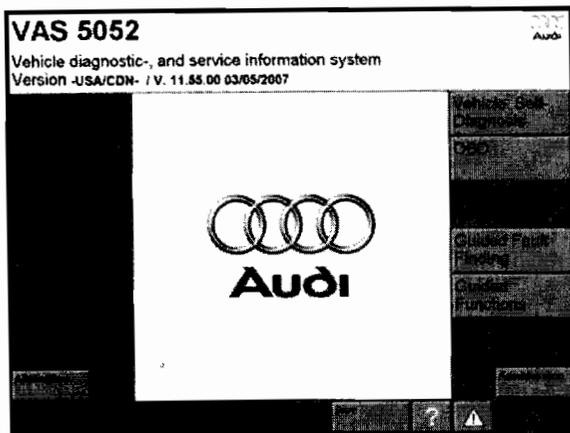
← The start screen shows the tester

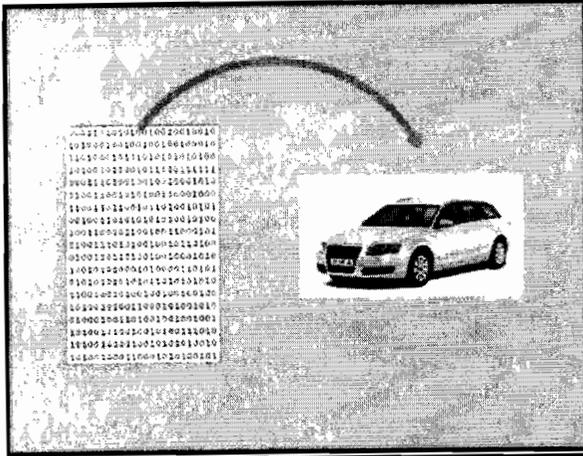
← When this screen is displayed, both tailgate drives will then be flashed. Wait until the software update is completed

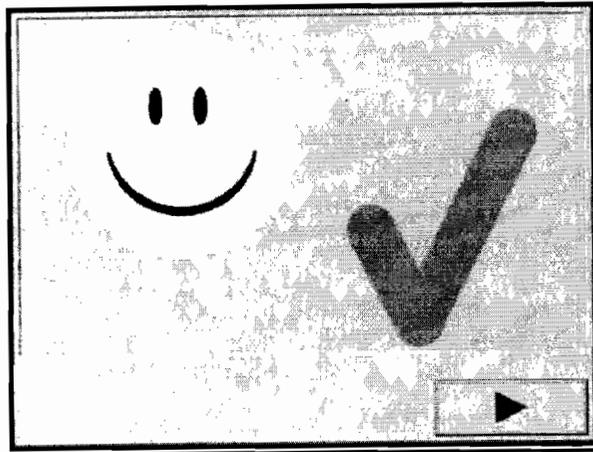
← If this screen display appears, the software update was successful

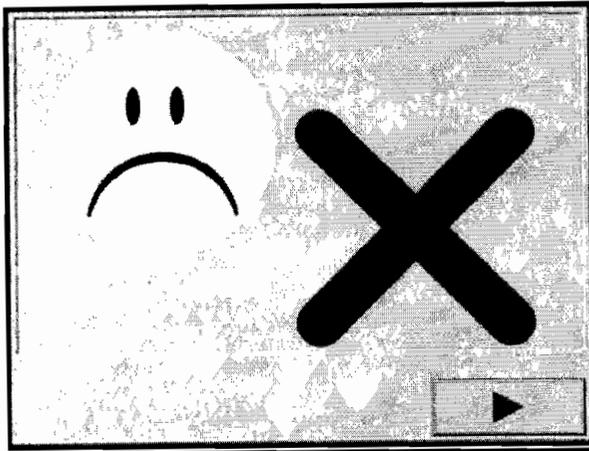
← If this screen display appears, the software update was not successful

- Make a note of the error number displayed on the screen
- Press the 'Next' button (▶)
- If the update was unsuccessful – **do not continue to Section C**

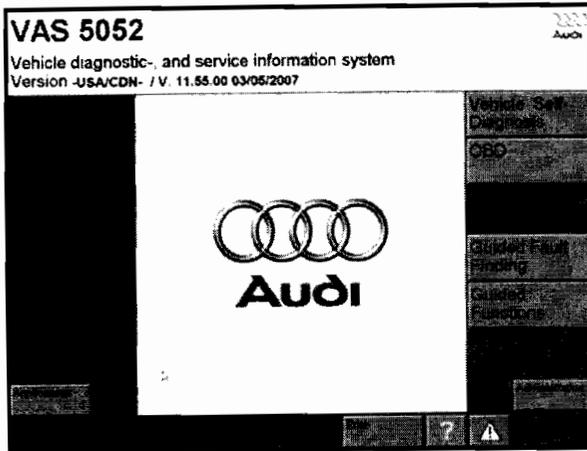
← With tester still connected to the vehicle, enter the SVM update into the User Test Plan by selecting the following inside *Guided Fault Finding*:

Go to >> *Function/Component Selection*
>> *Problem Related Hardware and Software Update* >> *Direct Input: SVM code for problem related update*
