INTERNATIONAL TRUCK AND ENGINE CORPORATION

Ref.: NSA-14sjm
PE07-034

Subject: Dash/Heater Fire on CE School Buses

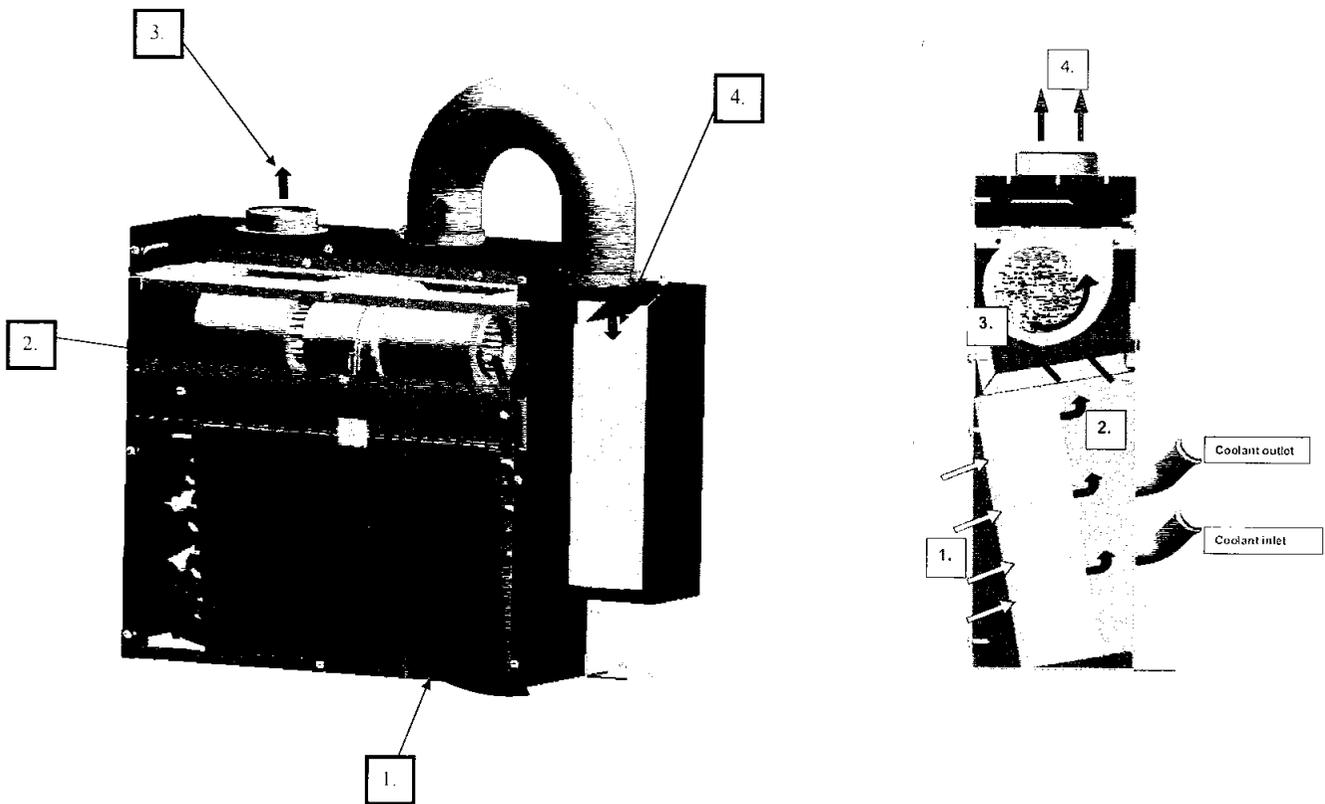
Schematic of Step-well Heater, BE & CE Bus

The tier one supplier of the heater system to International is Bergstrom, 2390 Blackhawk Road, Rockford Ill. The tier two supplier of the blower motor to Bergstrom is Fasco, 505 Conestoga Blvd. Cambridge Ontario. A schematic of the step-well heater air flow is given in the diagram below:

1. Ambient air enters the unit through the recirculation grill in the cover. It is pulled through the heater core by the blower package (530277) above.

2. Treated air is pulled into the blower package at (4) positions.

3. Treated air directed to defrost plenum.

1. Recirculated air in
2. Treated air (post heater core)
3. Air pulled into blower scroll
4. Air distributed to defrost plenum and outlet for steps.

The step well heater consists of a double shafted motor, each end having an air mover (blower wheel) attached. This blower motor is harnessed to have two speeds and an off position. In either high or low speed, ambient air enters the recirculation grill area in the lower front face. The air is pulled through the heater core and then into the blower wheels. The step well heater can only intake recirculated air.

Viewing the unit from inside the bus, the left side of the blower motor assembly pushes air into the defrost duct, aiding the main driver heater in defrost. The right side of the blower motor assembly pushes air into a flexible duct that feeds air to the steps and the entrance door. Both the left and right side of the blower assembly work in concert. Neither function is independent of the other.

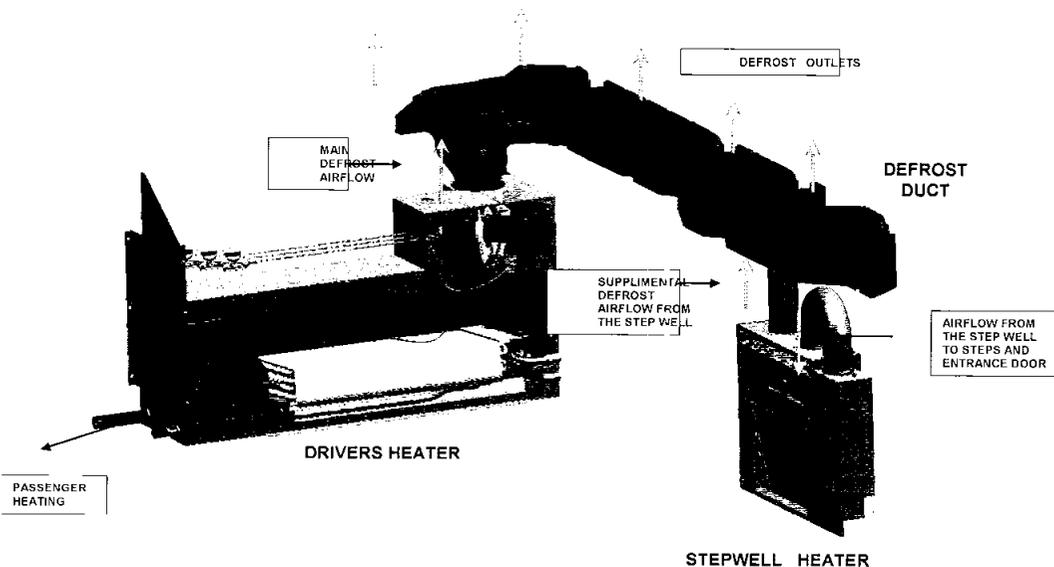
BUS HEATING SYSTEM

An electrical schematic is given in the attachment to "Response 10". A diagram of the complete heater defroster system is given on the next page:

Step Well Air Path:

The driver heater unit has multiple areas it supplies heat to. The only time it can interact with the step well is when it is in defrost mode, thus supplying air to the defrost duct shared by the left side of the blower motor assembly of the step well. The driver heater can intake recirculated air or fresh air.
