RE: NHTSA Recall 08E-016, Hyundai Recall 082

Subject: Campaign 082 – 2007/2008 Santa Fe and Veracruz Models – Trailer Wiring Harness Replacement

Subject **TRAILER HITCH WIRING HARNESS REPLACEMENT PROCEDURE (CAMPAIGN 082)**

This bulletin provides a procedure to replace the tow hitch control module and harness.

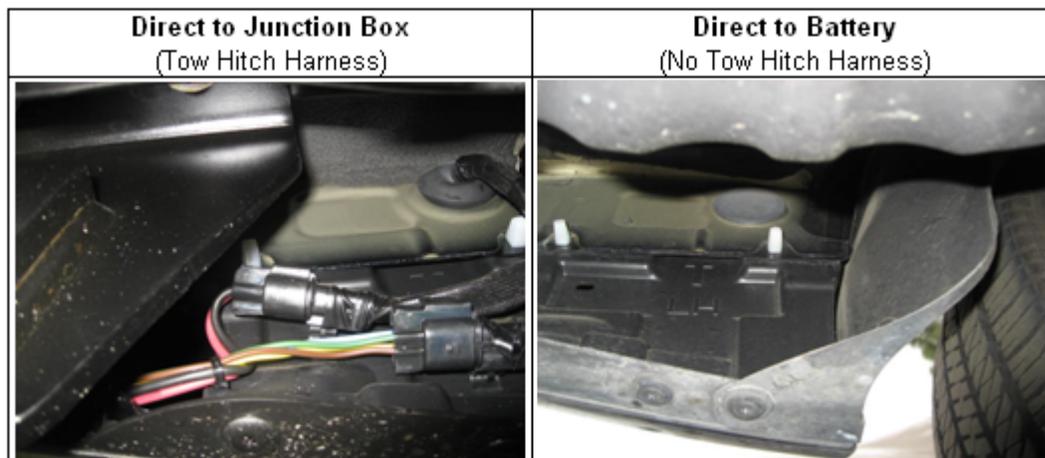
NOTE: Two (2) types of trailer hitch wiring harnesses have been installed on the affected vehicles. The type of wiring harness will determine the proper service procedure. Look inside the driver's side rear bumper, behind the rear wheel, to determine which procedure is appropriate for each vehicle.

Direct to battery is not used on the Veracruz.

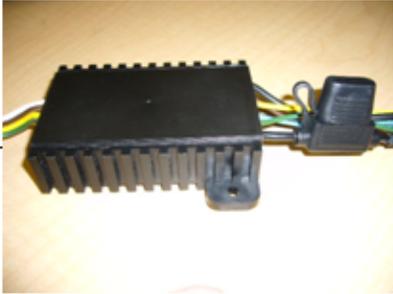
Part #	FIGURE	REMARK
U8612-2B001 Santa Fe (CM) <i>Direct to Junction Box</i>

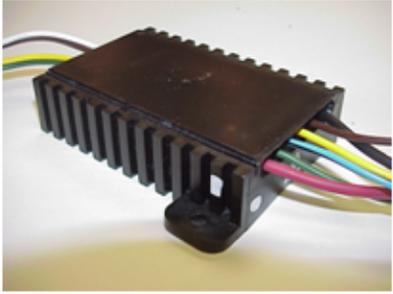
REVISED – 15A inline fuse
U8612-3J001 (EN Veracruz)		
U8614-2B001 Santa Fe (CM) <i>Direct to Battery</i>

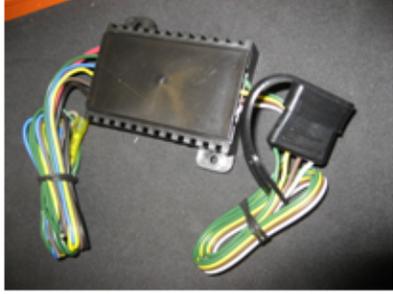
REVISED – Two White Dots
U8614-2B000 Santa Fe (CM) <i>Direct to Battery</i>

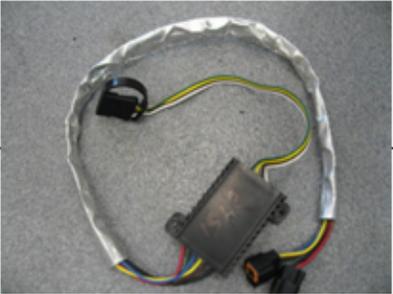
PREVIOUS
U8612-2B000 (CM Santa Fe)

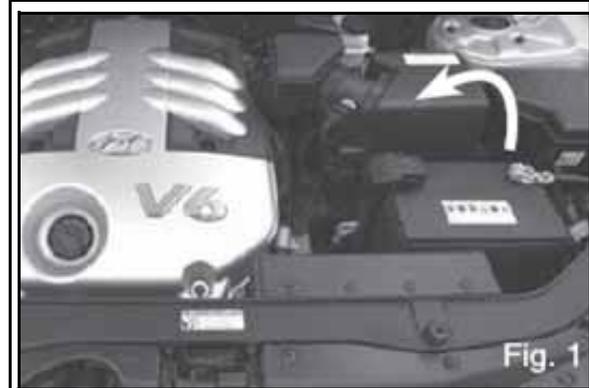
1. Using a 10 mm socket, remove the negative (-) battery cable and secure it away from the negative battery post.

CAUTION: Failure to disconnect from the battery may cause damage to the new replacement tow hitch control module.

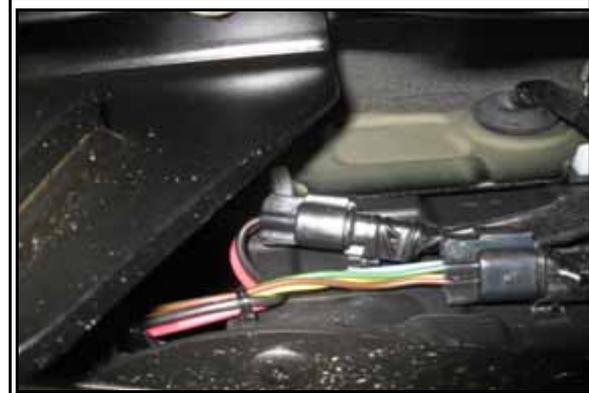
2. Carefully disconnect the two tow hitch harness connectors located on the driver's side, behind the rear wheel next to the muffler.

IMPORTANT: If no connector is present skip to the Direct to Battery Service Procedure.

NOTE: Connections may be separated by pressing on the locking tabs and carefully pulling apart.

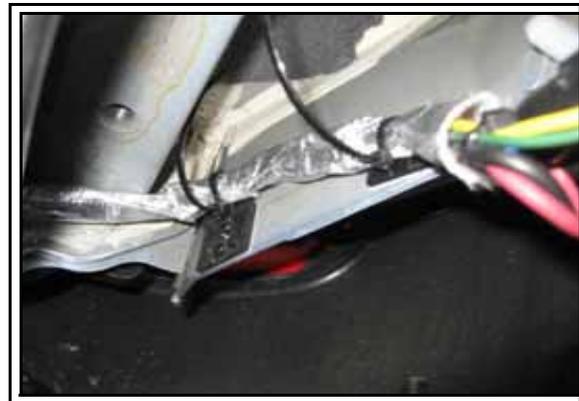
3. Carefully cut and remove the 4 cable ties securing the tow hitch harness to the individual anchor points.

NOTE: Do not remove the anchors.

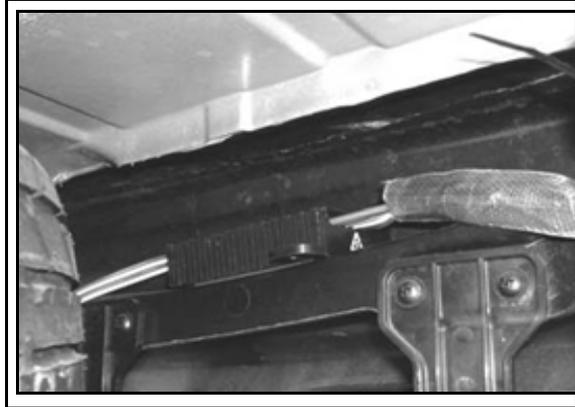
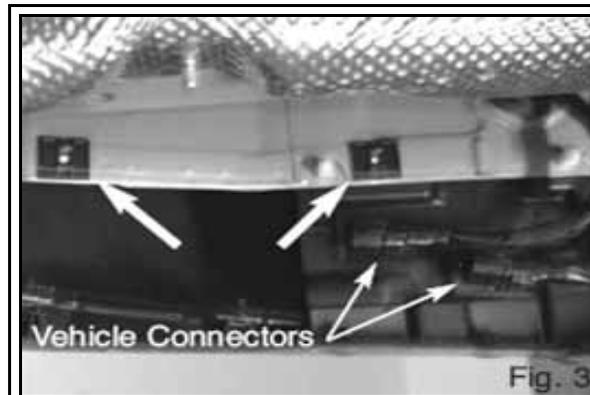
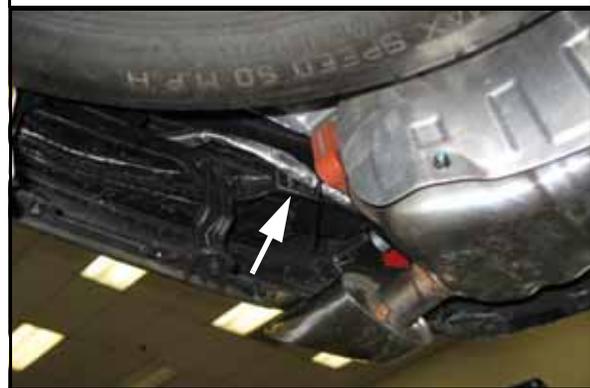
4. Remove the tow hitch control module and harness by grasping the module by the hand and gently rotating it back and forth until the adhesive separates from the bumper reinforcement.

5. Completely clean and remove all remaining adhesive tape from the top of the rear bumper reinforcement.

6. Locate the anchor points from step 3. Clean area. Install new anchor points by pressing firmly in position. Using a heat gun, apply heat to each of the anchor points for 5 minutes to cure the adhesive.

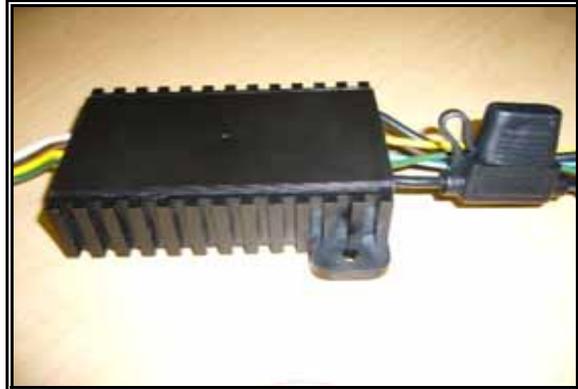
NOTE: The new module can be identified by the external fuse holder.

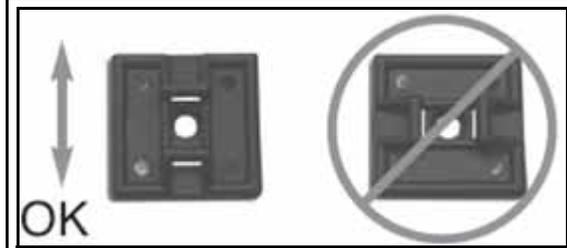
NOTE: Anchor orientation

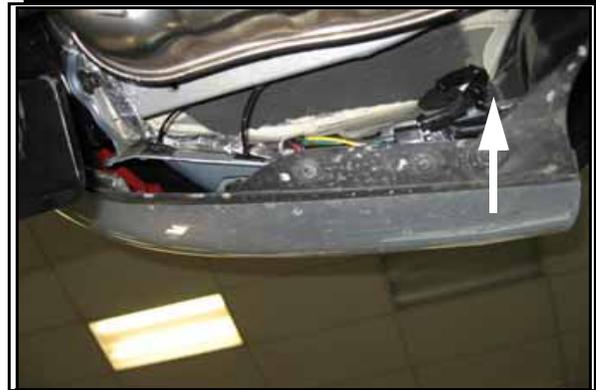
7. Insert matching connectors on the replacement tow hitch harness into the vehicle connectors. Press firmly into place until the locking tabs engage. Secure the tow hitch harness to the anchor points installed in step 6.

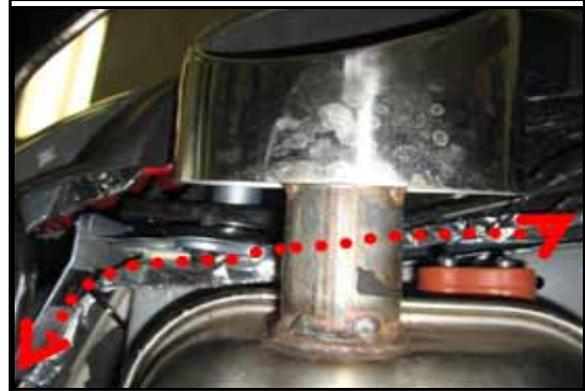
8. Route the wiring harness above the exhaust muffler, and bring the tow hitch control module to the center of the bumper.

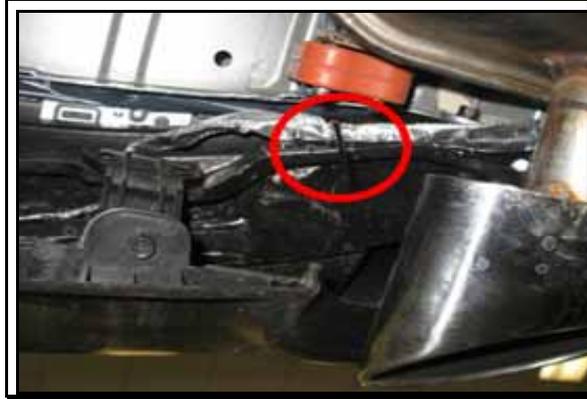
9. Use one (1) cable tie and cable anchor to support the wire harness.

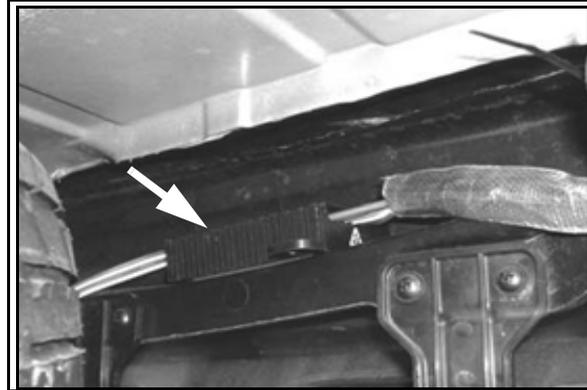
10. Secure the tow hitch control module above the ledge of the bumper by removing the adhesive backing and pressing firmly.

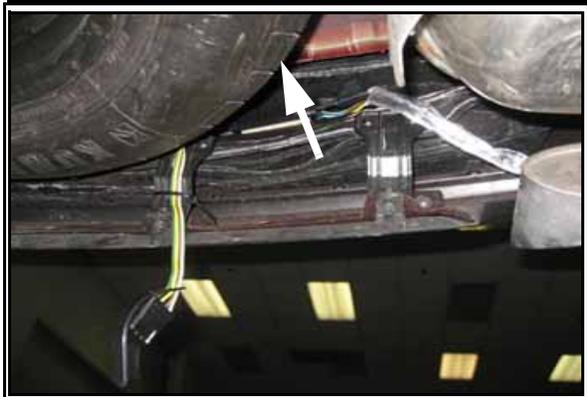
11. Route the tow hitch harness down along the bumper support bracket and secure into place with cable ties.

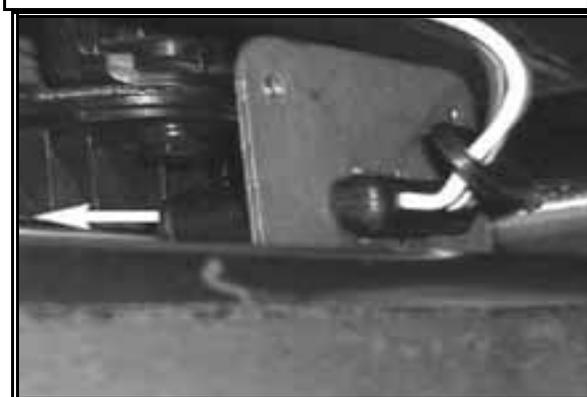
12. Remove the dust cover and carefully push the 4-pin flat trailer connector through the connector mounting bracket from under the vehicle until it snaps into place.

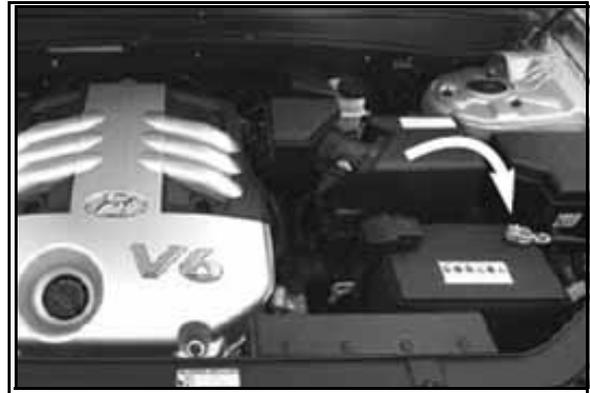
13. Reconnect the battery terminal.

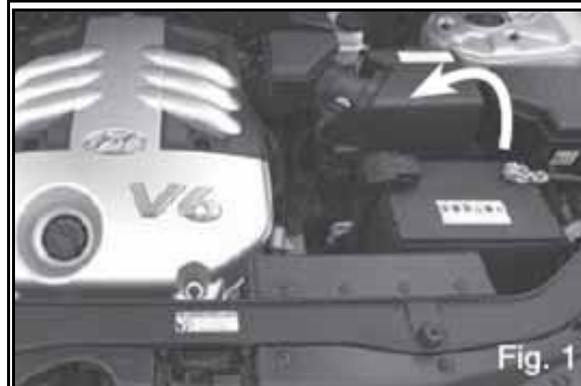
1. Using a 10 mm socket, remove the negative (-) battery cable and secure it away from the negative battery post.

CAUTION: Failure to disconnect from the battery may cause damage to the new replacement control module.

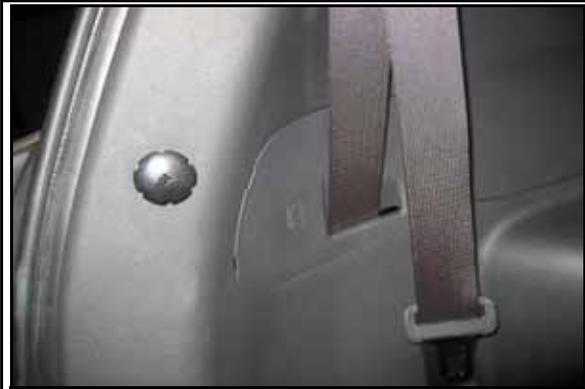
2. Raise the liftgate and remove the wiring harness access cover from the interior trim panel located on the left side of the vehicle.

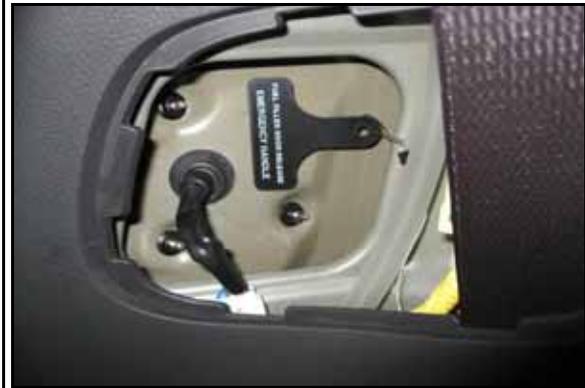
3. Using a 10mm socket, remove the three fasteners securing the left tail light assembly to the vehicle. Carefully pull the tail light assembly away from the body and lay the assembly inside the vehicle. Do not allow the assembly to hang.

NOTE: Repeat steps 2-3 on the right side of the vehicle.

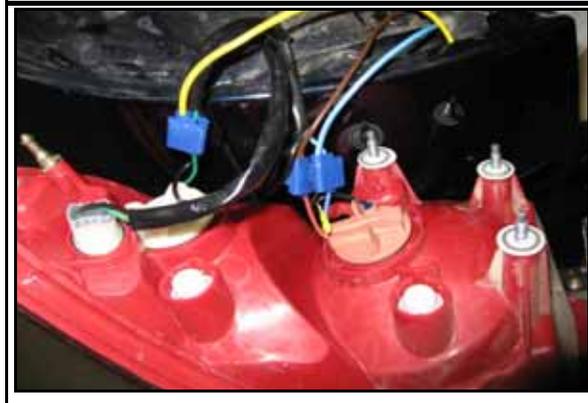
4. Cut the original trailer hitch wiring harness wires 2 inches away from the Scotch Lock.

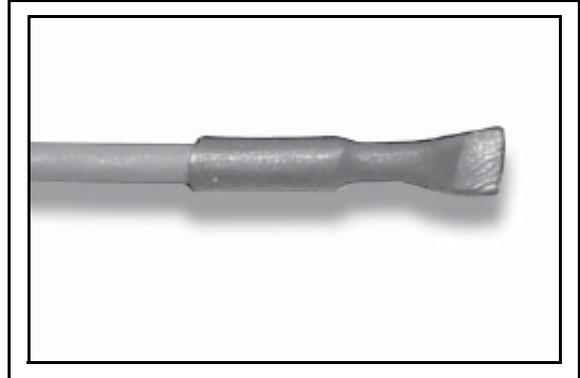
5. Seal original harness wires by placing one of the short heat shrink tubes over the end of each of the cut wires, total of 4 wires. Pinch ends and heat the shrink tube with a heat gun to seal the tube to the wire. Repeat for all wires cut (Brown, Yellow, Blue w/black stripe, and Green).

NOTE: The end of the shrink tube extending past the end of the wire should seal flat to keep moisture out.

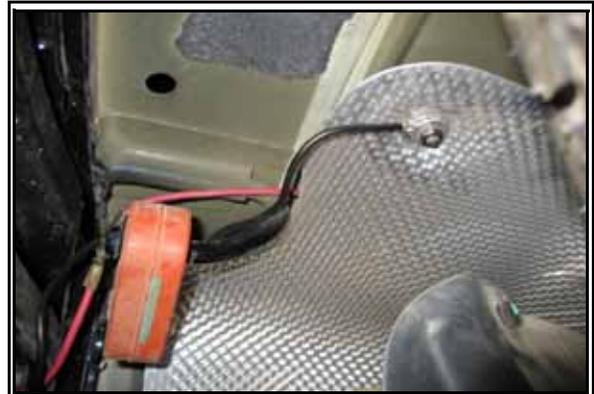
6. Remove the ring terminal from the heat shield.

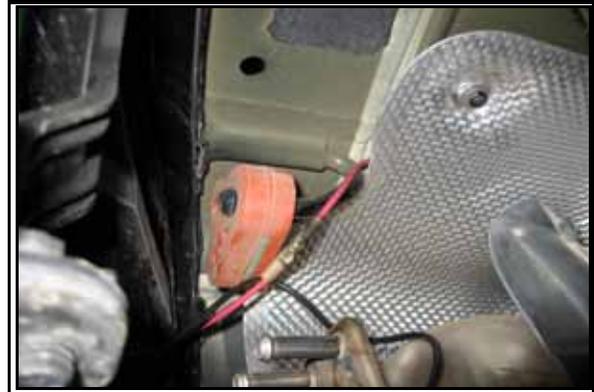
7. Cut the red wire towards the battery side near the heat wrap.

CAUTION: Disconnect battery cable prior to cutting red wire.

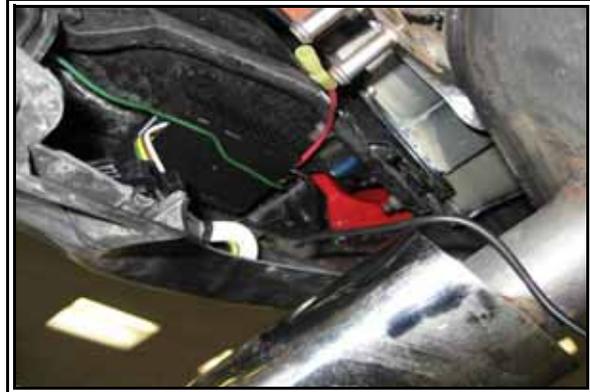
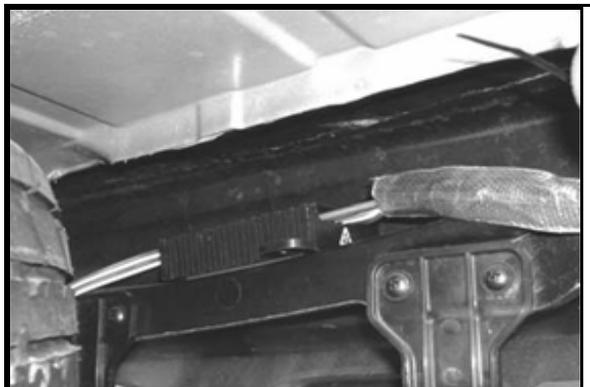
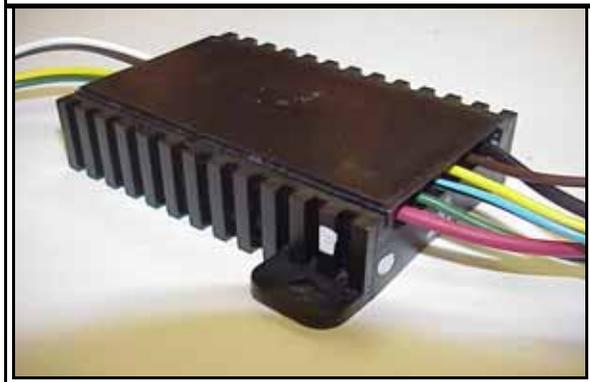
8. Remove the tow hitch control module and wiring harness that is attached to the bumper structure by gently rotating back and forth until the adhesive breaks away.

9. Completely clean and remove all remaining adhesive tape from the top of the rear bumper reinforcement.

10. Secure the tow hitch control module above the ledge of the bumper by removing the adhesive backing and pressing firmly.

NOTE: The new module can be identified by two (2) white dots as shown in the picture.

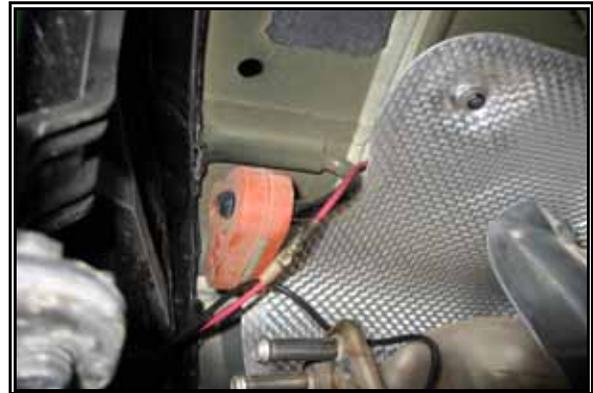
11. Connect the power lead to the harness. Strip approximately 0.3in of the insulation from the end of the red wire cut in Step 7. Insert the stripped wire into the butt connector located on the red power input wire on the trailer harness module. Making sure the wire end is properly seated, make a crimp connection using a tool designed for insulated splices.

12. Apply heat directly to the splice, working from the center out to the edges, using a hot air gun or other heat source, until the tubing shrinks and the adhesive flows.

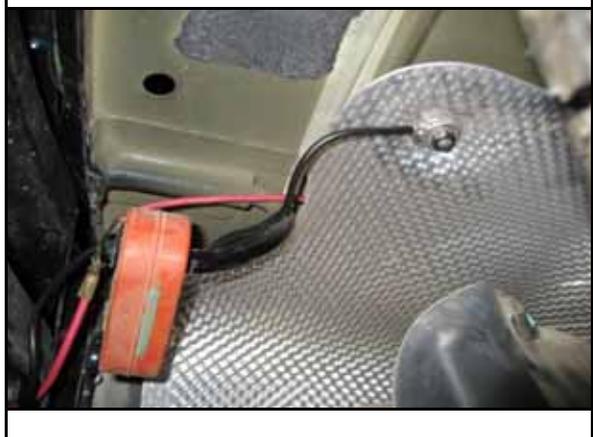
13. Position the ring terminal on the tow hitch harness black wire over the heat shield nut that was previously removed in step 6.

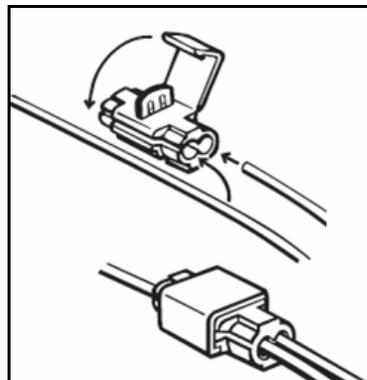
16. To properly secure the wire tap, open the cover completely and lay the original wire completely into the exposed channel. Insert the tow hitch harness wire into the opening up to the stop. With both wires properly positioned inside the wire tap, use a pair of blunt nose pliers to seat the blade and pierce each wire in the wire tap. With the blade secured, close the cover of the wire tap, to lock it into place.

CAUTION: Failure to properly secure the wire tap will lead to intermittent operation of the harness and potential electrical system damage.

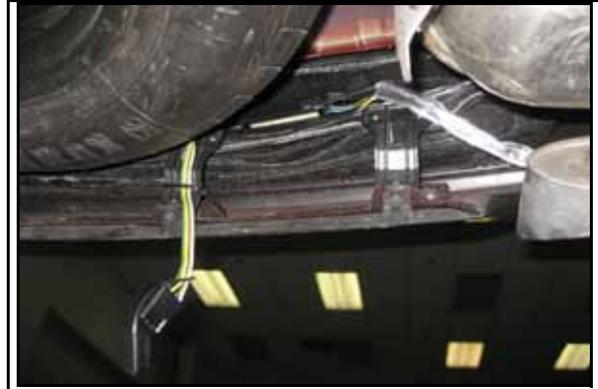
17. Route the tow hitch harness down along the bumper support bracket and secure into place with cable ties.

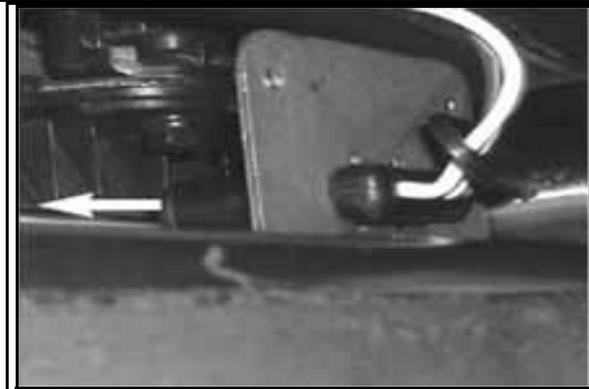
18. Remove the dust cover and carefully push the 4-pin flat tow hitch connector through the connector mounting bracket from under the vehicle until it snaps into place.

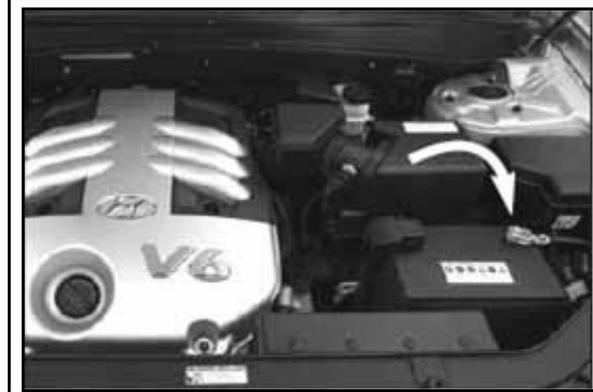
19. Reconnect the battery terminal.
