RECALL CAMPAIGN BULLETIN

NTB13-093

VOLUNTARY SAFETY RECALL CAMPAIGN 2013-2014 PATHFINDER ABS SOFTWARE UPDATE

APPLIED VEHICLE: All 2013 - 2014 Pathfinder (R52)

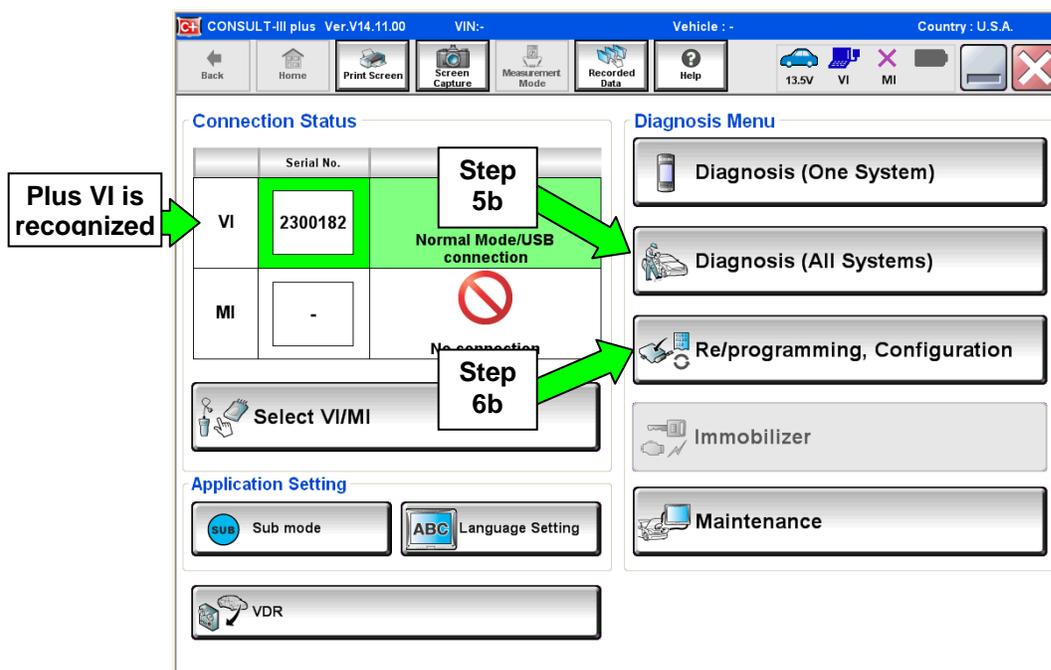
Figure 1

6. Go to **Re/programming, Configuration**.

- Select the **Home** button and then **YES** to return to the screen shown in Figure 1.
- Select **Re/programming, Configuration**.

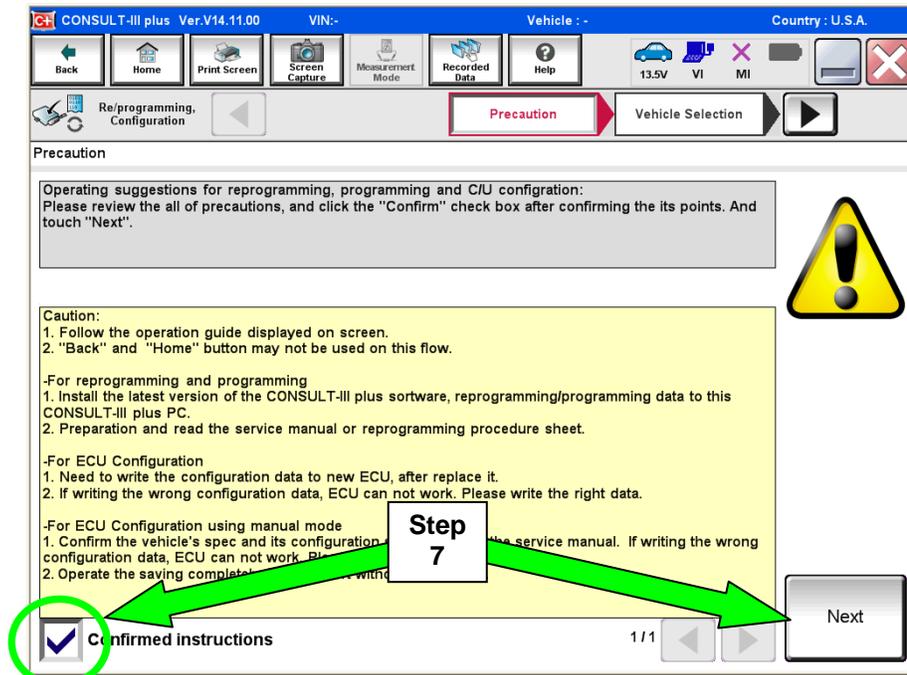
Figure 2

7. Check the box for **Confirmed Instructions**, and then select **Next**.

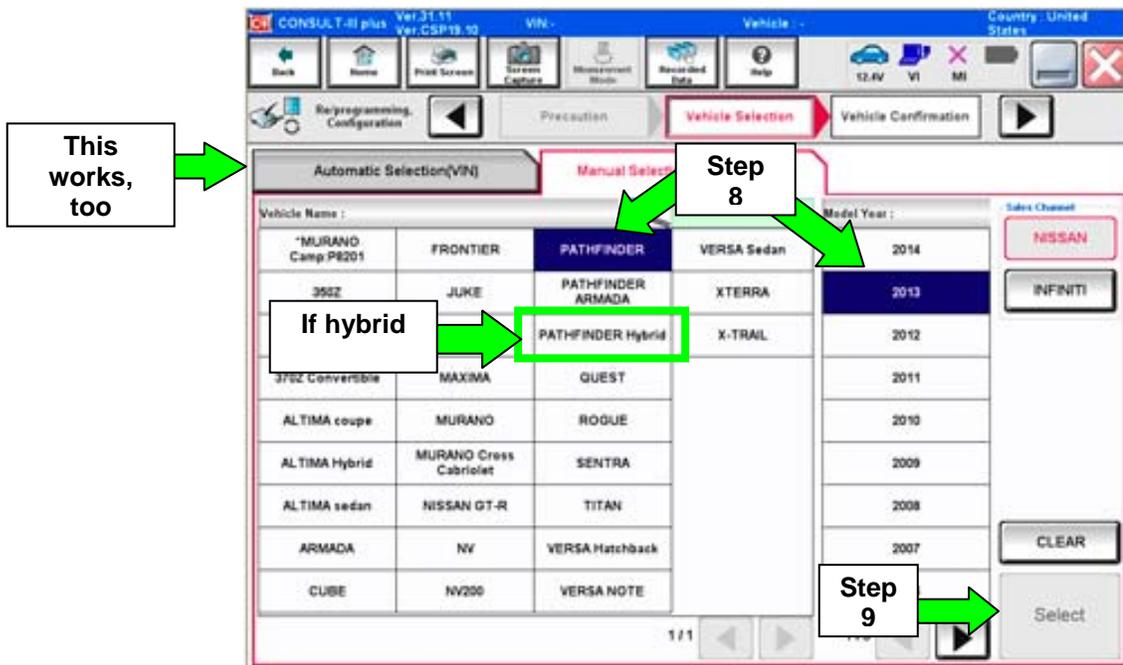
Figure 3

8. Select the correct model and the model year, or **Automatic Selection(VIN)**.

- Under **Manual Selection(Vehicle Name)** select **Nissan, Pathfinder** or **Pathfinder hybrid**, the model year and then click **Select**.
- If **Automatic Selection(VIN)** is selected, wait for the Reading VIN screen (not shown) to complete.

9. Select **Select**.

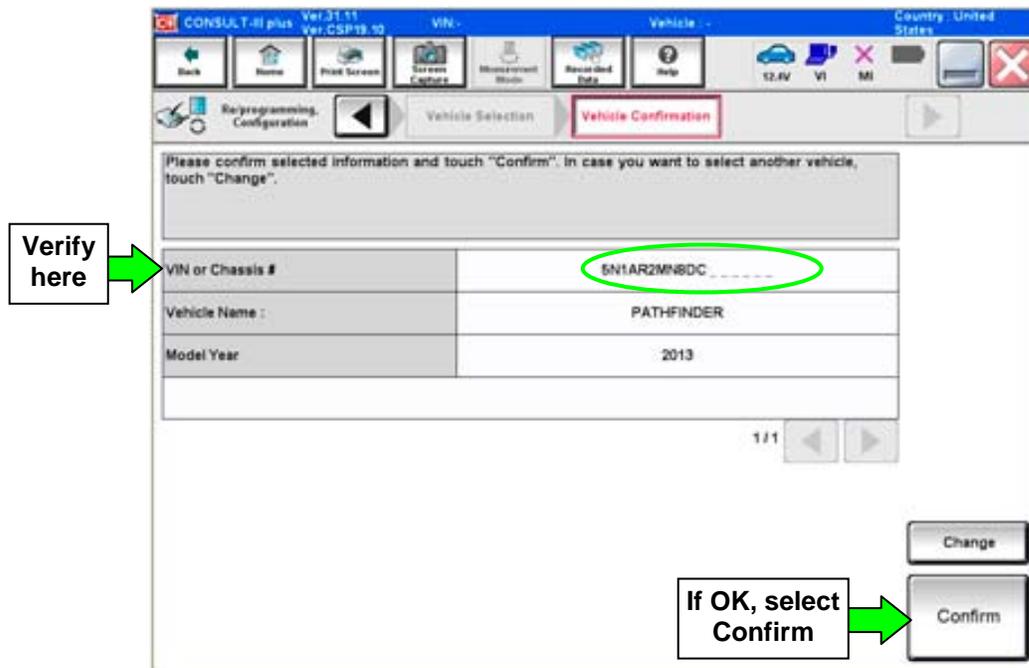
Figure 4

10. Verify the VIN or Chassis # matches that of the vehicle.

- If the correct VIN is displayed, select **Confirm**.

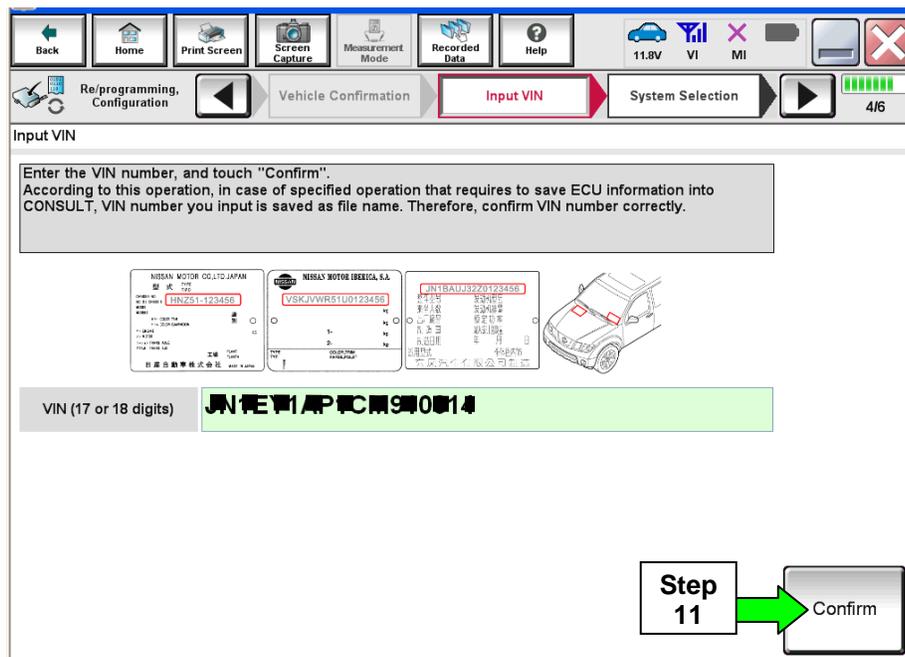
Figure 5

11. Select **Confirm** again.

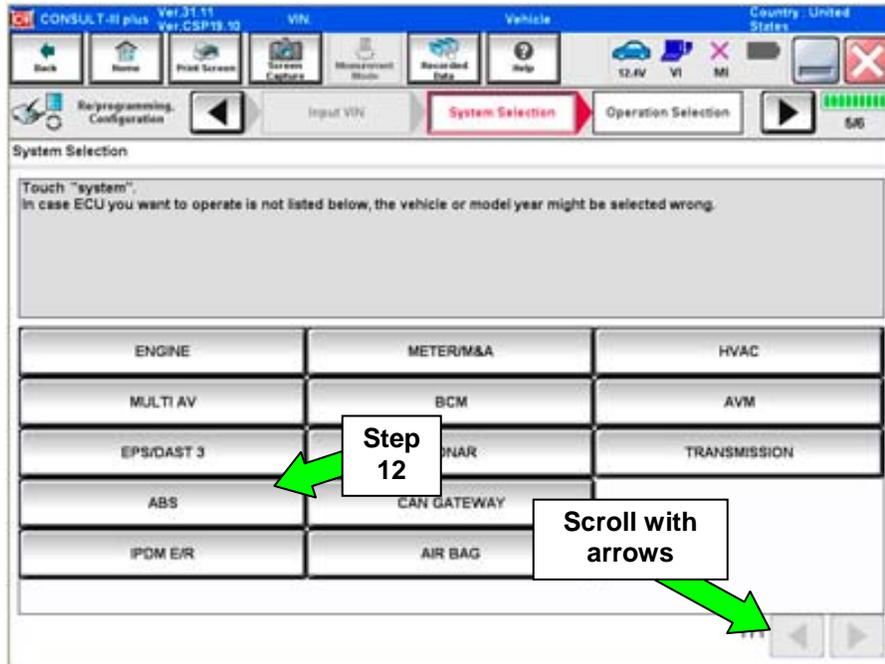
Figure 6

12. Use the page scroll arrows and select **ABS**.

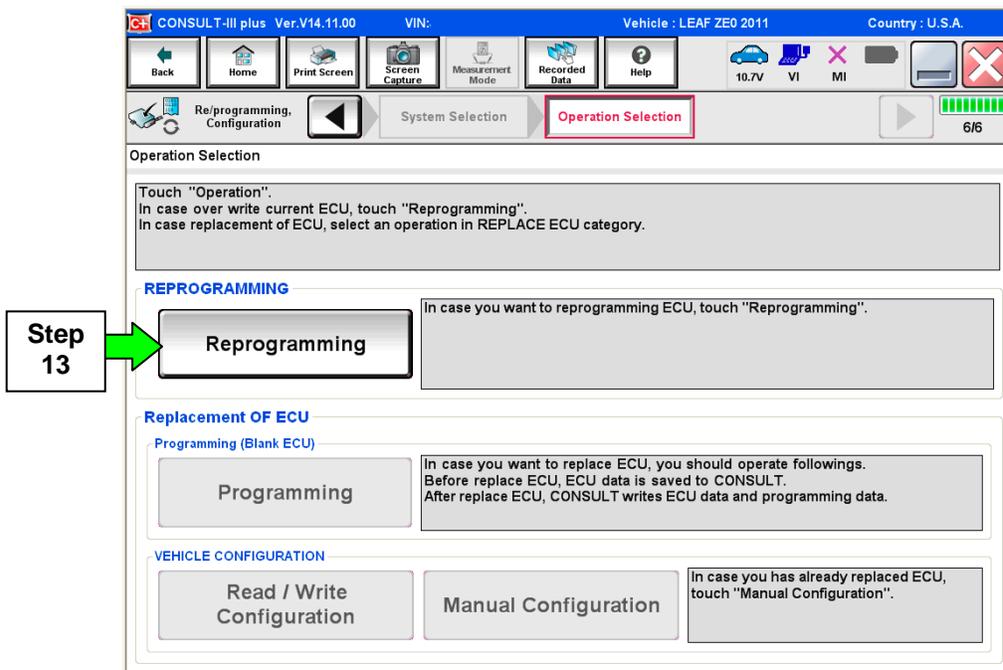
Figure 7

13. Wait for System Call to complete and then select **Reprogramming**.

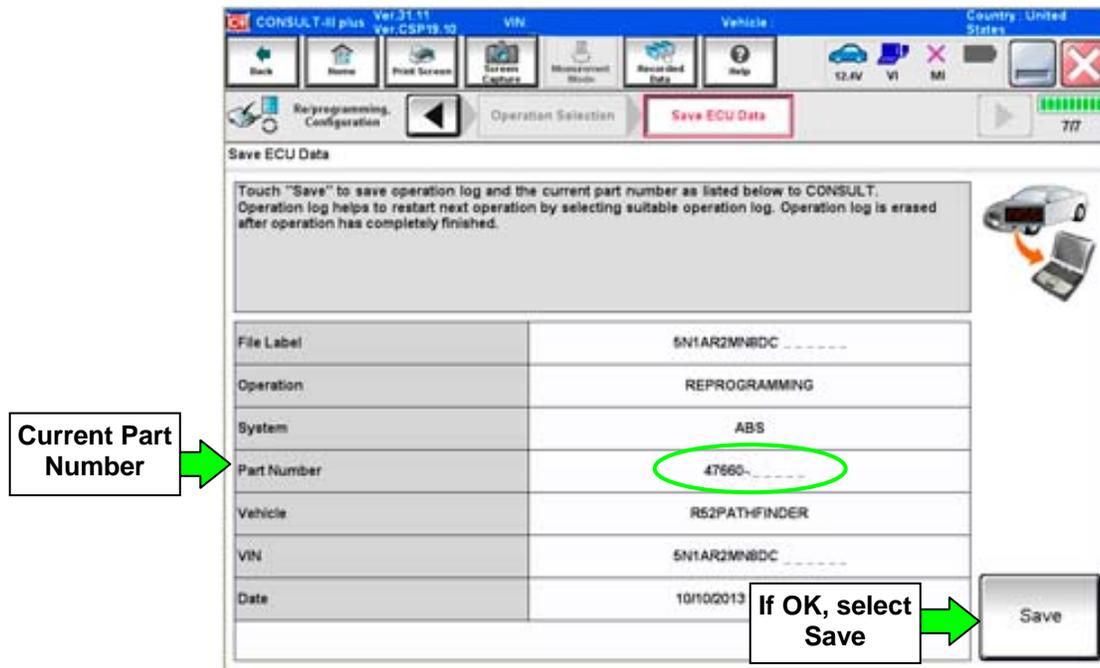
Figure 8

14. When you get to the screen shown in Figure 8, confirm reprogramming applies as follows:

- a. Find the ABS Part Number and write it on the repair order.

NOTE: This is the current ABS Part Number.

16. Verify the Current Part Number matches the Part Number written down in step 14, and then select **Next**.

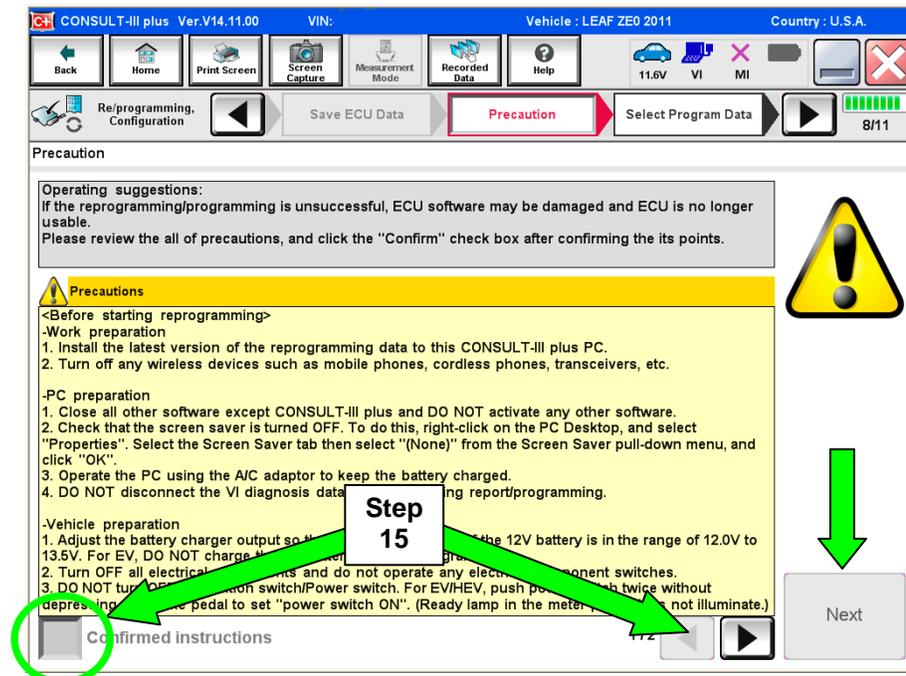
Figure 9

15. Read the precautions on page 1 shown in Figure 9, and then select page 2 with arrow (page 2 not shown). After reading page 2, select **Confirmed instructions**, and then select **Next**.

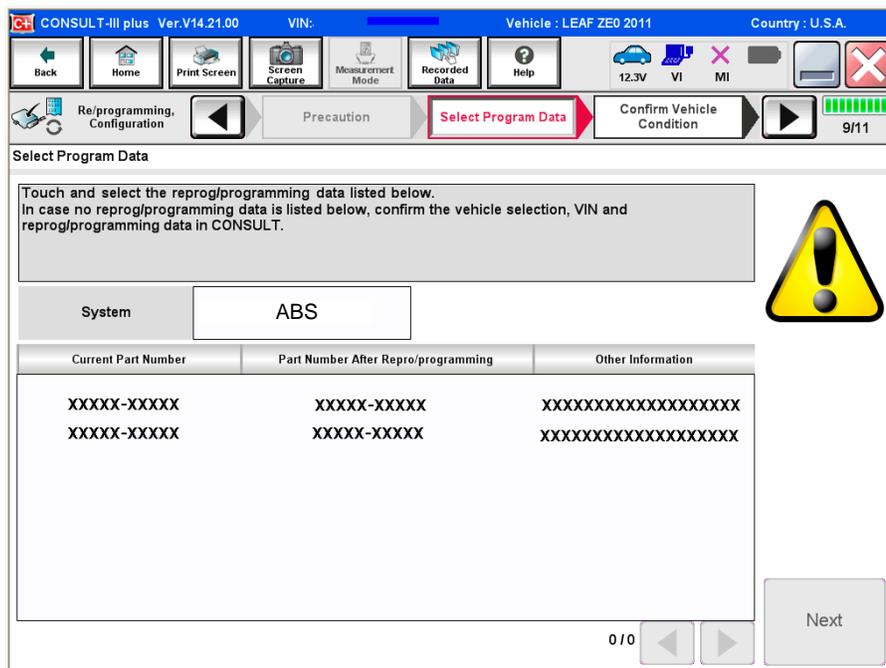
NOTE: In some cases, more than one new P/N for reprogramming is available.

- In this case, the screen in Figure 10 will display.
- Select and use the reprogramming option that does not have the message “Caution! Use ONLY with NTBXX-XXX”.
- If you get this screen and it is blank (no reprogramming listed), it means that there is no reprogramming available for this vehicle. This campaign does not apply or it has already been done. Recheck Service Comm for campaign eligibility.

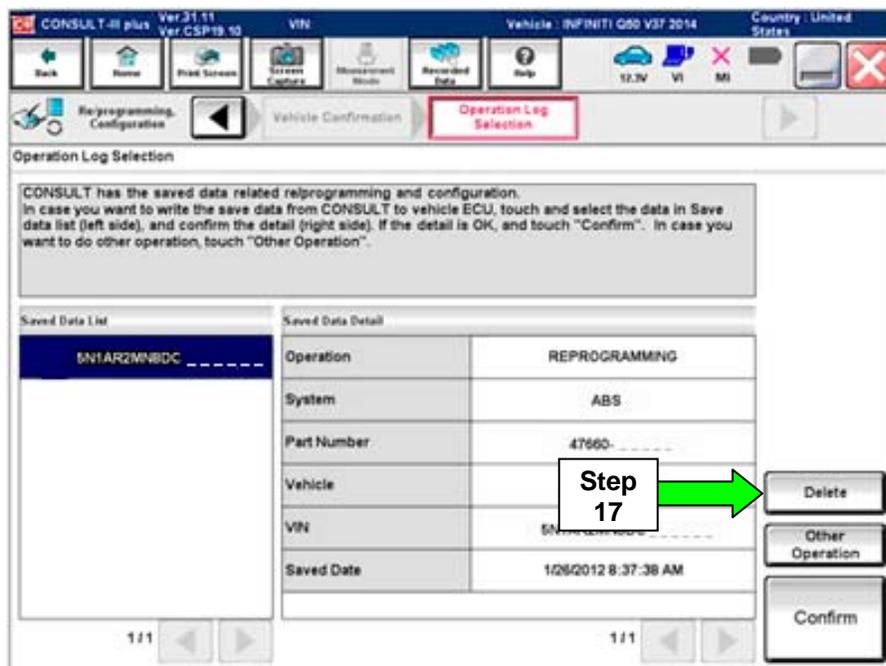
17. If the screen in Figure 12 appears, first select **Delete** then **Confirm**, and then **Other Operation**.

- This will erase the Saved Data List and restart the reprogram from step 12. You must go back to step 12.
- If no Saved Data List is stored, Figure 13 on the next page will be displayed. Proceed to step 18.

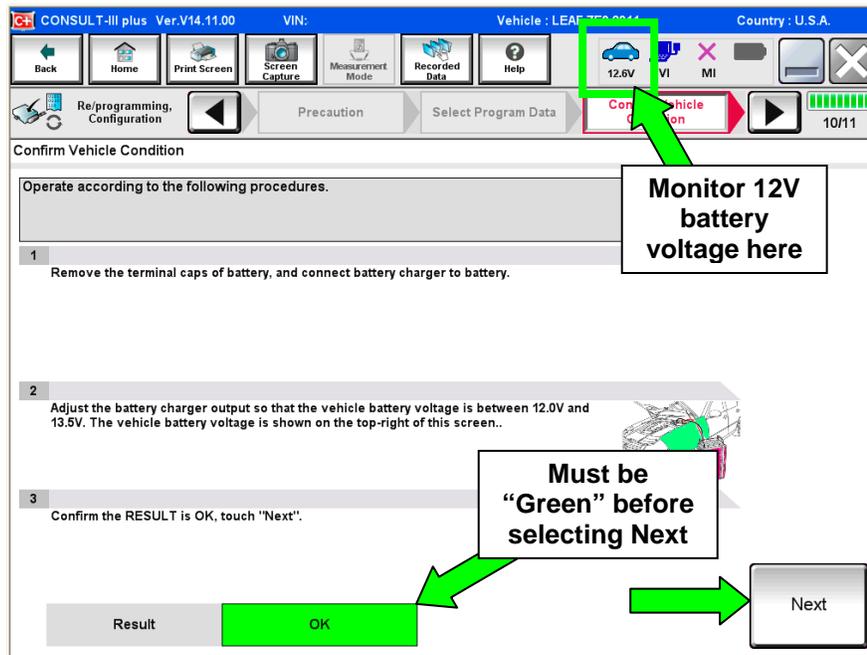
Figure 13

18. Confirm battery voltage is correct, and then select **Next**.

NOTE: Battery voltage must stay within the specified range to make the indicator turn green.

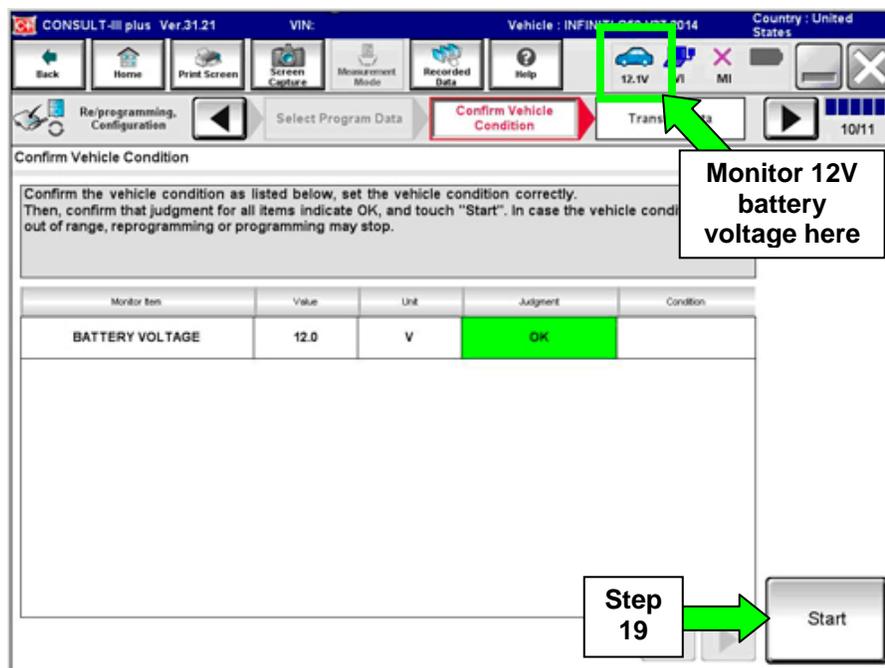
Figure 14

19. With battery voltage OK (green), select **Start**.

- The reprogramming process begins when Start is selected.

NOTE: For reprogramming to continue, vehicle 12V battery voltage must stay within 12 volts and 15.5 volts.

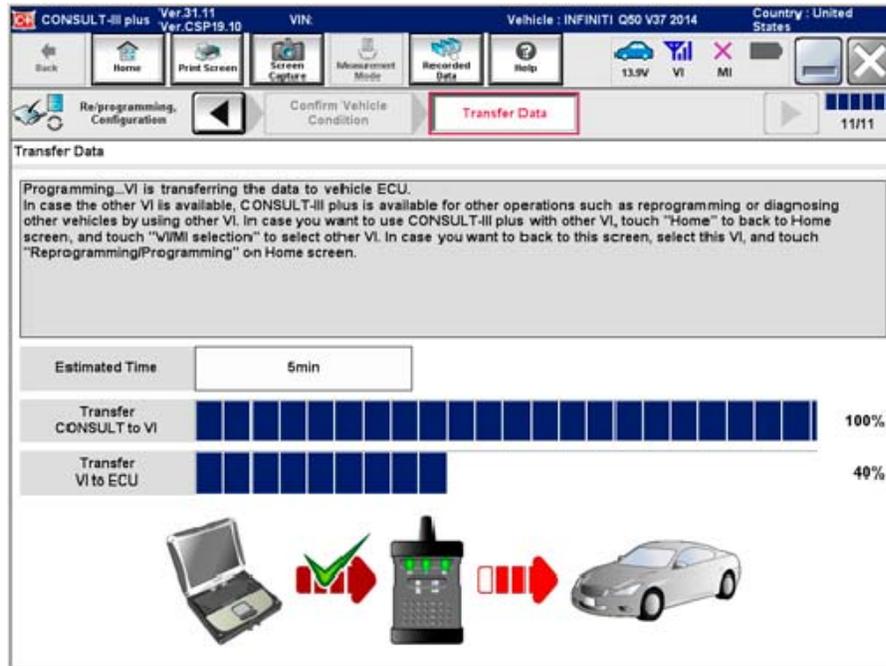
Figure 15

20. Wait for both bar graphs to complete.

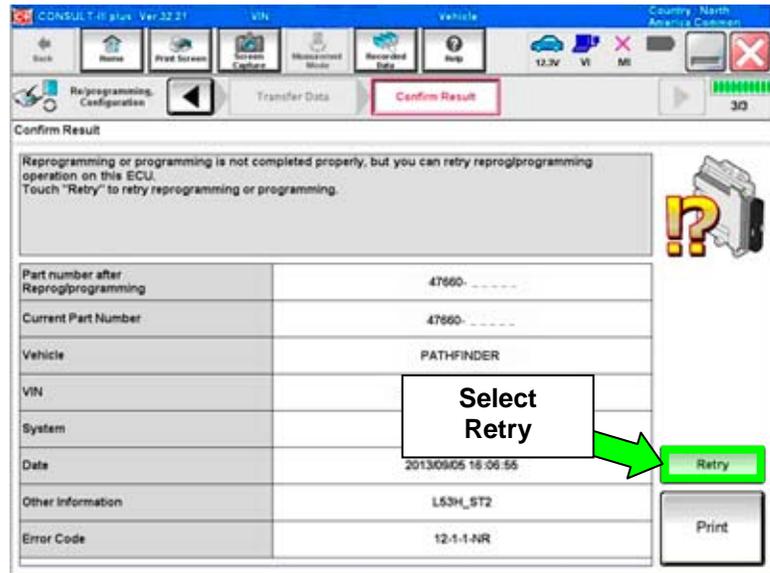
Figure 16

If reprogramming does not complete and the “!?” icon displays as shown in Figure 16:

- Check battery voltage (12.0–15.5 V).
- Ignition is ON, engine OFF. Ready Mode is OFF.
- External Bluetooth® devices are OFF.
- All electrical loads are OFF.
- **Select retry and follow the on screen instructions.**
- “Retry” may not go through on the first attempt and can be selected more than once.

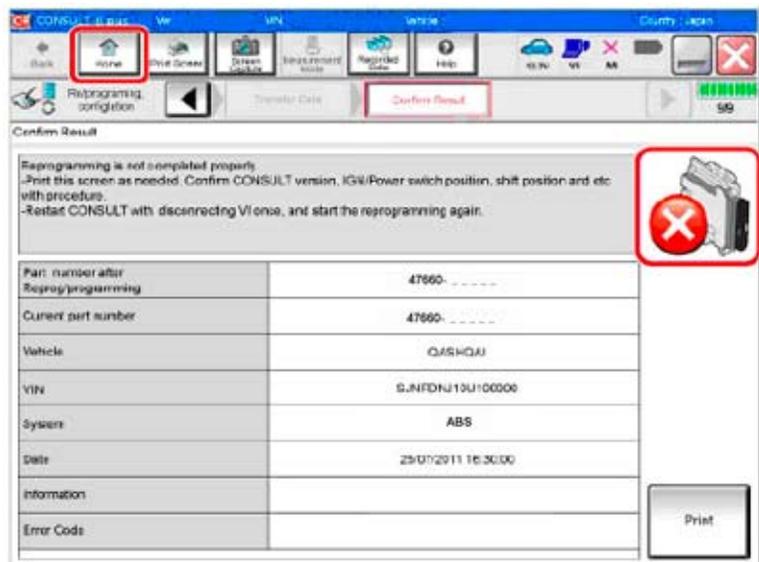
Figure 17

If reprogramming does not complete and the “X” icon displays as shown in Figure 17:

- Check battery voltage (12.0 – 15.5 V).
- CONSULT A/C adapter is plugged in.
- Ignition is ON, engine OFF. Ready Mode is OFF.
- Transmission is in Park.
- All C-III plus / VI cables are securely connected.
- All C-III plus updates are installed.
- **Select Home, and restart the reprogram procedure from the beginning.**

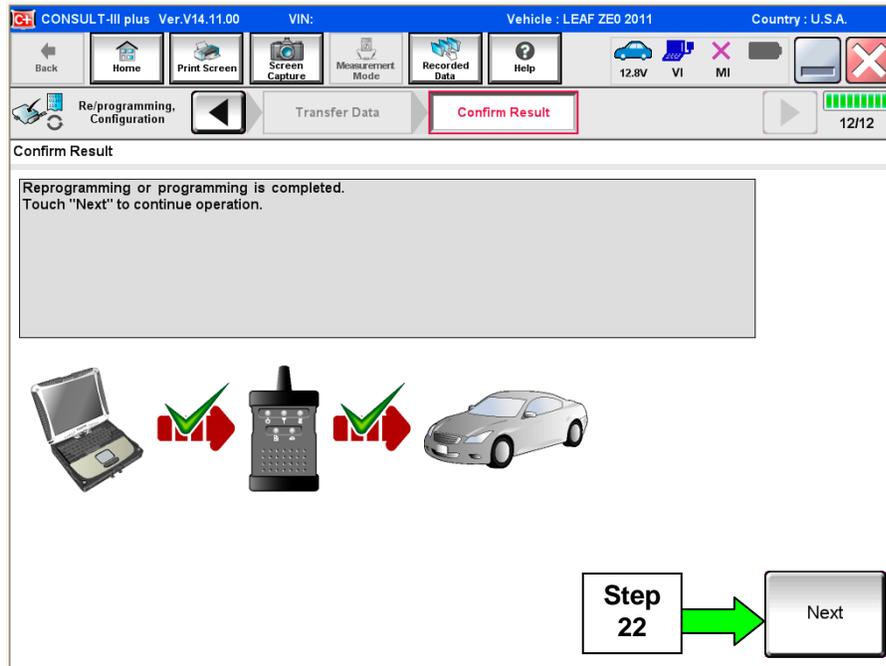
22. Select **Next**, and then wait for System Call to complete.

21. When the screen in Figure 18 on page 13 displays, the reprogramming is complete.

NOTE: If the screen in Figure 18 is not displayed (reprogramming is not complete), refer to the information on the next page.

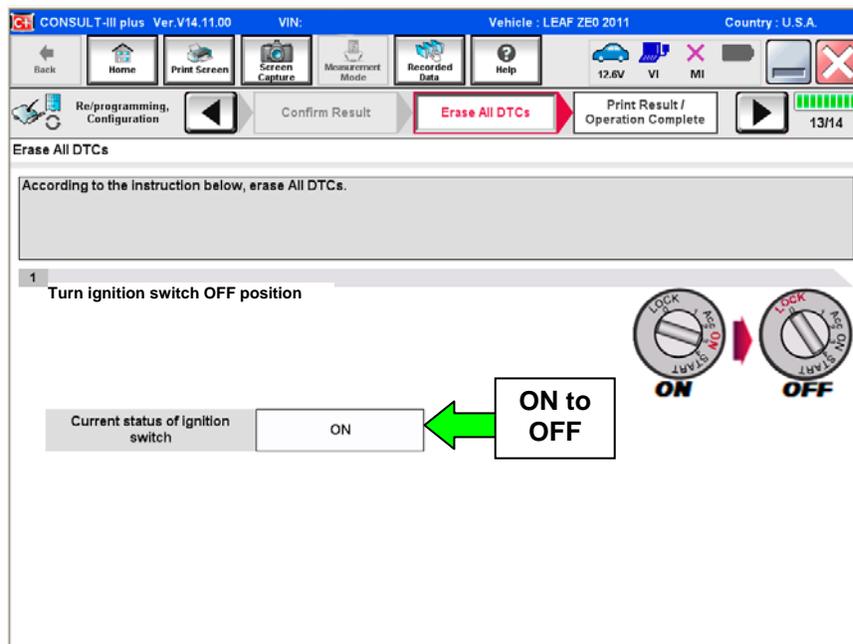
a. Turn "ignition" OFF.

- The screen in Figure 19 will read **OFF** after pressing the power switch once.

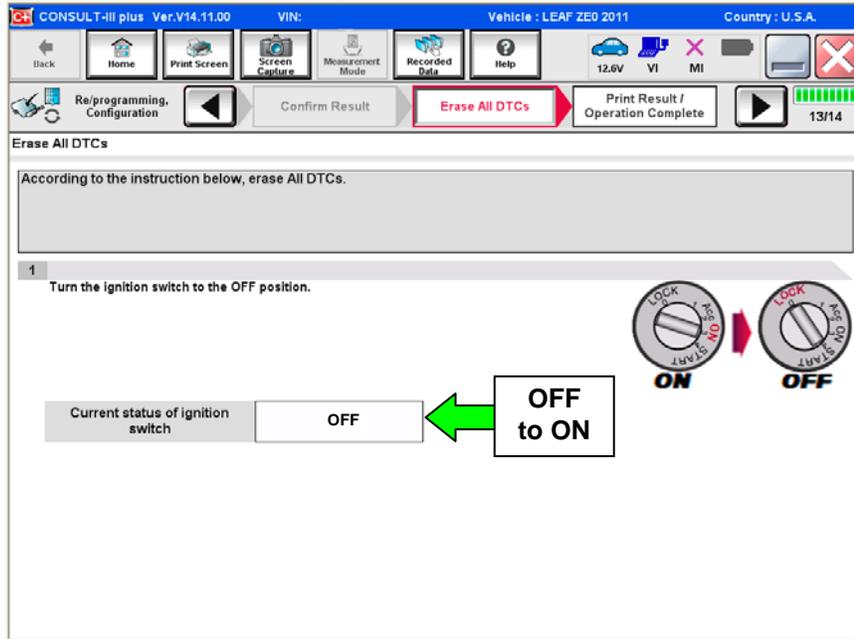
- b. Wait 1 minute with the ignition OFF.
- c. Turn the ignition ON, but do not start the engine or place in Ready Mode (press switch twice without depressing the brake pedal).
 - The screen in Figure 20 will read **ON** after pressing the power switch twice.

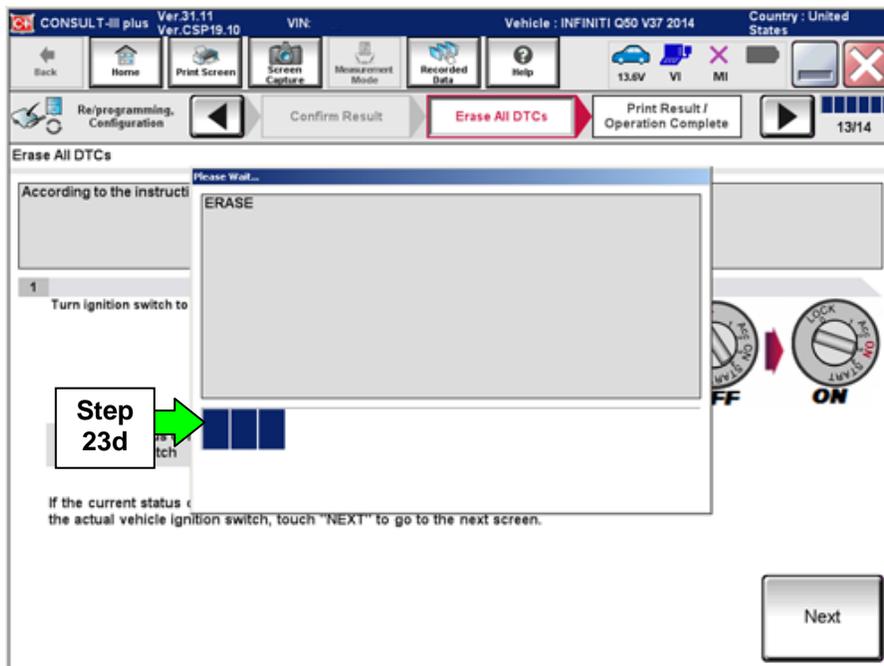
Figure 21

- d. Wait for the bar graph in the **ERASE** window to complete 100%.

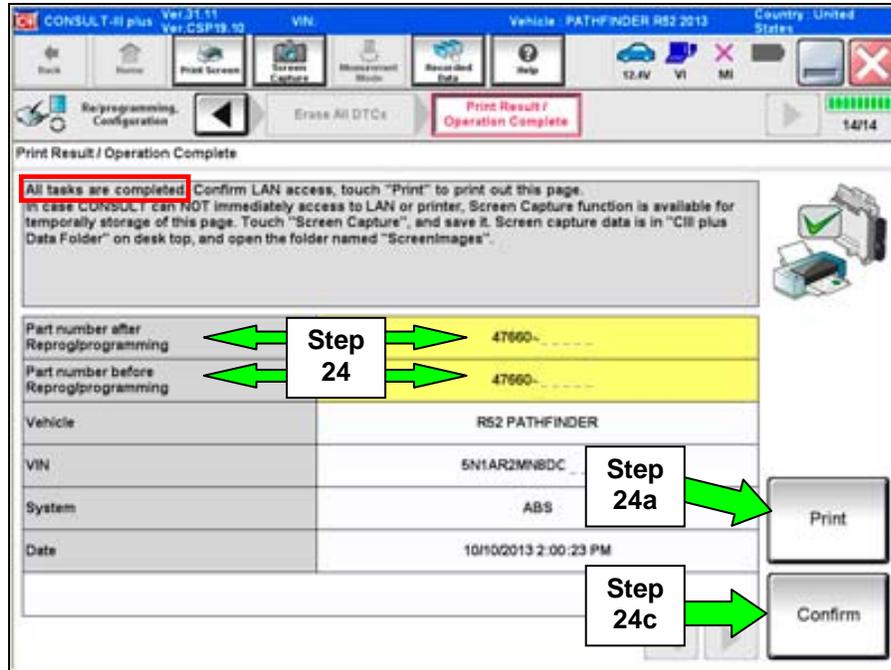
24. Verify the part number has changed (before and after reprogramming part numbers should be different).
 - a. Print a copy of the screen in Figure 22 by selecting **Print**.
 - b. Attach the copy to the repair order.
 - c. Once a copy has been printed, select **Confirm**.

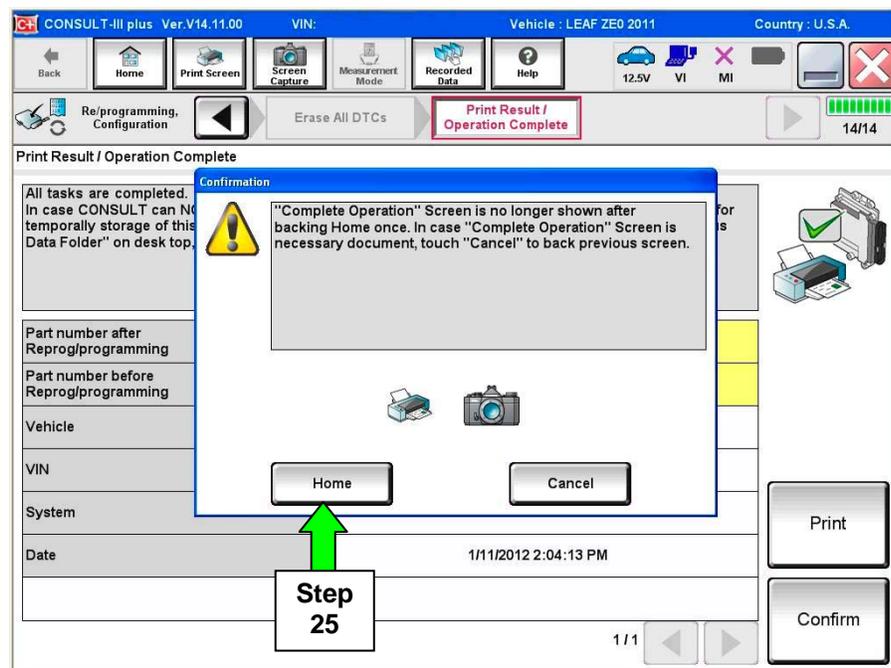
Figure 23

25. After Confirmation has completed, select **Home** and close C-III plus.
