Aftersales Retailer Support

MY2014 Infiniti Q50 Directive Adaptive Steering

Voluntary Safety Recall

Reference: R1310

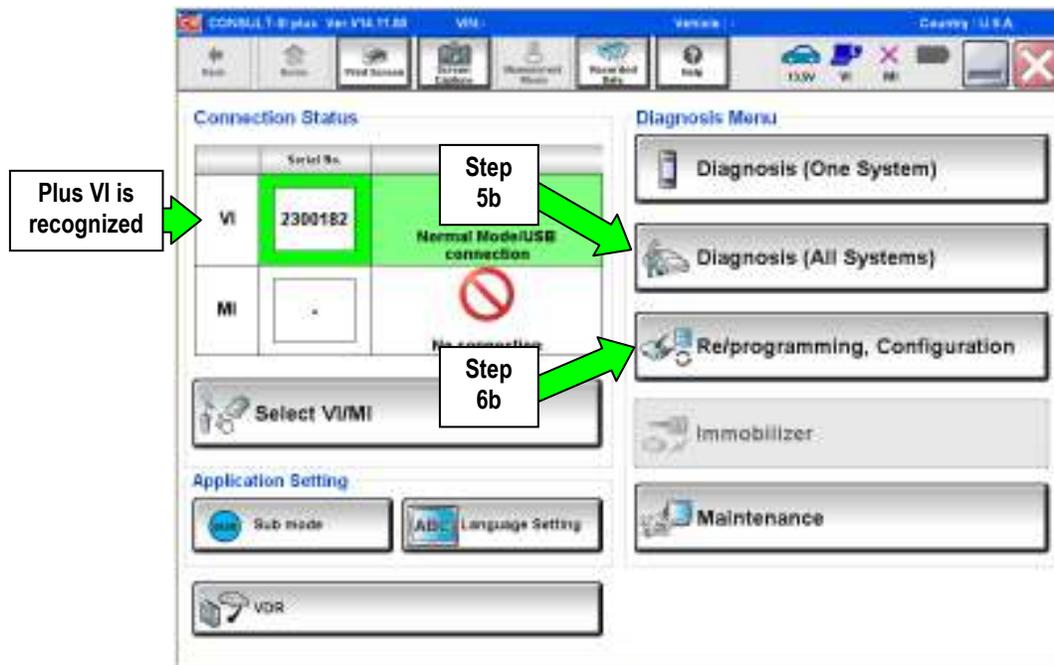
Figure 1

6. Go to **Re/programming, Configuration**.

- Select the **Home** button and then **YES** to return to the screen shown in Figure 1.
- select **Re/programming, Configuration**.

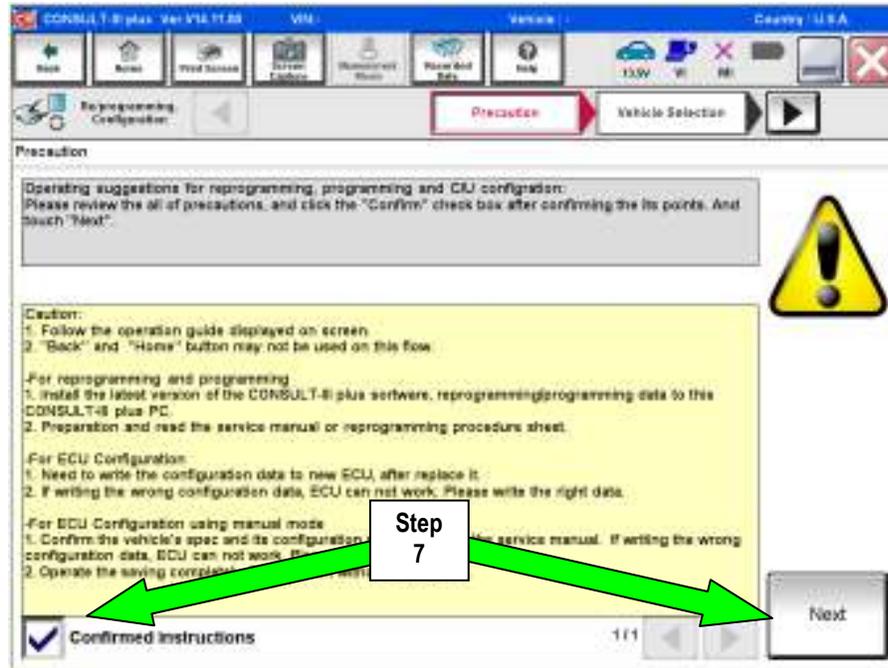
Figure 2

7. Check the box for **Confirmed Instructions**, and then select **Next**.

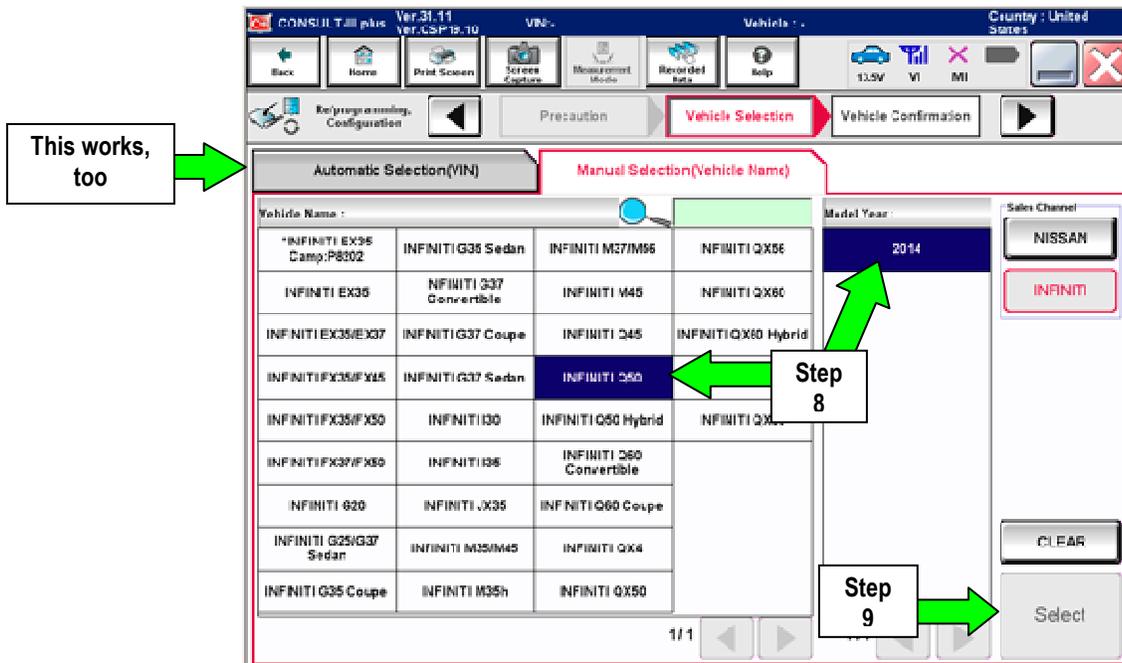
Figure 3

8. Select **Q50** and **2014**, or **Automatic Selection(VIN)**.

- Under **Manual Selection(Vehicle Name)** select Infiniti, Q50, 2014 and then click **Select**.
- For Hybrid vehicles, select Infinity Q50 Hybrid and 2014.
- If **Automatic Selection (VIN)** is selected, wait for the **Reading VIN** screen (not shown) to complete.

9. Select **Select**.

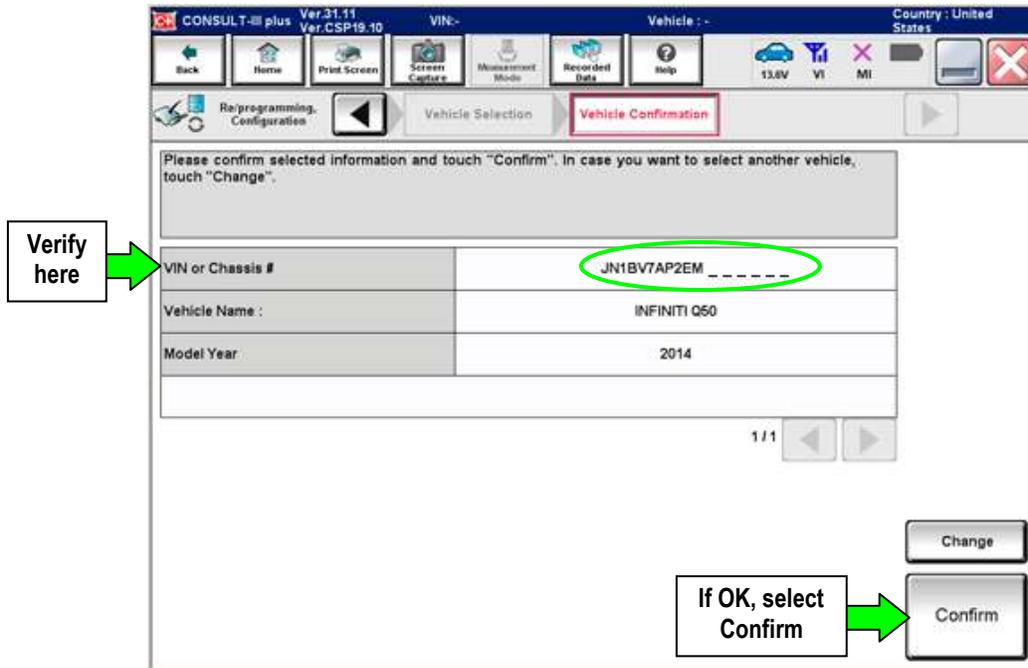
Figure 4

10. Verify the **VIN or Chassis #** matches that of the vehicle.

- If the correct VIN is displayed, select **Confirm**.

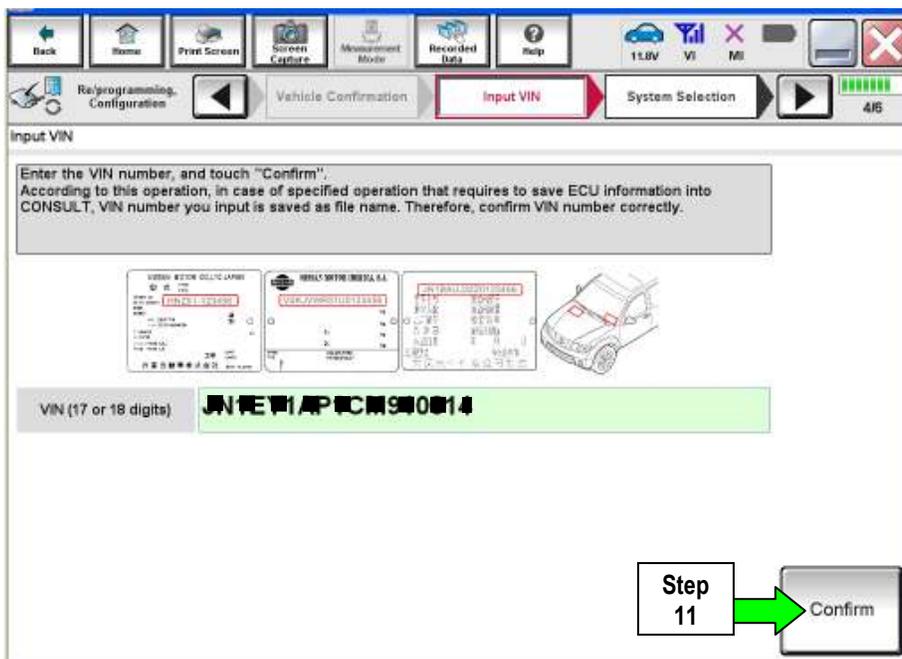
Figure 5

11. Select **Confirm** again.

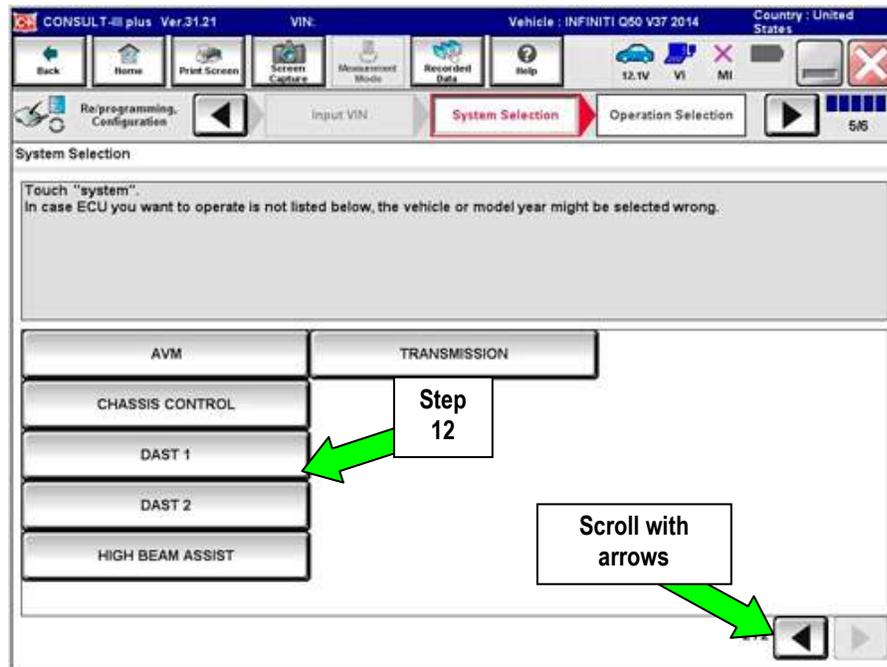
Figure 6

12. Use the page arrows to scroll and **select the correct control unit** to be reprogrammed.

Make sure to reprogram the control units in this order:

DAST 1, then **DAST 2**, and then **EPS/DAST 3**

NOTE: DAST 1 and DAST 2 are shown in Figure 6; EPS/DAST 3 is not shown.

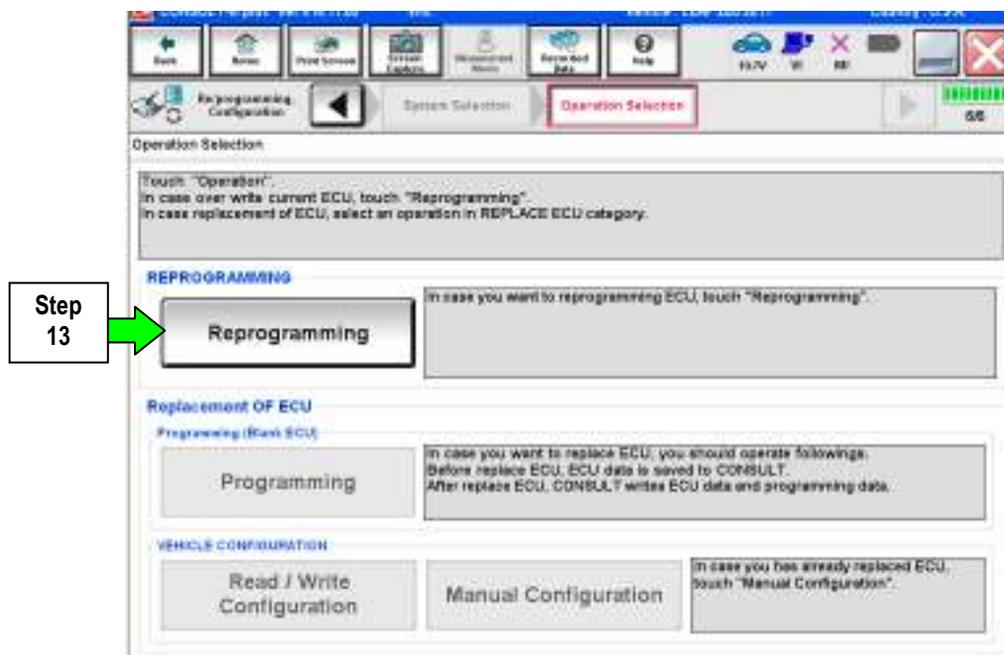
Figure 7

13. Wait for System Call to complete and then select **Reprogramming**.

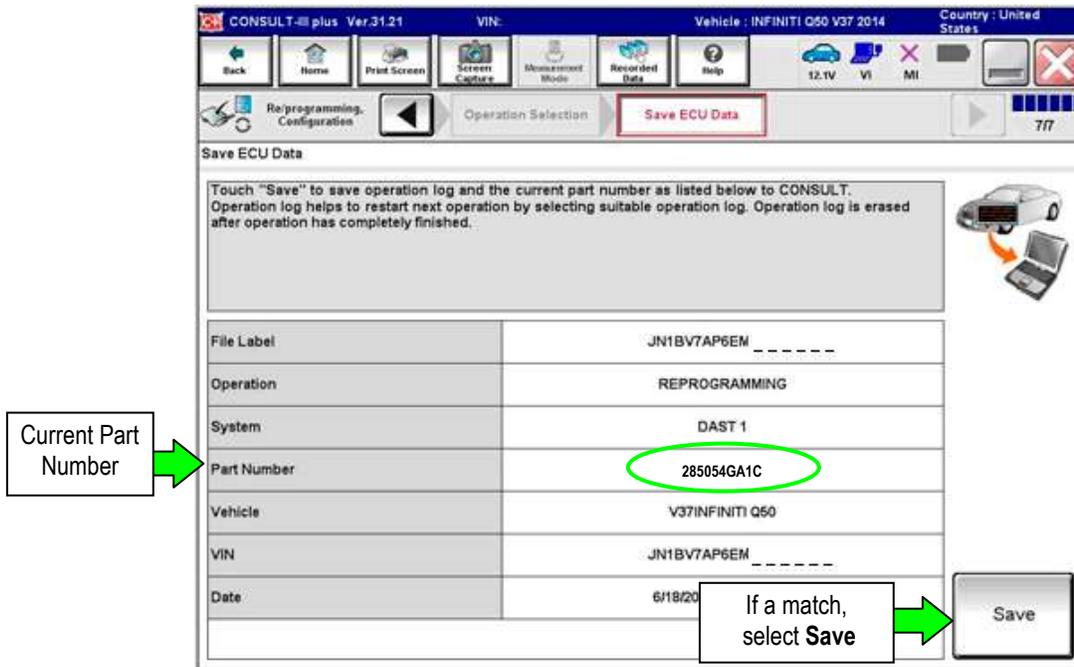
Figure 8

14. When you get to the screen shown in Figure 8, confirm reprogramming applies as follows:

A. Find the DAST **Part Number** and write it on the repair order.

NOTE: This is the current DAST Part Number. DAST 1 is shown; DAST 2 and DAST 3 are similar.

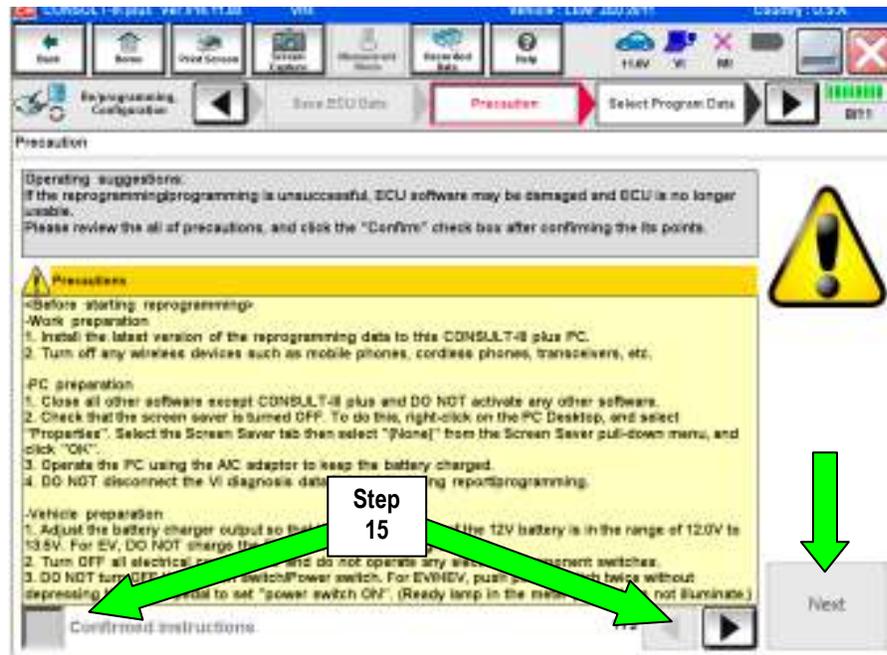
Figure 9

15. Read the precautions on the C-III plus screen (use page arrow as needed). After reading, select **Confirmed instructions**, and then select **Next**.

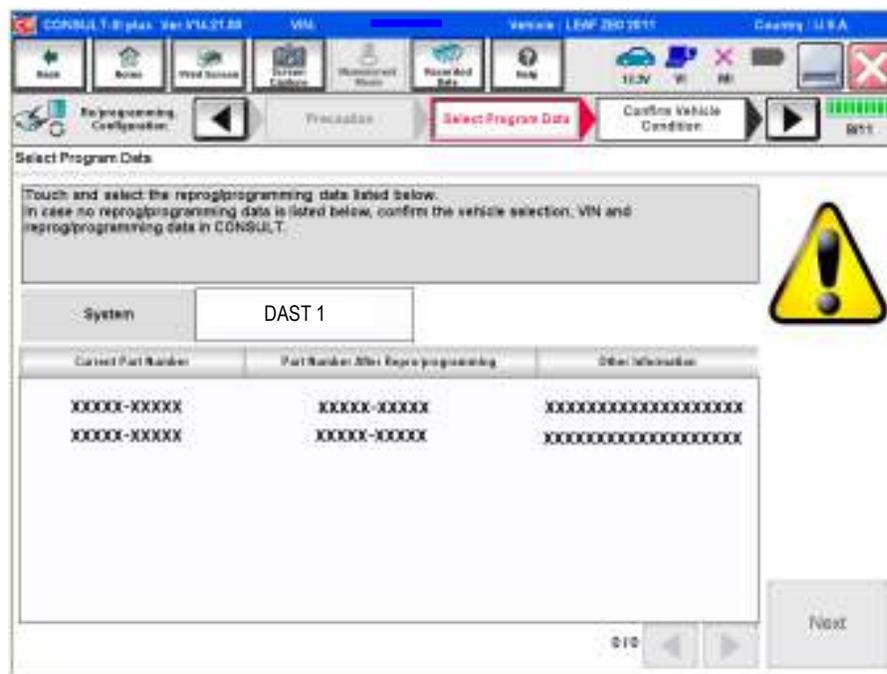
NOTE: In some cases, more than one new P/N for reprogramming is available.

- In this case, the screen in Figure 10 will display.
- Select and use the reprogramming option that **does not** have the message "Caution! Use ONLY with ITBXX-XXX".
- If you get this screen and it is blank (no reprogramming listed), it means there is no reprogramming available for that control unit.

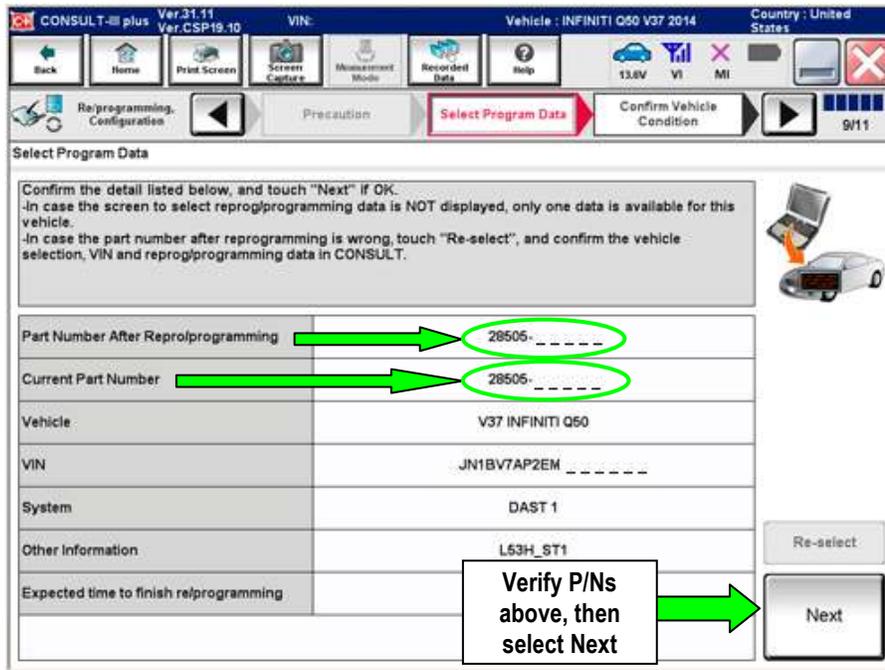
Figure 11

16. Verify the **Current Part Number** matches the Part Number written down in step 14, and then select **Next**.

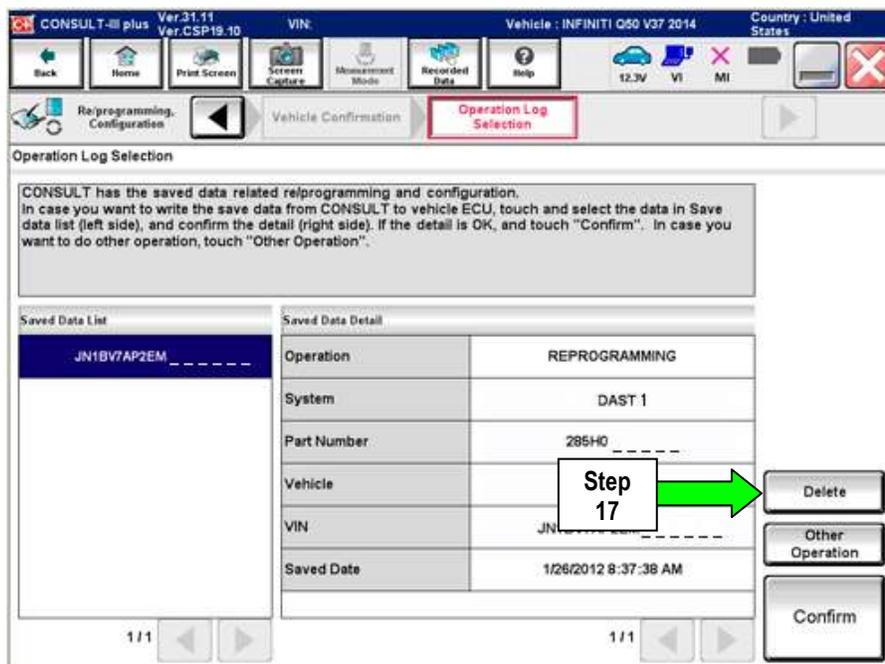
17. If the screen in Figure 12 appears, first select **Delete** then **Confirm**, and then **Other Operation**.

- This will erase the **Saved Data List** and restart the reprogram from step 12. You must go back to step 12.
- If no **Saved Data List** is stored, Figure 13 on the next page will be displayed.

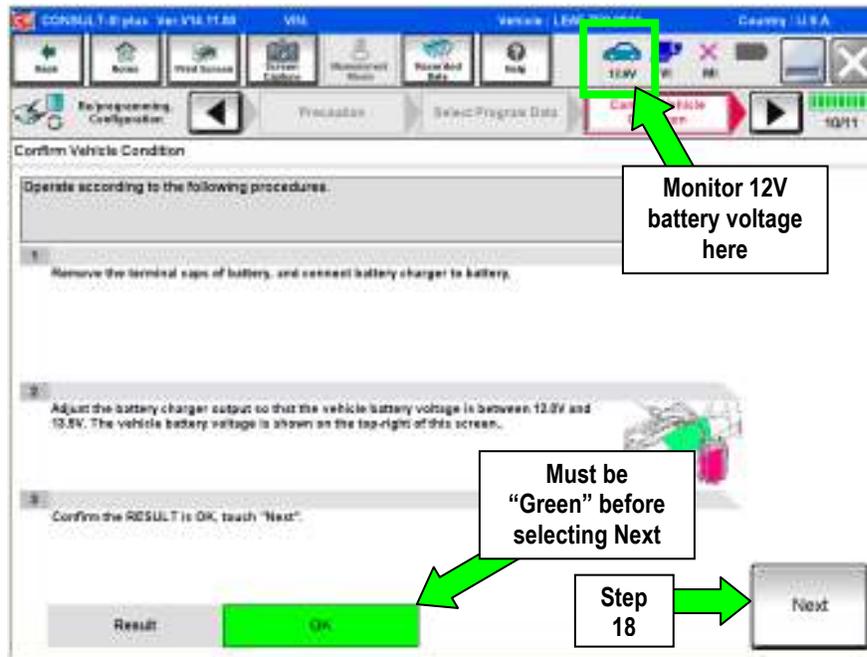
Figure 13

18. Confirm battery voltage is correct, and then select **Next**.

NOTE: Battery voltage must stay within the specified range to make the indicator turn green.

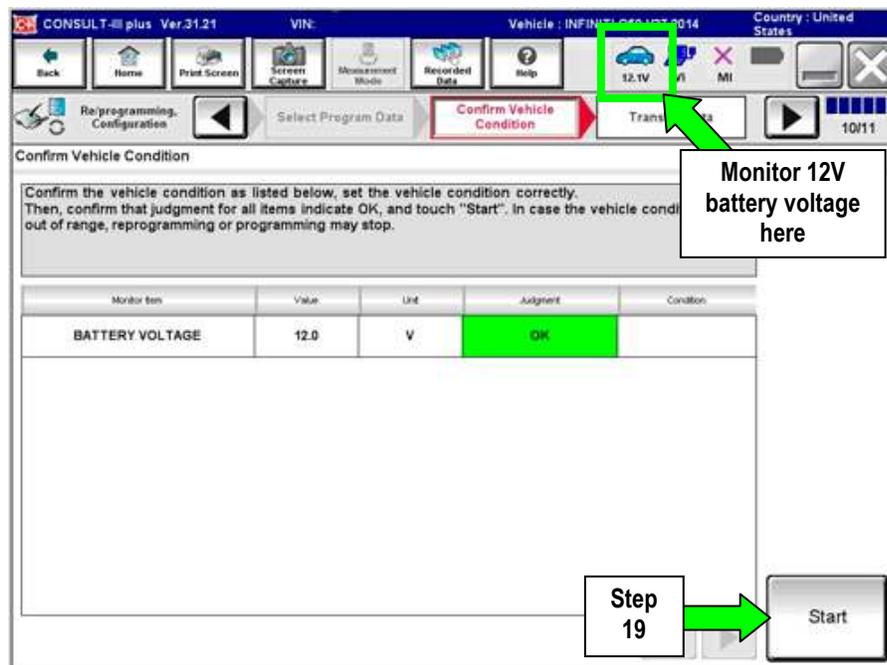
Figure 14

19. With battery voltage OK (green), select **Start**.

- The reprogramming process begins when **Start** is selected.

NOTE: For reprogramming to continue, vehicle 12V battery voltage must stay within 12 volts and 13.5 volts. .

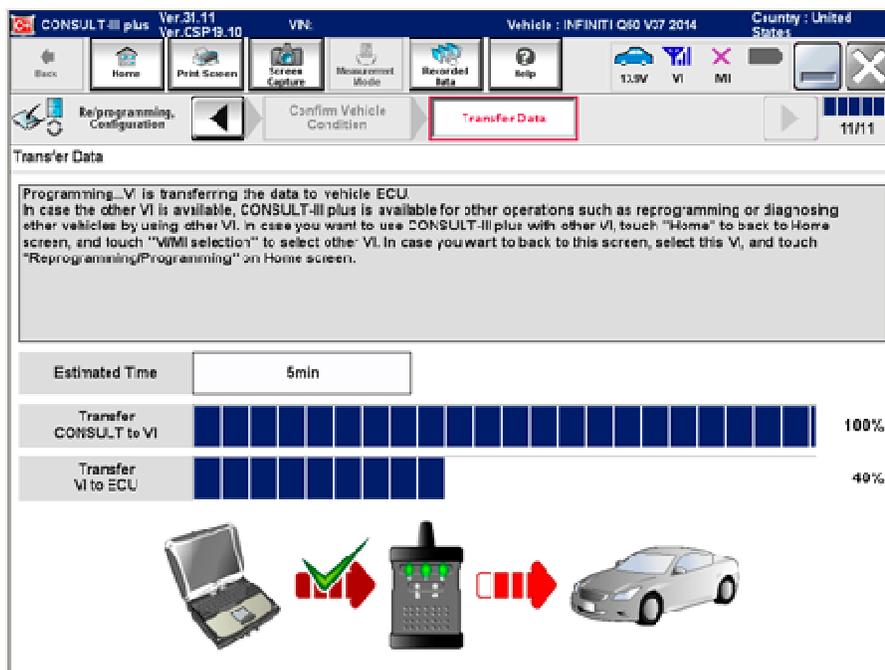
Figure 15

20. Wait for both bar graphs to complete.

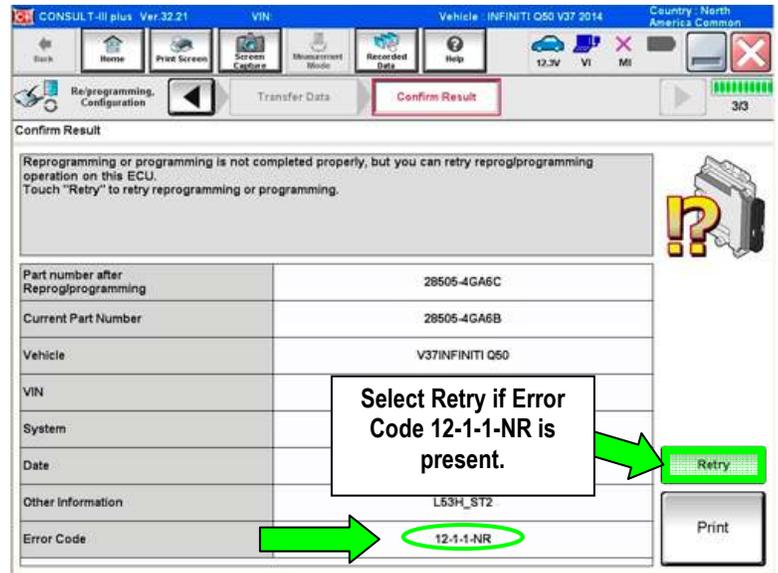
If reprogramming does not complete and the “!?” icon displays as shown in Figure 16:

- Check battery voltage (12.0–13.5 V).
- Ignition is ON, engine OFF (not READY).
- External Bluetooth® devices are OFF.
- All electrical loads are OFF.
- **Select retry and follow the on screen instructions.**
- “Retry” may not go through on the first attempt and can be selected more than once.

- If the progress bar freezes at 90% of a complete transfer to the VI and error code “12-1-1NR” is displayed (see Figure 16 on the next page), **turn the ignition OFF, then ON**, and then refer to Control Unit Recovery on the next page.
- If the progress bar freezes at 90% more than 3 times “on the same DAST control unit” but without Error Code “12-1-1NR”, send email to nafgasupport@nissan-usa.com. Include:
 - VIN
 - Dlr number
 - Contact information

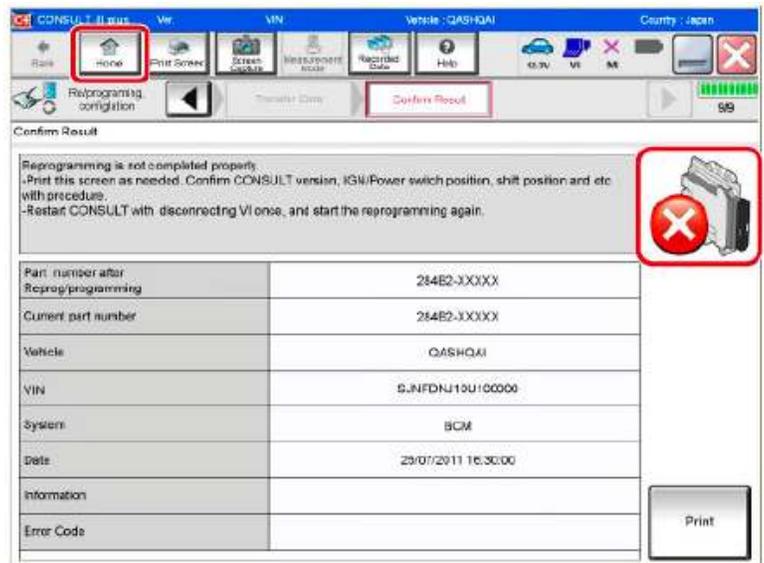
Figure 17

If reprogramming does not complete and the “X” icon displays as shown in Figure 17:

- Check battery voltage (12.0 – 13.5 V).
- CONSULT A/C adapter is plugged in.
- Ignition is ON, engine OFF (not READY).
- Transmission is in Park.
- All C-III plus / VI cables are securely connected.
- All C-III plus updates are installed.
- **Select Home, and restart the reprogram procedure from the beginning.**

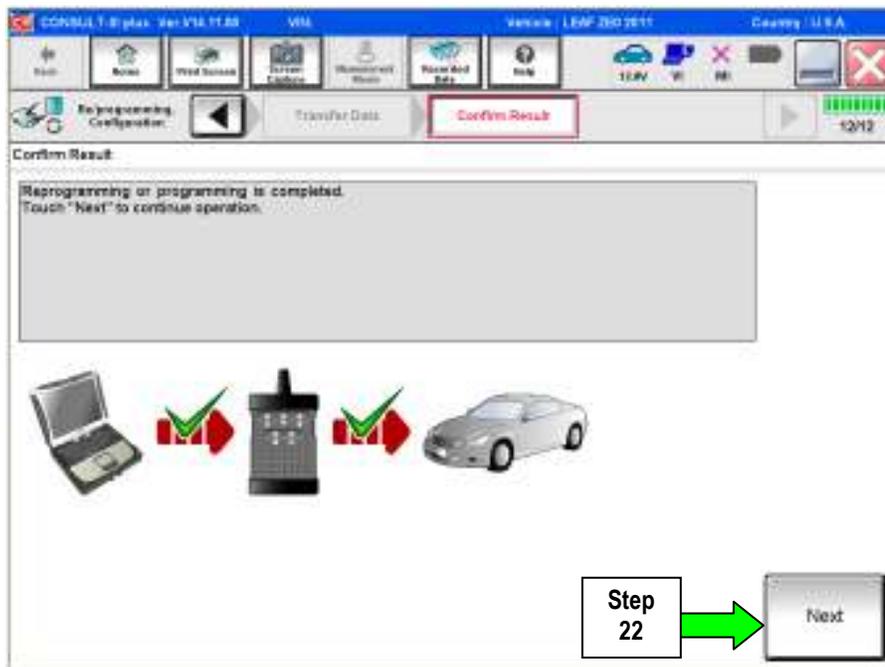
21. When the screen in Figure 18 appears, reprogramming is complete.

22. Select **Next**.

23. Wait for System Call to complete.

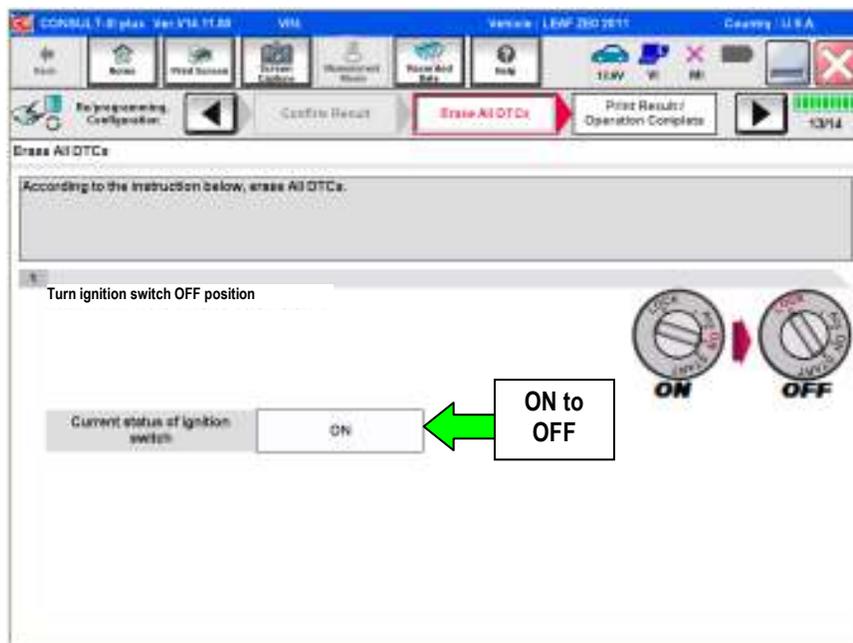
a. Turn "ignition" OFF.

- The screen in Figure 19 will read OFF after pressing the power switch once.

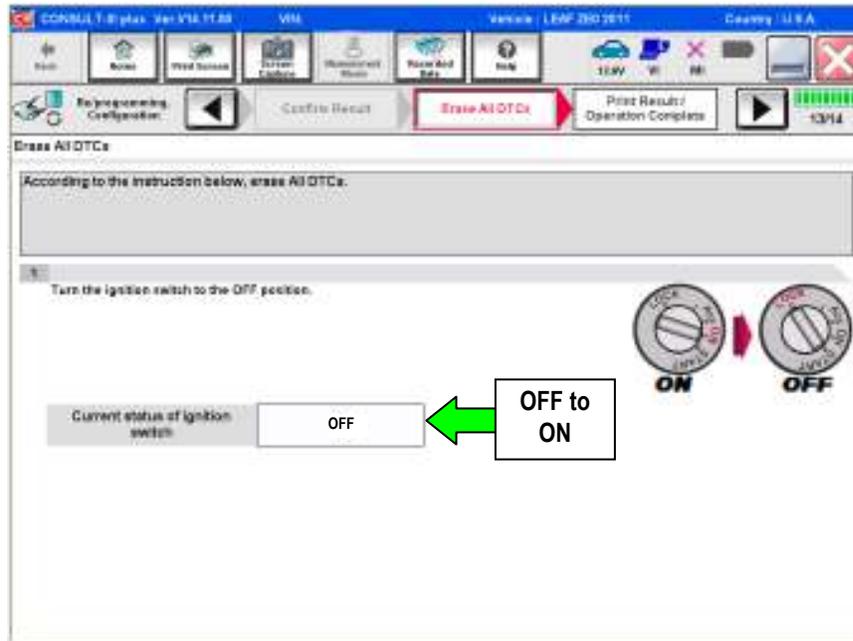
Figure 20

- b. Turn the ignition ON with engine OFF (press switch twice, no foot on brake).
 - The screen in Figure 19 will read **ON** after pressing the power switch twice.
- NOTE:** Do not be confused by any screen messages. At this point, simply turn the ignition ON.

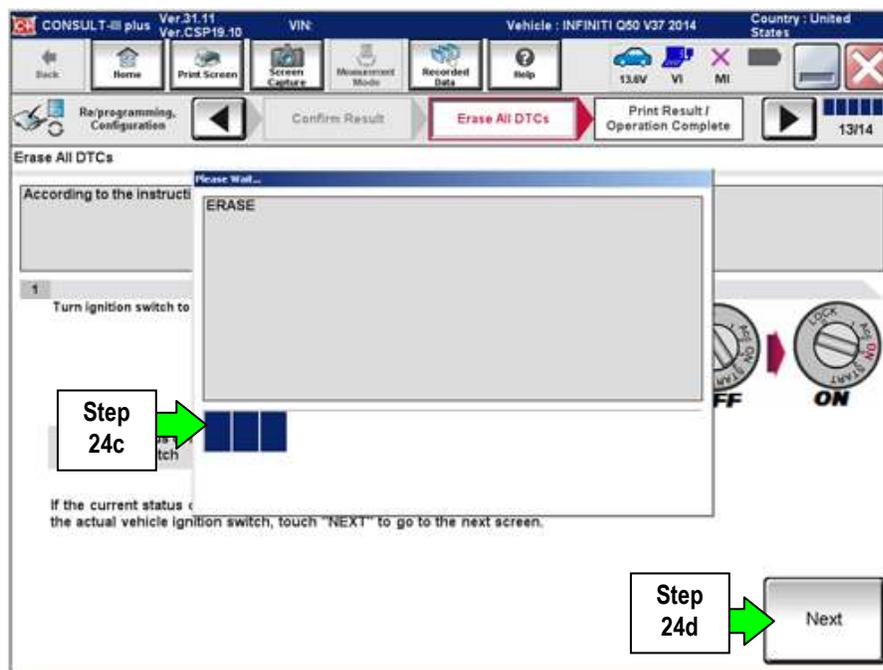
Figure 21

- c. Wait for the bar graph in the **ERASE** window to complete 100%.
- d. Select **Next**.

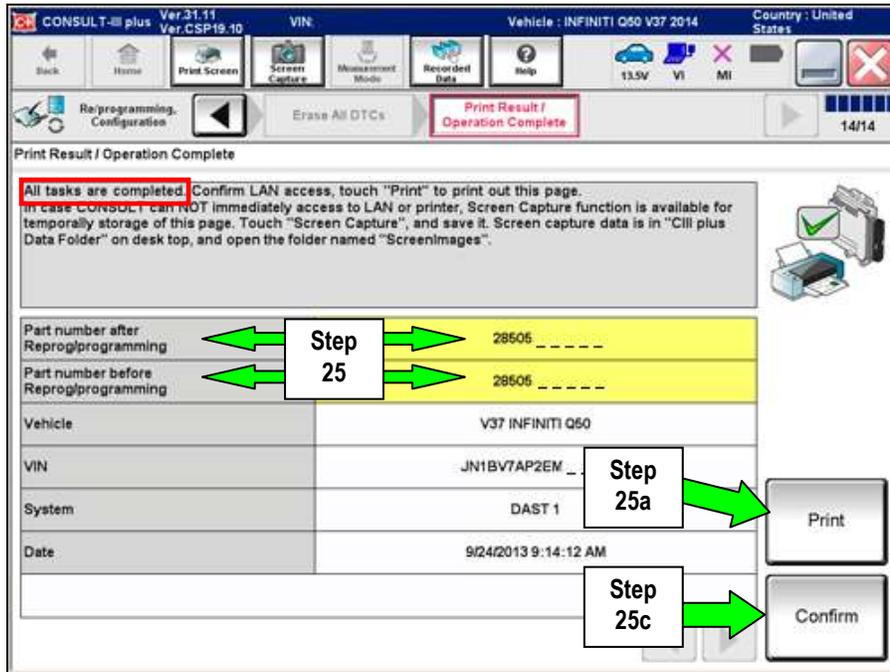
25. Verify the part number has changed (before and after reprogramming part numbers should be different).
- Print a copy of the screen in Figure 22 by selecting **Print**.
 - Attach the copy to the repair order.
 - Once a copy has been printed, select **Confirm**.

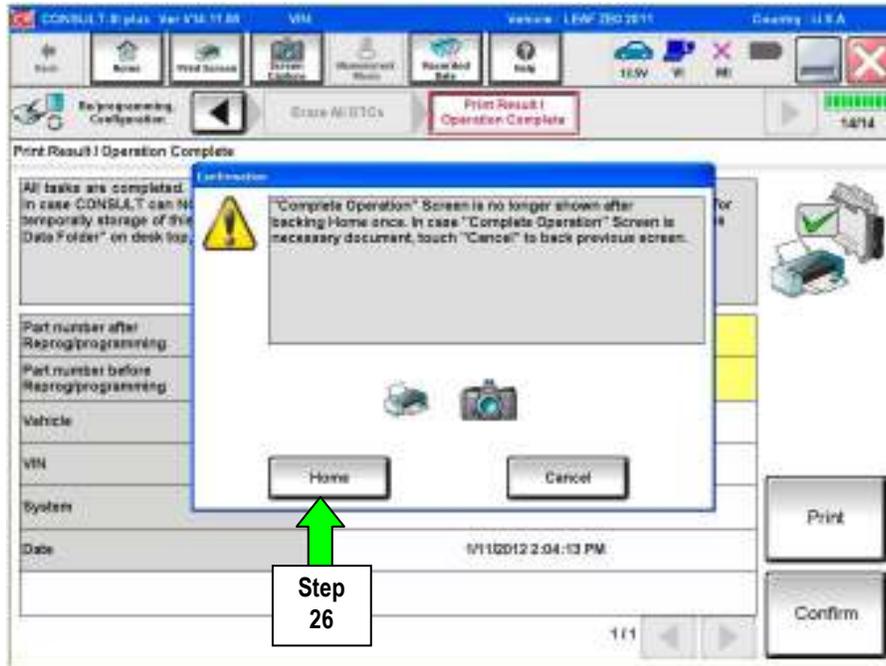
Figure 23

26. After Confirmation has completed, select **Home**
