## **Safety Recall N52 / NHTSA 13V-552 Engine Balance Shaft Module**

**2013 - 2014 (JS) Dodge Avenger and Chrysler 200**

**(JC) Dodge Journey**

**(MK) Jeep Compass and Patriot**

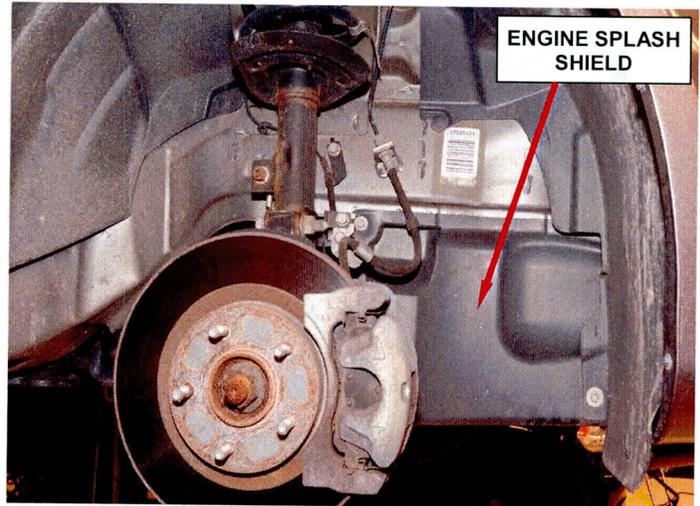
**Figure 1 – Engine Splash Shield**

1. Open the hood.
2. Remove and save the engine oil dipstick.
3. Lift the vehicle on an appropriate hoist.
4. Remove and save the right front tire/wheel assembly.
5. Remove and save the right side engine splash shield (Figure 1).
6. Remove the engine oil pan drain plug and drain the oil from the engine crankcase.
7. Remove and discard the original engine oil filter (Figure 2).
8. Install a new engine oil filter (Figure 2).
9. Install the engine oil pan drain plug.
10. Remove and save the air conditioning compressor lower mounting bracket (Figure 2).
11. Remove and save the engine oil pan bolts.
12. Carefully remove the engine oil pan from the engine block.

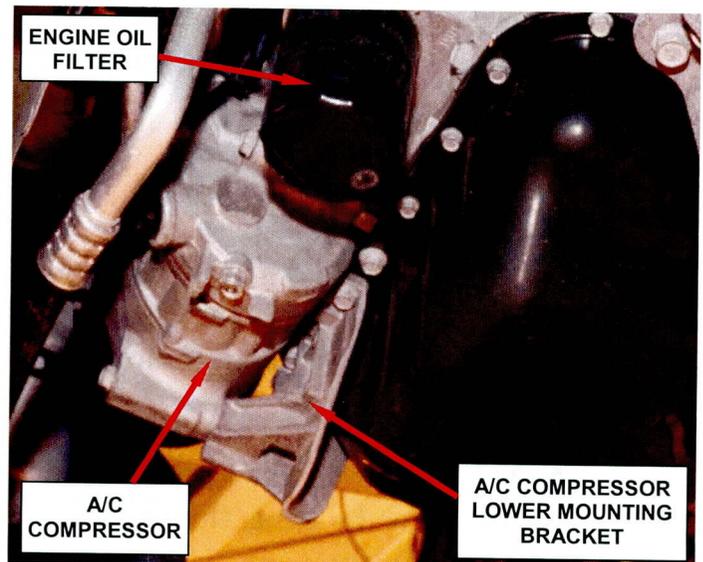
**Figure 2 – Air Conditioning Compressor Lower Mounting Bracket**

27. Apply RTV engine sealant to the oil pan rail.
28. Spray brake clean onto a rag and wipe the engine oil pan mounting surface on the engine block to ensure that there is no oil residue on the engine block.
29. Install the engine oil pan and air conditioning compressor lower mounting bracket onto the engine block. Tighten the engine oil pan bolts to 105 in. lbs. (12 N·m). Tighten the two long oil pan bolts to 195 in. lbs. (22 N·m).
30. Install the right side engine splash shield.
31. Install the right front tire/wheel assembly. Tighten the lug nuts to:
  - 100 ft. lbs. (135 N·m) for JC and JS models.
  - 92 ft. lbs. (125 N·m) for MK models.
32. Lower the vehicle from the hoist.

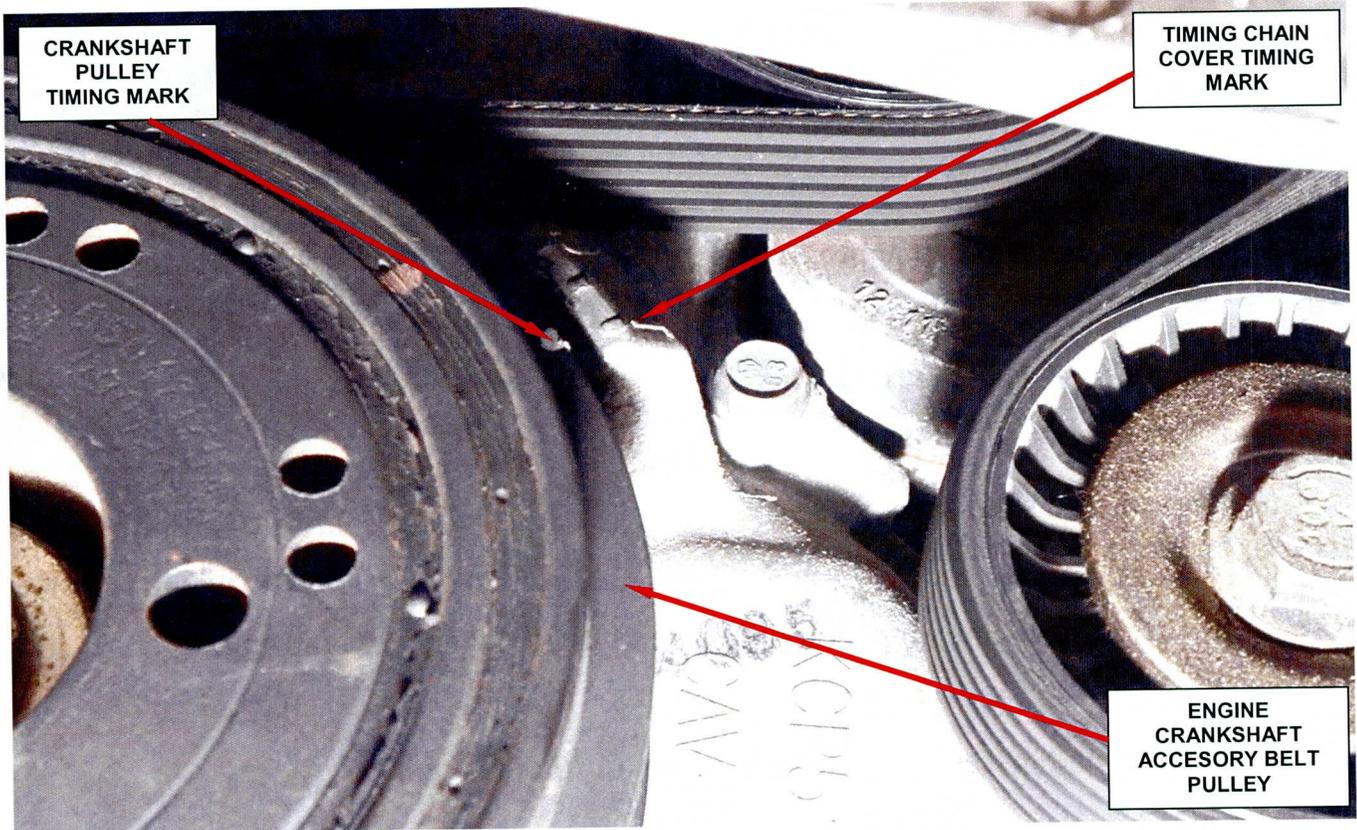
**Figure 3 – Timing Chain Cover Timing Marks**

13. Bar the engine over and align the timing mark on the crankshaft accessory belt pulley with the “T” on the timing chain cover (Figure 3).
14. Verify that the mark on the balance shaft module chain sprocket aligns with the mark on the balance shaft module housing (Figure 4).

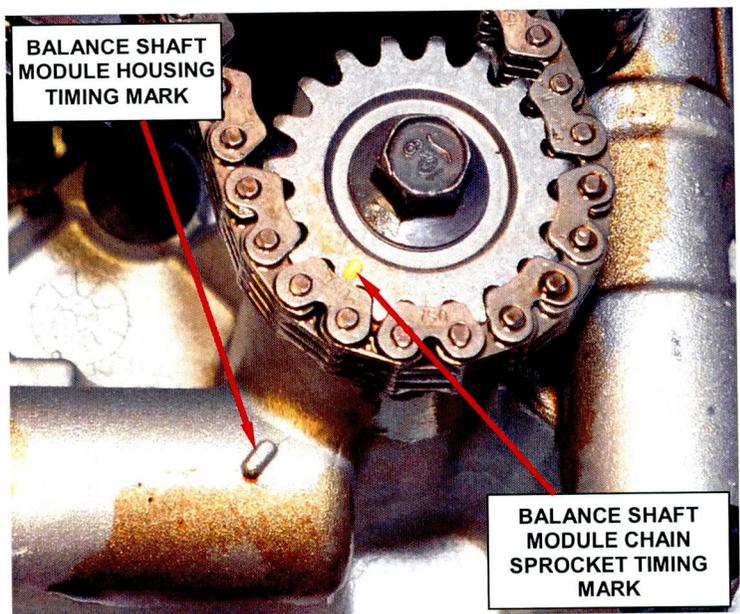
**Figure 4 – Timing Marks**

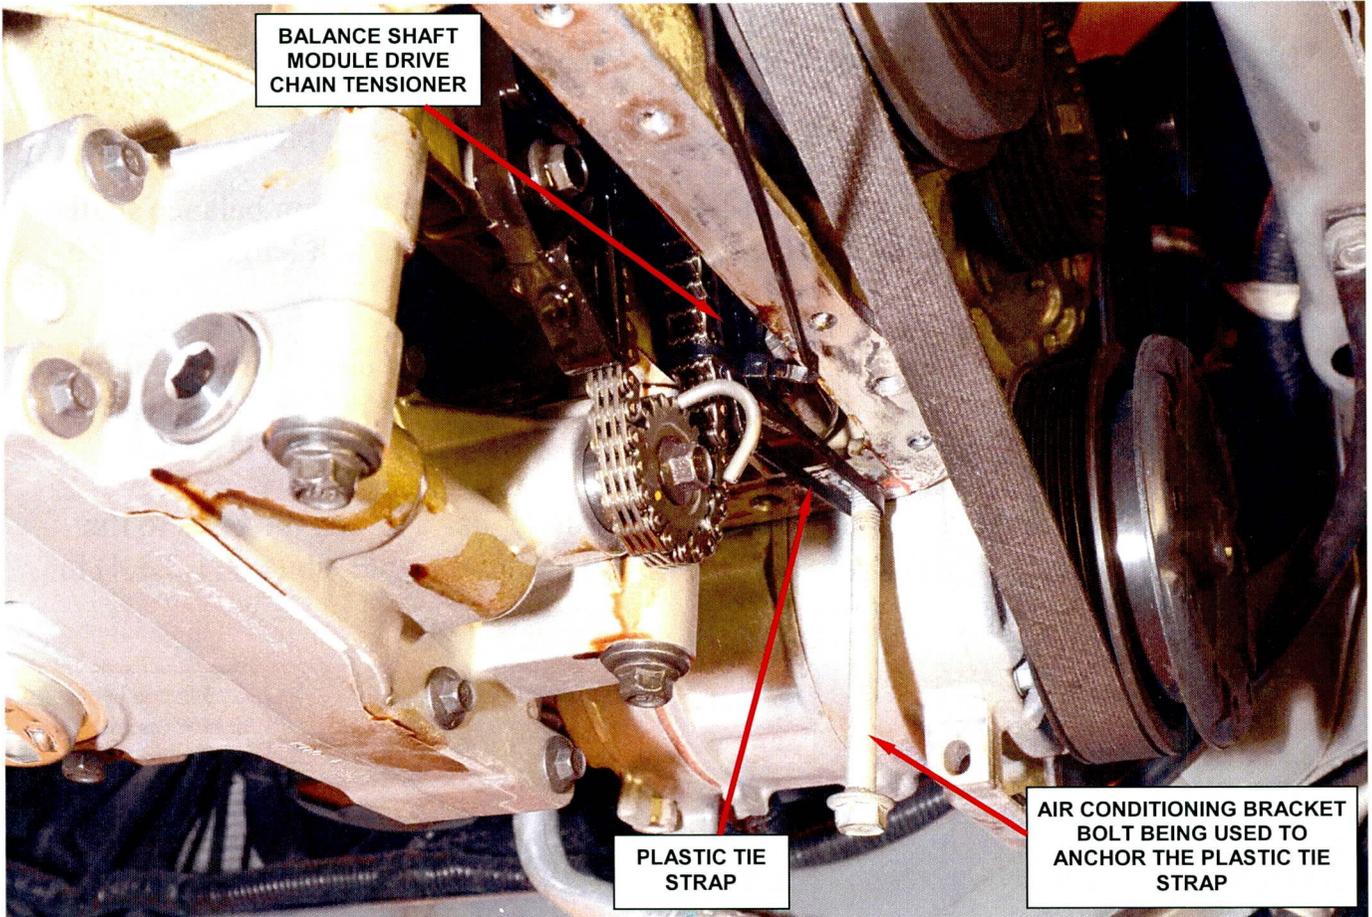
**Figure 5 – Relieve Balance Shaft Drive Chain Tension**

15. Install one air conditioning bracket bolt into the engine block oil pan rail as shown in Figure 5.
16. Using a screwdriver, collapse the balance shaft module drive chain tensioner (Figure 6).
17. Hold the collapsed balance shaft module drive chain tensioner in the collapsed position while tightening the plastic tie strap as shown in Figure 5.

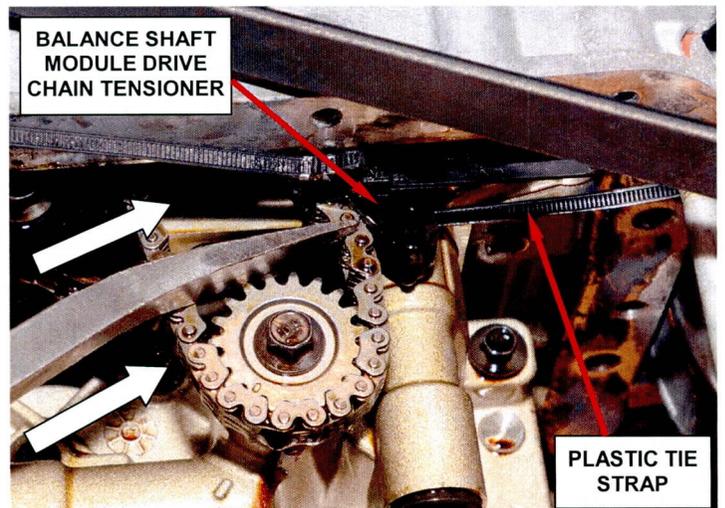
**Figure 6 – Compress Balance Shaft Module Drive Chain Tensioner**

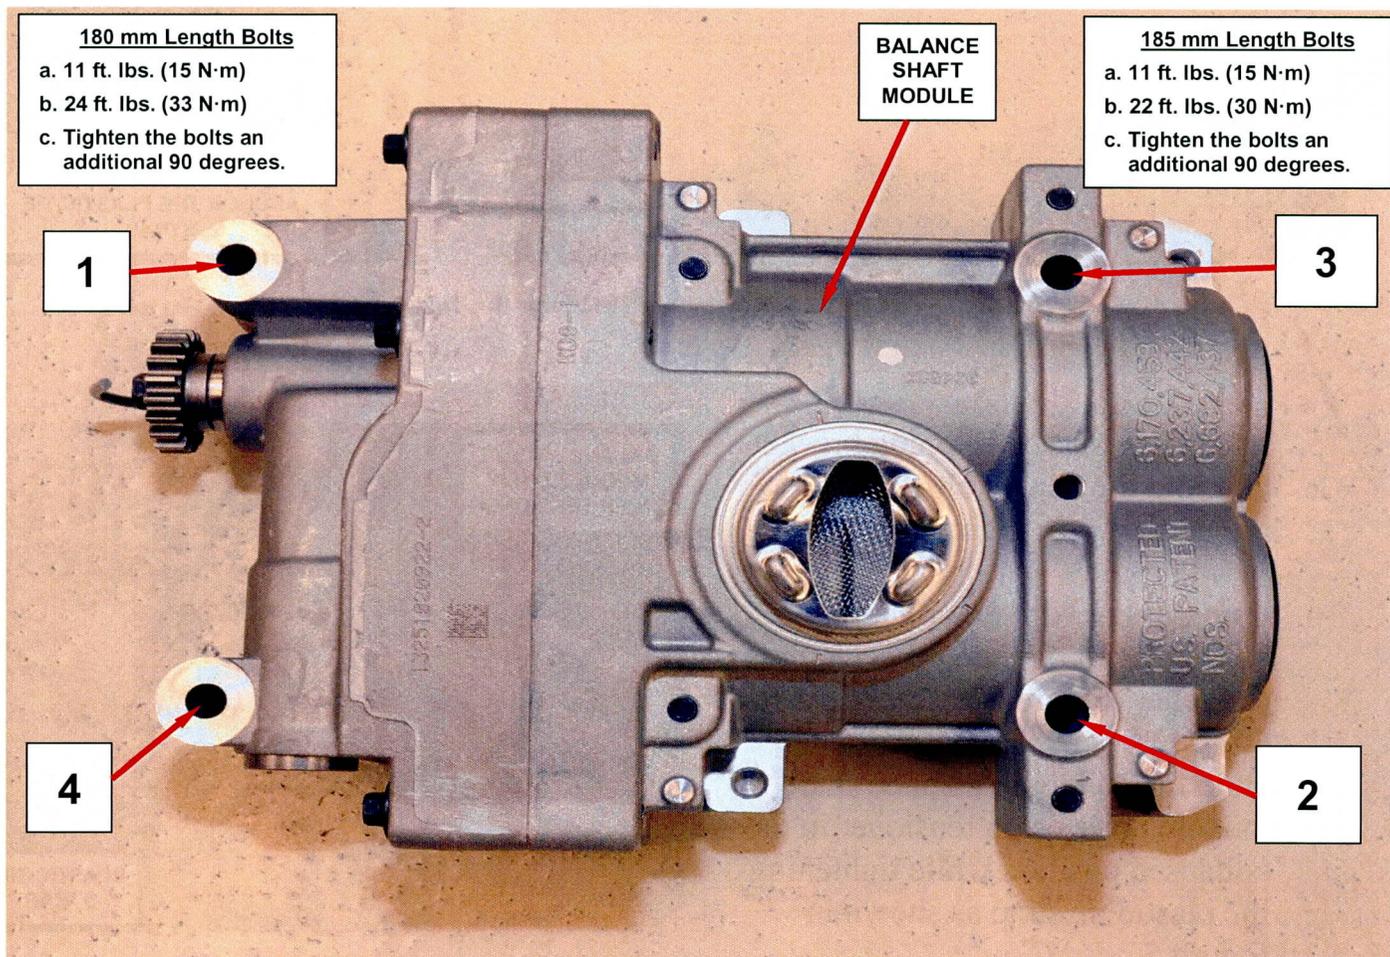
18. Remove and save the four balance shaft module mounting bolts.
19. Carefully remove and discard the balance shaft module from the engine.
20. Thoroughly clean the oil pan mounting surface on the engine block.
21. The balance shaft kit comes with four 180 mm and four 185 mm balance shaft module mounting bolts. Use the four bolts that match the bolt length removed from the engine.
22. Verify that the timing marks on the balance shaft module chain sprocket align with the mark on the balance shaft housing and install the new balance shaft module to the engine (Figure 4).
23. Install the four balance shaft module mounting bolts. Tighten the bolts to the following three step torque sequence (a,b,c) and in the order shown (1,2,3,4) in Figure 7:

Figure 7 – Balance Shaft Module Mounting Bolt Tightening Sequence and Specification

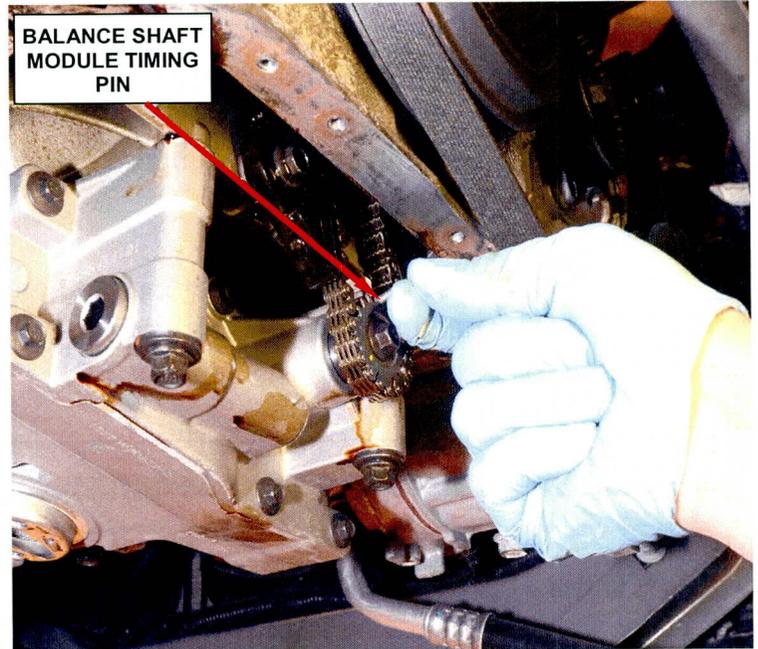
24. Remove the plastic tie strap and ensure that the balance shaft module drive chain tensioner is tight against the chain.
25. Remove and discard the balance shaft module timing pin (Figure 8).
26. If the original engine oil pan is being reused, clean the oil pan rail thoroughly.

**Figure 8 – Balance Shaft Module Timing Pin**
