Subject: Freightliner Cascadia Daytime Running Lights

Models Affected: Two specific groups of Freightliner Cascadia vehicles that use the forward turn signal bulb filaments as turn signal indicators and as daytime running lights (DRLs), SAM Cab software version 6.2, and the "Turn-Tip" function activated. The first group was manufactured with this configuration May 7, 2012, through March 2, 2013. The second group received this as part of a software update during a service visit. (Vehicles not configured in this manner are not affected.)

April 2015
FL641A
NHTSA #13V-099
Transport Canada #13-086

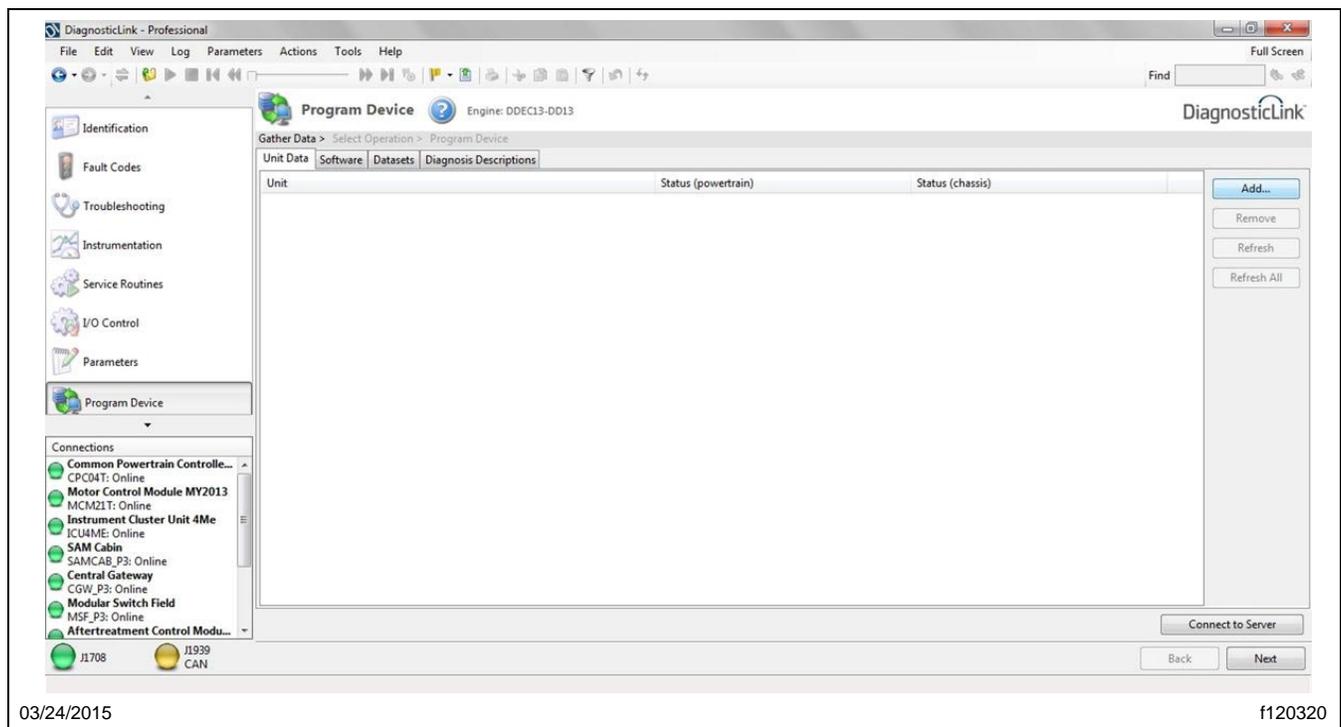
Fig. 1, Gather Data Page

1. Check the base label (Form WAR259) for a completion sticker for FL641 (WAR260) indicating this work has been done. The base label is usually located on the passenger-side door about 12 inches (30 cm) below the door latch. If a completion sticker is present, no work is needed. If a completion sticker is not present, proceed with the next step.
2. In DiagnosticLink, click **Program Device** in the sidebar to display the "Gather Data" page in the program device window. See **Fig. 1**.

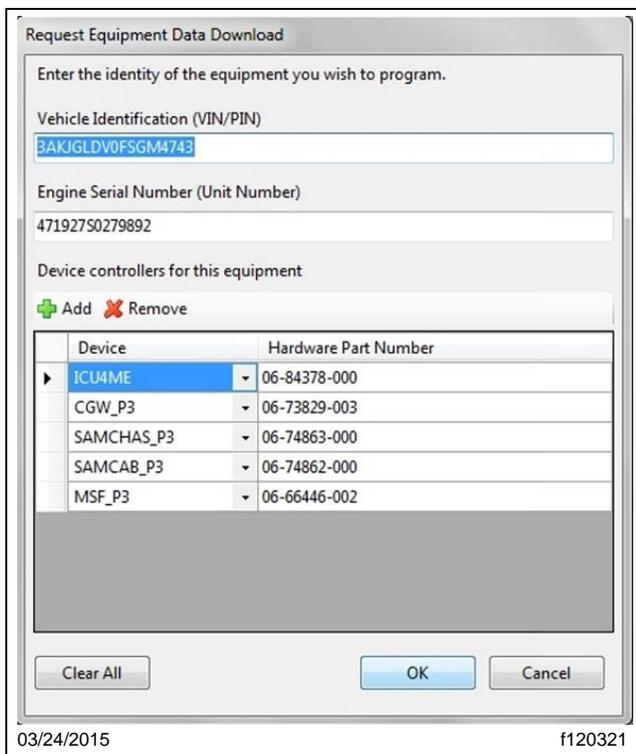
Fig. 2, Request Unit or Vehicle Dialog Box

3. Collect the equipment data for the vehicle.
 - 3.1 Click **Add** to display the "Request Unit or Vehicle" dialog box. See **Fig. 2**.
 - 3.2 The VIN automatically populates the "Vehicle Identification" box when DiagnosticLink is connected to the vehicle. If the vehicle is not connected, enter the VIN manually.
 - 3.3 Click **OK** to close the dialog box.
4. Click **Connect to Server**.
5. Enter the user name and password in the dialog box (**Fig. 3**), then click **OK** to download the required data. When the data is successfully downloaded, the status changes to OK in the "Unit Data" list. See **Fig. 4**.
6. Continue to "Programming the SAM Cab."

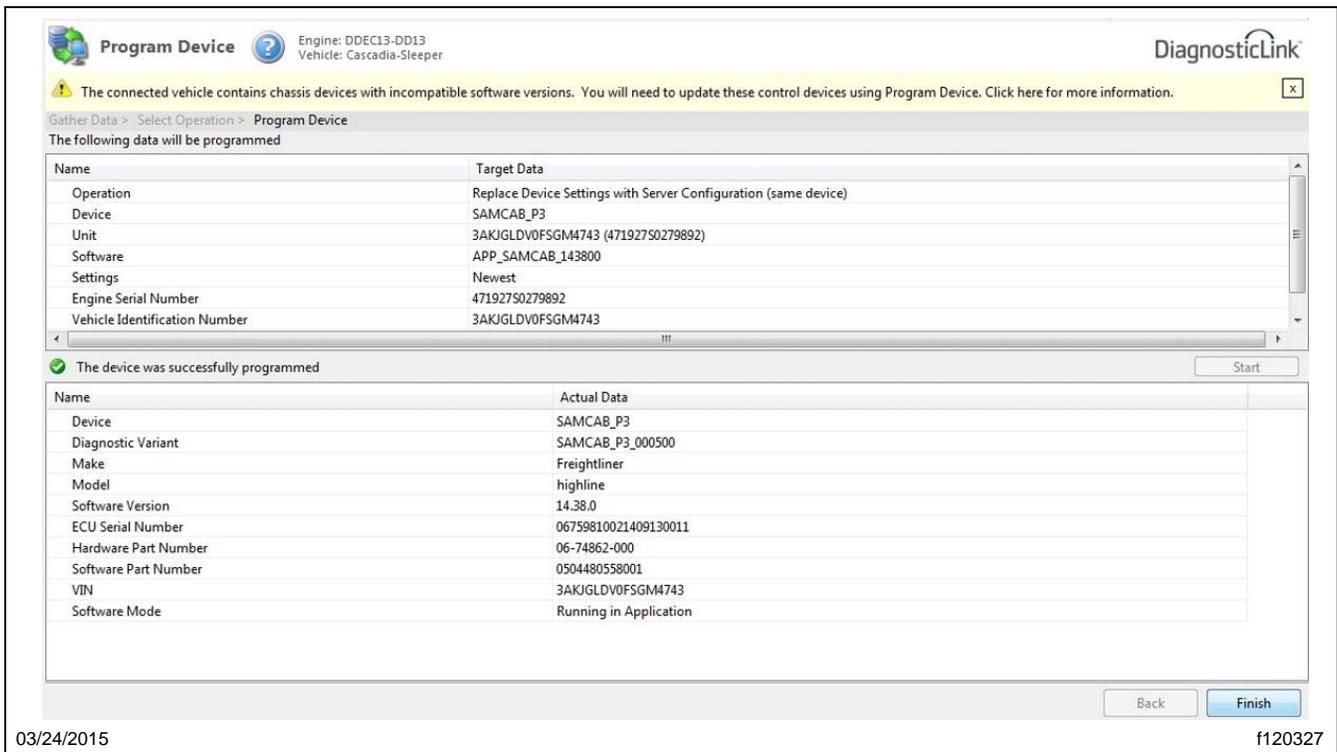
Fig. 7, Gather Data Page

5. Once the programming steps are completed, the lower table will show the new settings programmed into the module. See **Fig. 7**.

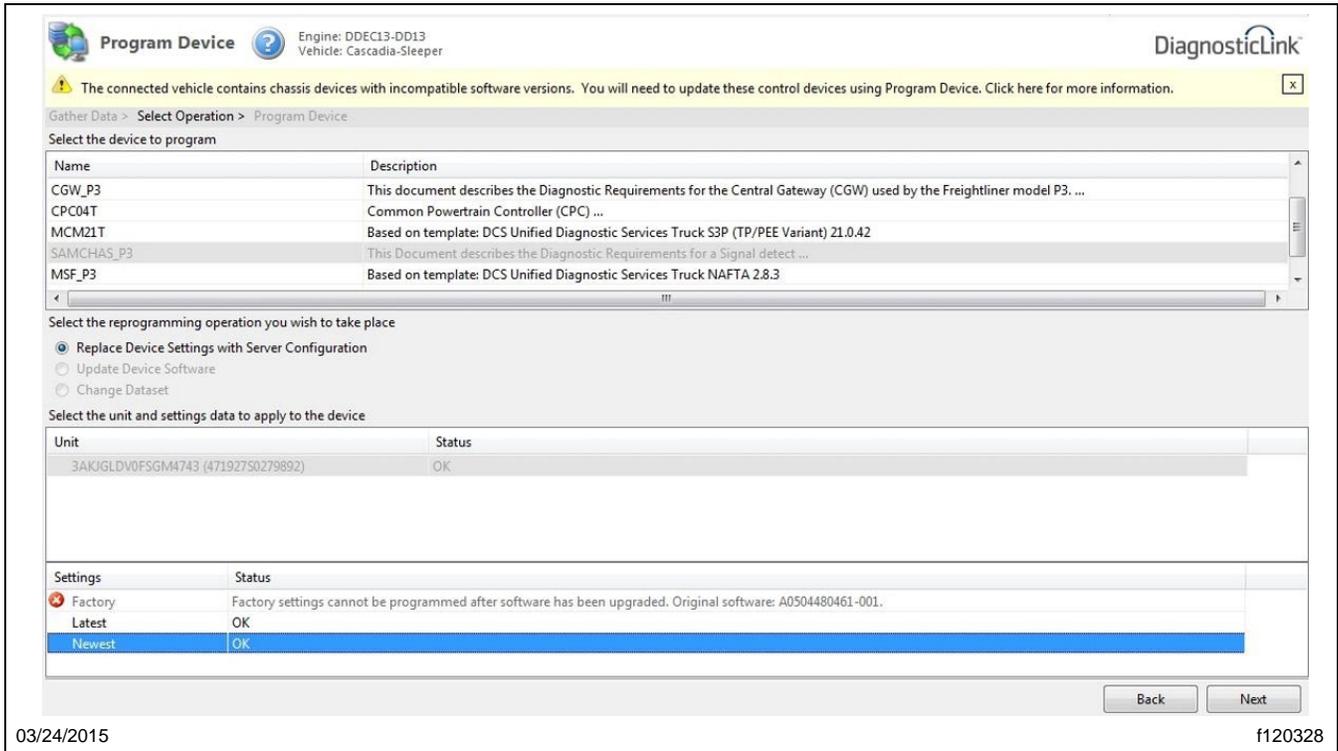
Fig. 8, Select Operation Page

1. Click **Next** to display the "Select Operation" page in the Program Device window. See **Fig. 8**.
 - 1.1 Select **SAMCHAS_P3** from the table at the top of the window.
 - 1.2 The "Replace Device Settings with Server Configuration" radio button is automatically selected.
 - 1.3 Select the VIN of the vehicle to be programmed.
 - 1.4 Select the newest setting.
2. Click **Next** to display the "Program Device" page. See **Fig. 9**.
3. Carefully check the VIN and software version in the table at the top of the page; the software version should be **APP_SAMCHAS_142800**.
4. If the information is correct, click **Start** to begin programming the SAM Chassis.

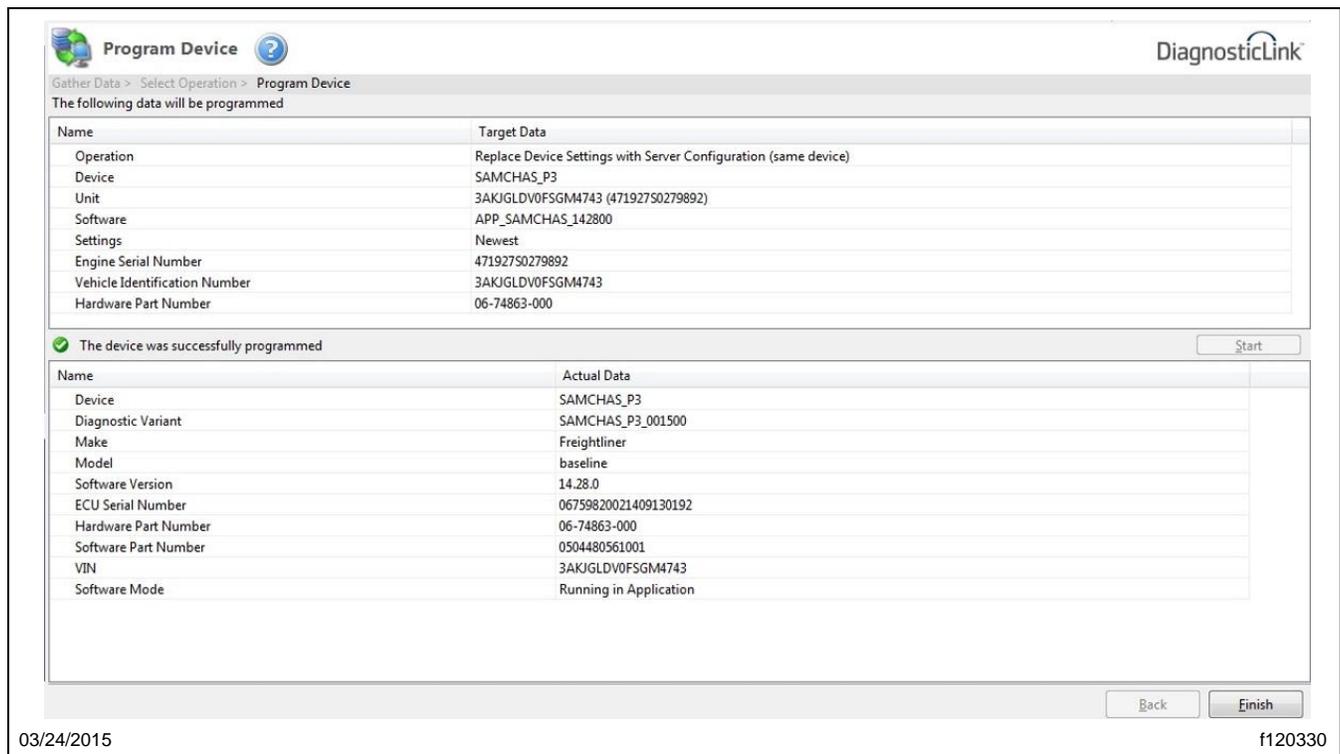
Fig. 10, New Settings

5. Once the programming steps are completed, the lower table will show the new settings programmed into the module. See **Fig. 10**.

The message above the new settings confirms that the process was successful. Click **Finish**. DiagnosticLink will return to the "Gather Data" page.

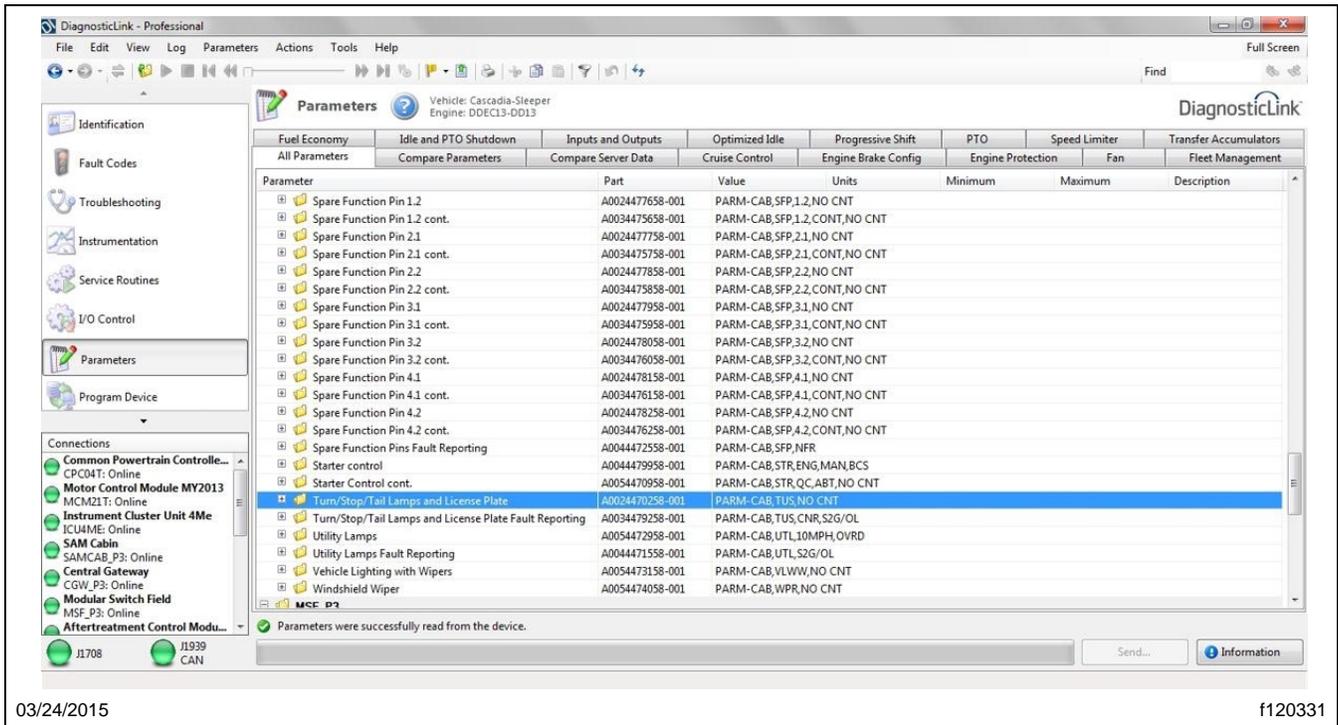
Fig. 11, Locating the Parameter in the Search Bar

2. The "All Parameters" tab at the top of the window should be selected. If not, click the "All Parameters" tab at the top of the window.
3. Locate the **Turn/Stop/Tail Lamps and License Plate** parameter under **SAMCAB_P3**. The search bar can also be used. See Fig. 11.
4. Click the **Value** cell for **Turn/Stop/Tail Lamps and License Plate**. This can also be done by clicking the parameter entry and clicking **Enter**, or double-clicking anywhere in the parameter entry. See Fig. 12.
5. The "Value" cell will be enabled as a drop-down menu. Select the desired value from the menu:
 - **A0024470258-001**: No turn tip
 - **A0024470358-001**: Turn tip, flashes 5 times
 - **A0024478558-001**: Turn tip, flashes 3 times

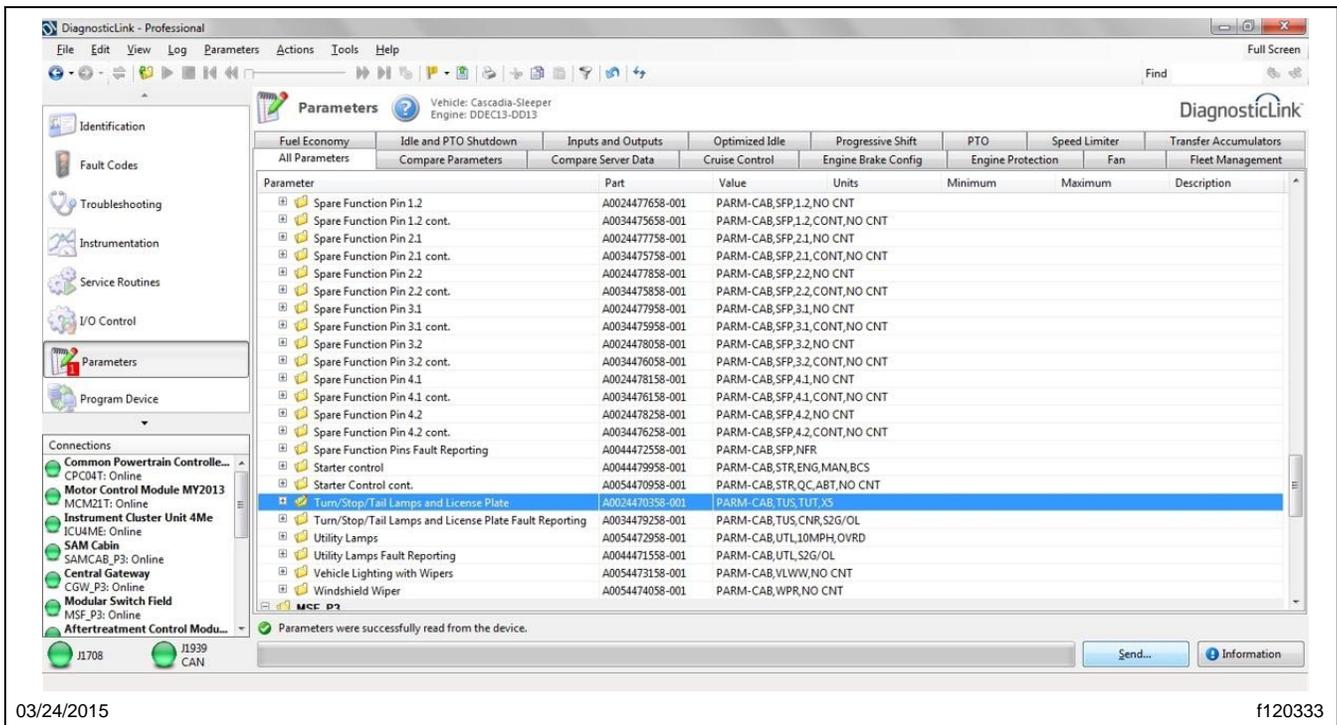
Fig. 13, Parameters Window

The change in value will be marked in the "Parameters" window. See Fig. 13.

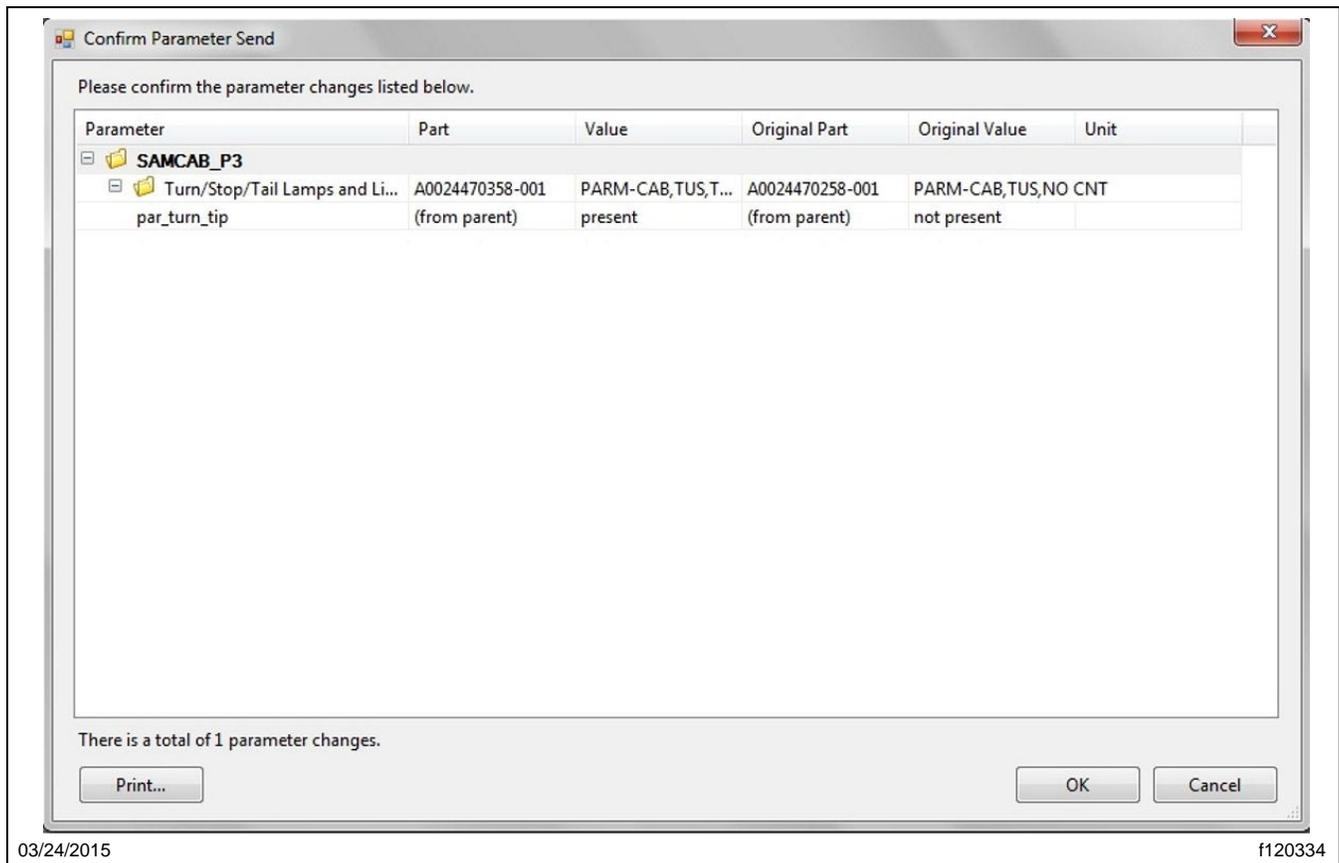
Fig. 14, Confirm Changes

6. Click **Send**.
7. Verify the parameter change. See **Fig. 14**.

8. Click **OK** to send the changes to the connected modules. The bar at the bottom of the window will show progress as the parameters are sent to the connected modules. (Click **Cancel** if you need to cancel these changes.)
9. Clean a spot on the base label (Form WAR259), write the campaign number, FL641, on a blank red completion sticker (WAR260), and attach it to the base label.
