GROUP ELE	MODEL 2014MY Soul (PS)
--------------	------------------------------

TECHNICAL SERVICE BULLETIN

SUBJECT: SERVICE ACTION: BCM UPGRADE - IPM LOGIC
IMPROVEMENT (SA164)

This bulletin provides information related to the reprogramming of the Body Control Module (BCM) on some 2014MY Soul (PS) vehicles, produced from August 26, 2013 to December 13, 2013, which may exhibit a condition related to intermittent operation of the welcome function on the headlights. To prevent and/or correct this condition, the BCM should be reprogrammed using the GDS download, as described in this bulletin. Kia is requesting the completion of this Service Action on all affected vehicles, including dealer stock, prior to delivery. For confirmation that the latest reflash has been done to a vehicle you are working on, verify ROM ID using the tables in this TSB.

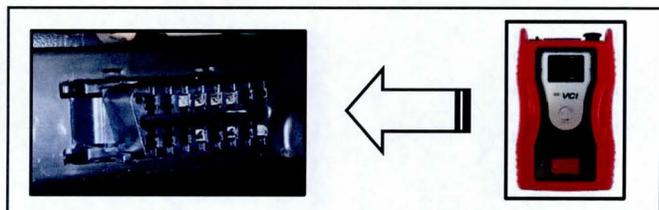
5. Connect the Main 16-pin DLC cable (GHDM – 241000) to the VCI.
6. Connect the Main 16-pin DLC cable (GHDM – 241000) to the OBD-II connector, located under the driver's side of the instrument panel.

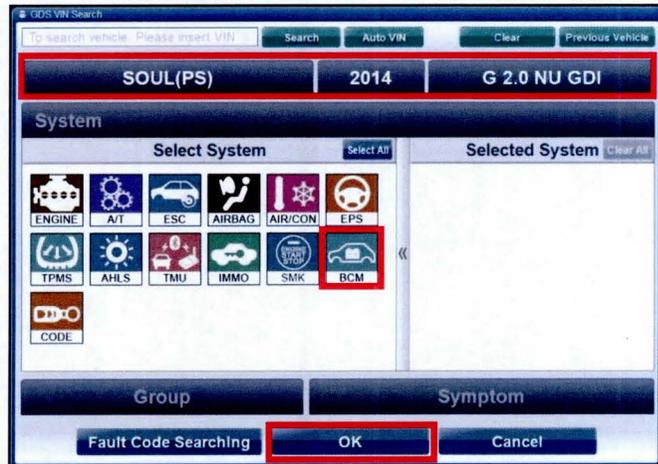
7. With the ignition key **OFF**, turn ON the VCI and GDS and manually input the VIN into the search box. Then, click the Search button.

8. Select **BCM** and click **OK**.

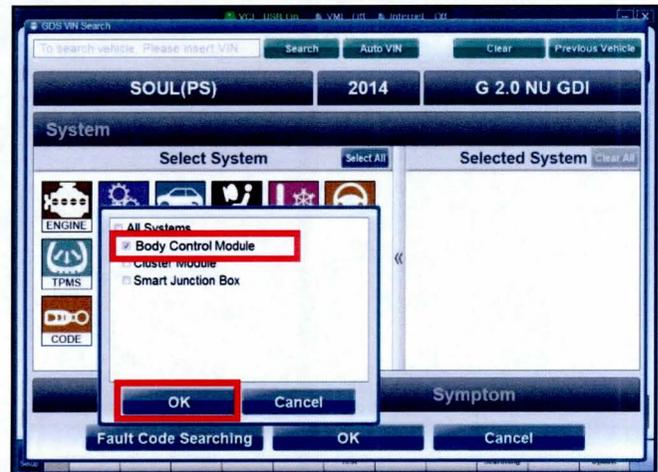
9. Select **Body Control Module** and click **OK**.

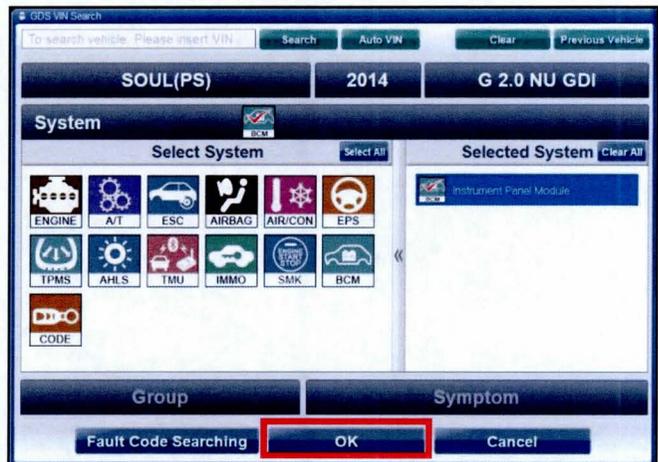
10. Click on **OK**.

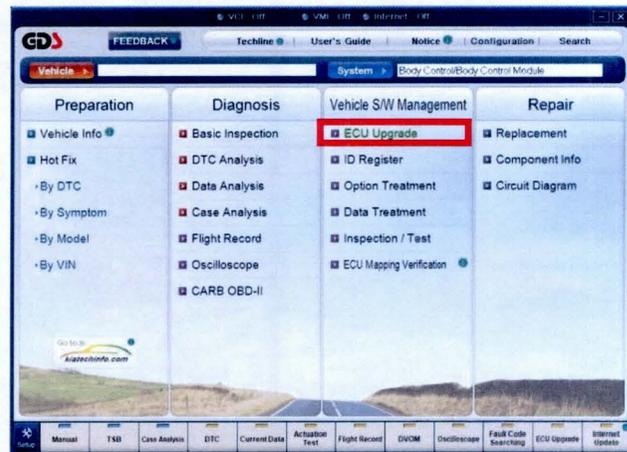
11. Select **ECU Upgrade** from the GDS main screen.

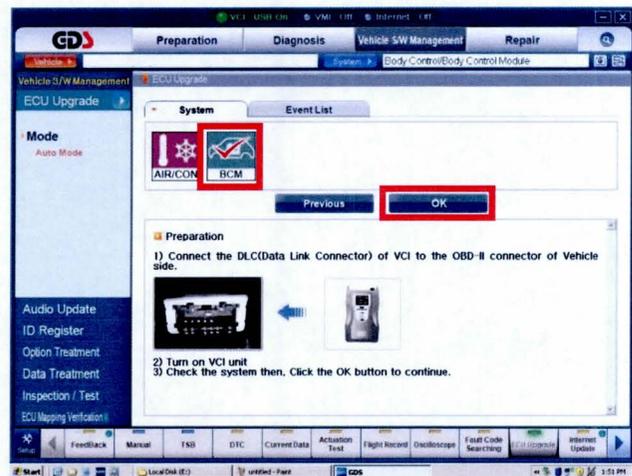
12. Select **BCM** and Click **OK**.

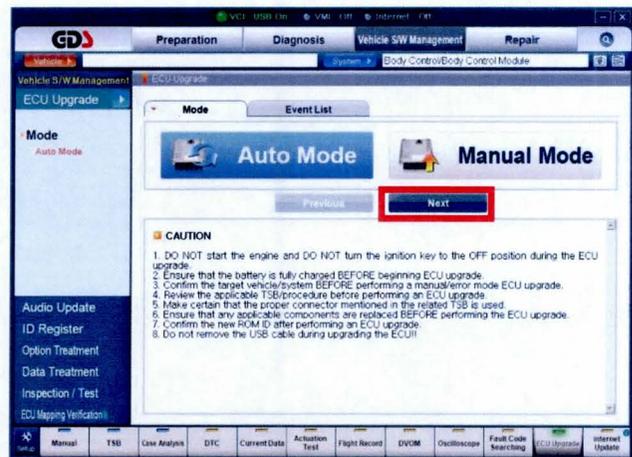
13. Select **Auto Mode** and click **OK**.

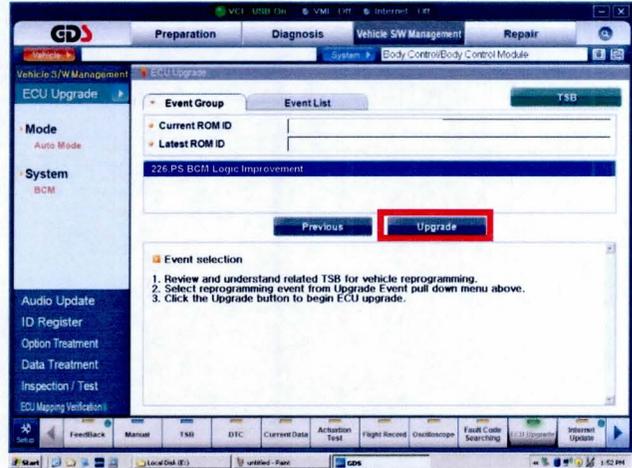
- 14. After the system reads the ROM ID, select Event: **226. PS BCM Logic Improvement** and Click **Upgrade**.

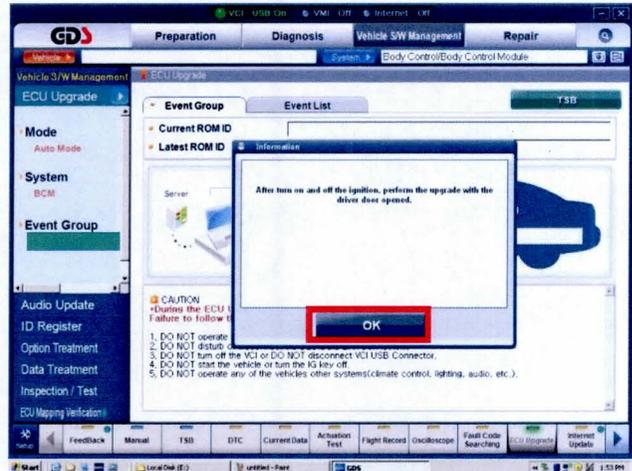
- 15. Click **OK** on the voltage check screen and cycle the ignition ON and OFF once. Then, open the driver's door and click **OK**.

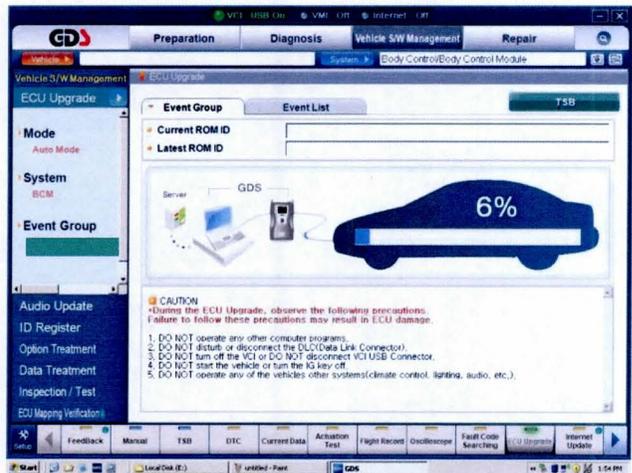
- 16. The upgrade will begin and the progress of the upgrade will appear on the bar graph.

*** NOTICE**
If the upgrade fails, disconnect the negative (-) terminal from the battery for 20 seconds and restart the procedure.

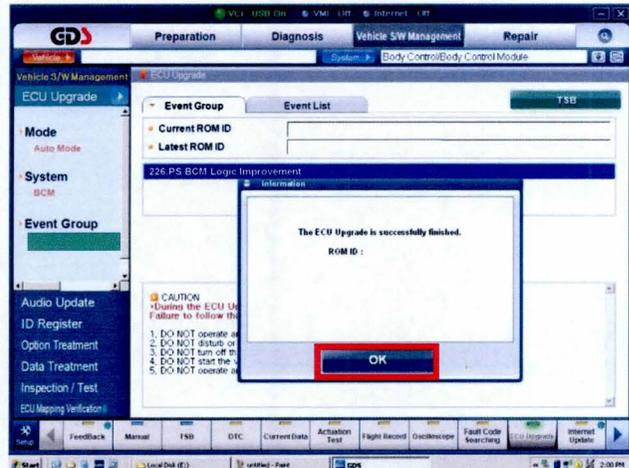
- 17. Click **OK** on the final screen. Upgrade event 226 is now complete.

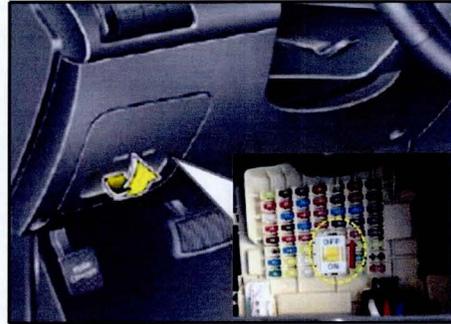
Before performing the manual update, cycle the fuse box panel power switch to the “OFF” position for 20 seconds. Then, cycle the fuse box panel power switch back to the “ON” position.
