F/CMVSS Noncompliance Recall

45340-01 BYOM1 Lockup with Loss of Key Chime

Reference Number: A162045340
GWM Number: 2045340
Revision Description: This bulletin has been updated to include additional information in the Service Procedure section, including a possible SPS error code and a frequently asked questions table. Please discard all copies of bulletin 45340.

Release Date: June 2016
Revision: 01

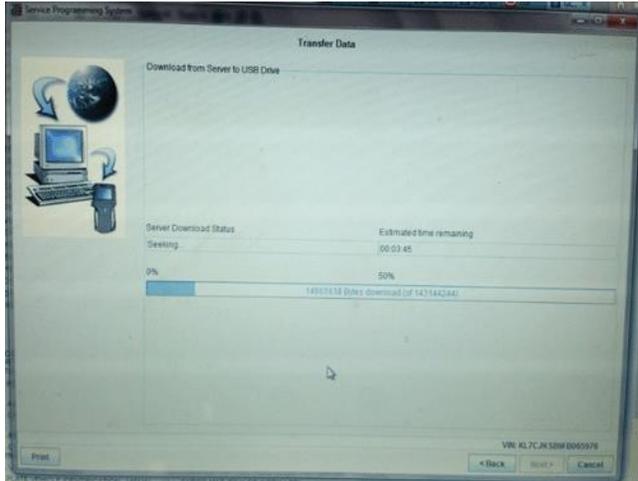
4516356

5. Upon completion of the file transfer, remove the USB drive from the computer.
6. Ignition ON, radio ON.
7. Connect the USB drive to the USB port in the vehicle.

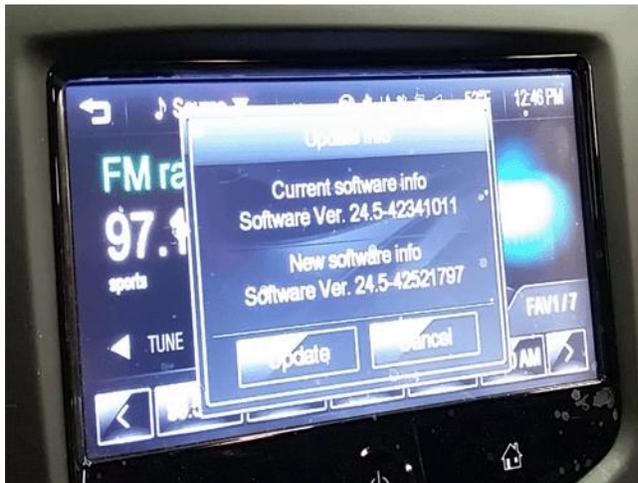
4516357

Note: If "Update" is not selected within 30-60 seconds, the selection screen disappears and the USB drive will need to be removed and reinserted to initiate the USB software update again.

8. Follow the infotainment display on screen instructions and select "Update" when prompted. (Trax shown as example- Sonic and Spark will be similar).

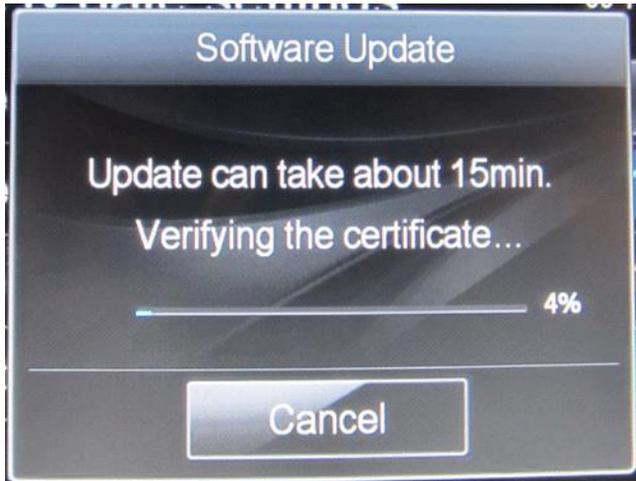
4516358

9. Programming will take several minutes.

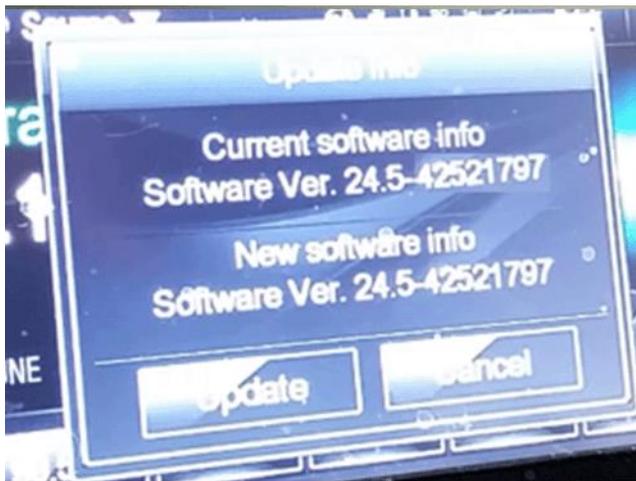
4516359

Note: When USB programming has completed, the radio will go to the Home/Menu screen, and the calibration ID screen will show, confirming the current and new software is now the same. Audio should be playing before removing the USB drive. Select “Cancel” and continue to step 10. (Trax shown as example-Sonic and Spark will be similar).

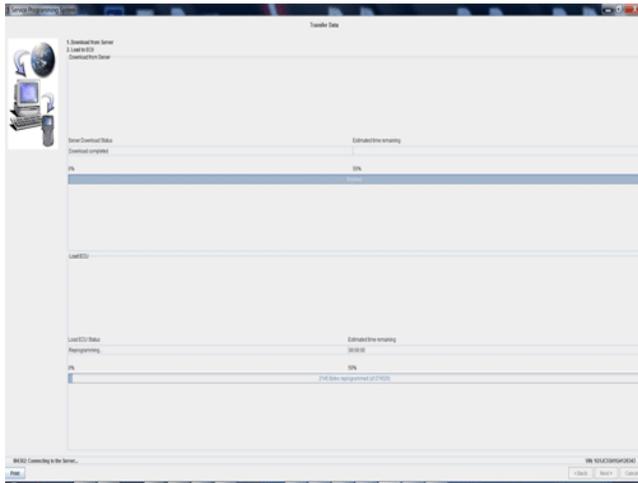
4516360

Note: During SPS programming, the radio display may be blank. For progress, refer to the SPS screen.

Note: After the radio has completed SPS programming, the radio will restart. DO NOT cycle the key or turn off the radio until audio is heard.

10. When USB programming is complete, remove the USB device from the vehicle USB port and access the Service Programming System (SPS) and follow the on-screen instructions.
11. When USB programming has been completed, on the SPS Supported Controllers screen, select A11 Radio – Programming, and follow the on-screen instructions.
