After-sales Retailer Support Hybrid Powertrain Module Reprogram Voluntary Safety Recall Campaign

Reference: R1623
Date: July 12, 2016

R1623 – 2012 - 2013 M35 Hybrid Control Module Reprogram

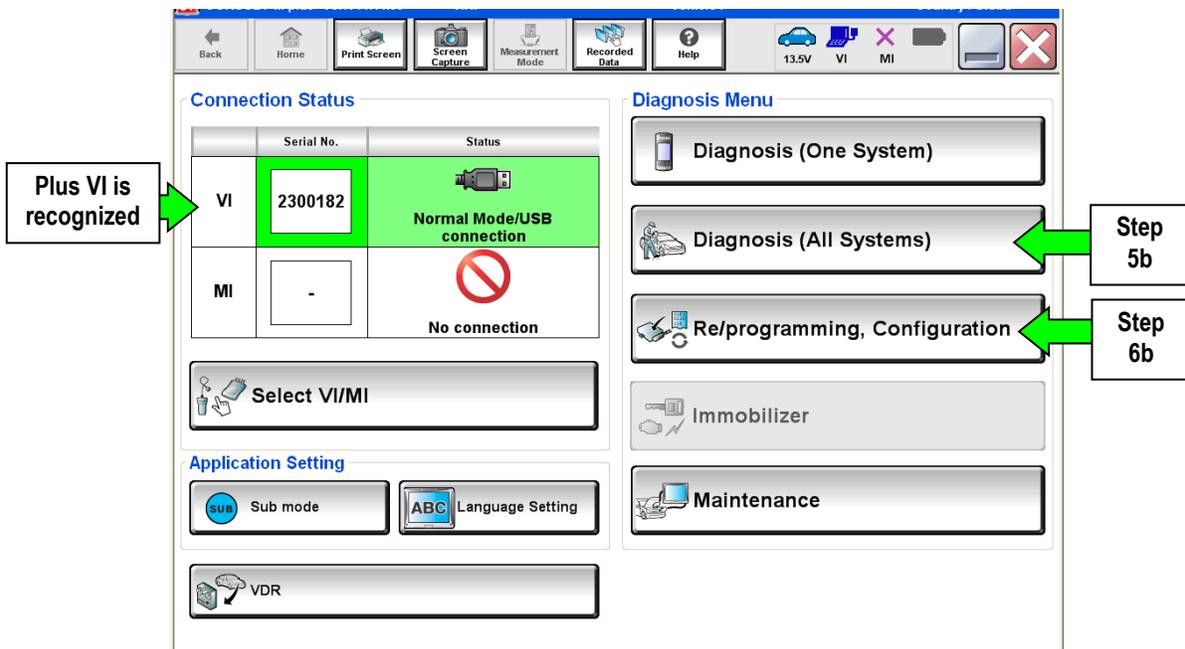
Figure 1

6. Go to **Re/programming, Configuration**.
 - a. Select the **Home** button, and then **YES** to return to the screen shown in Figure 1.
 - b. Select **Re/programming, Configuration**.

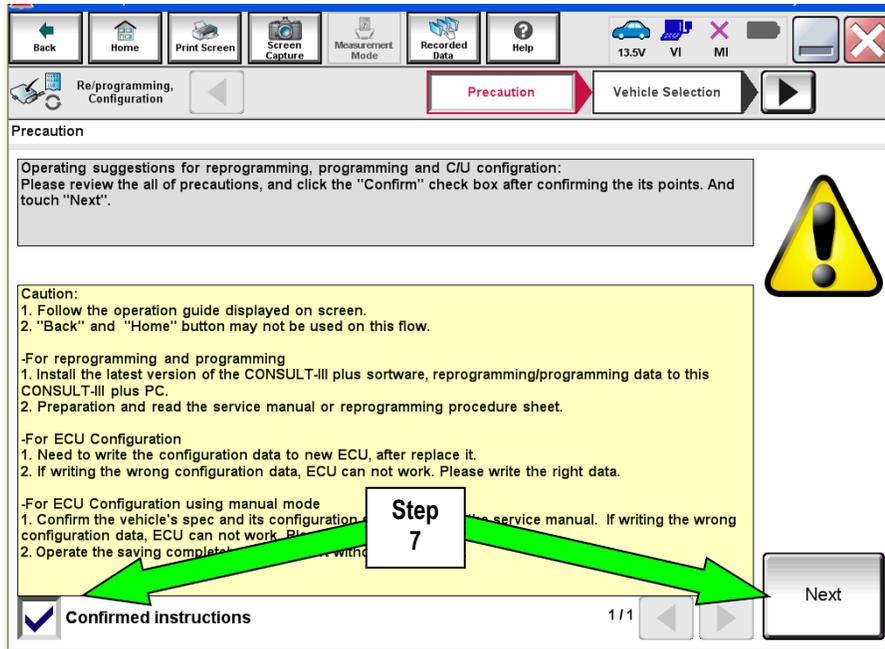
Figure 2

7. Check the box for **Confirmed Instructions**, and then select **Next**.

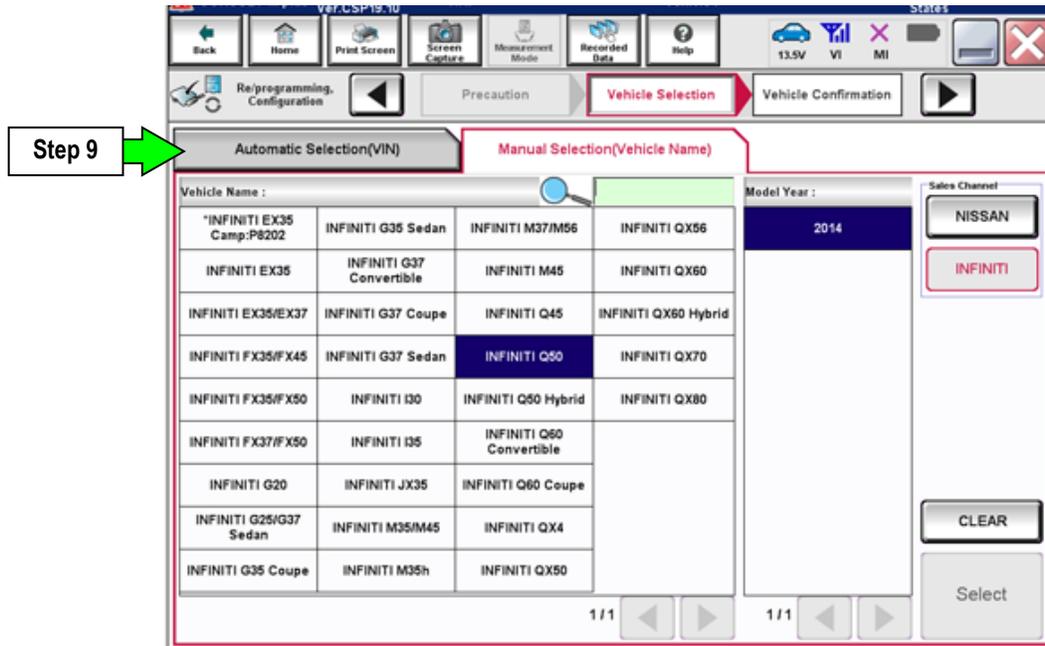
8. If the screen in Figure 3 does not display, skip to step 10.

9. If the screen in Figure 3 displays, select **Automatic Selection(VIN)**.

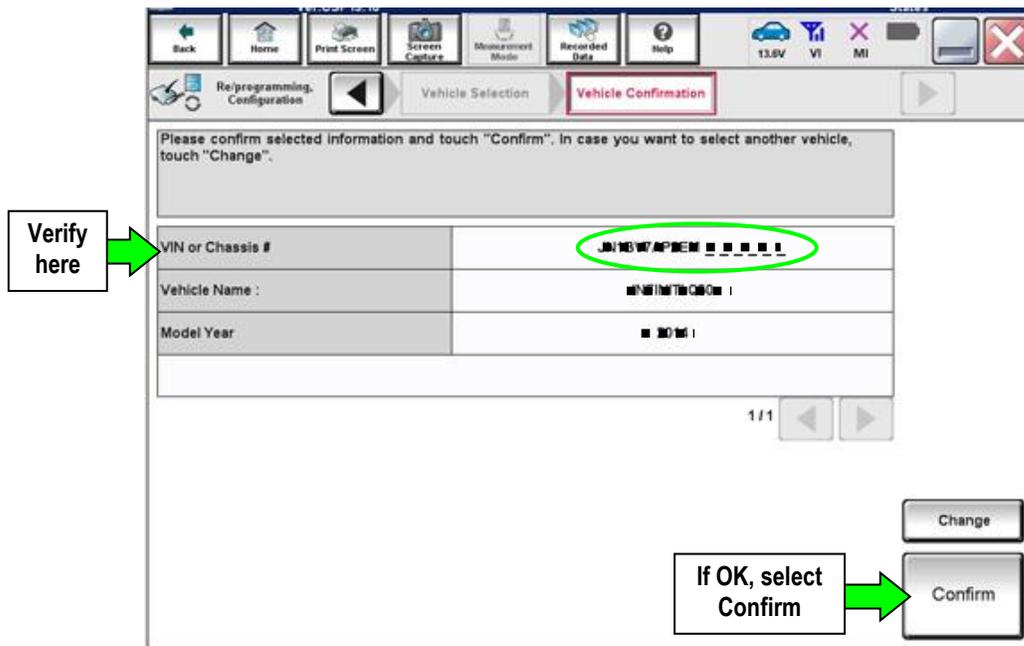
Figure 4

10. Verify the **VIN or Chassis #** matches that of the vehicle.

- If the correct VIN is displayed, select **Confirm**.

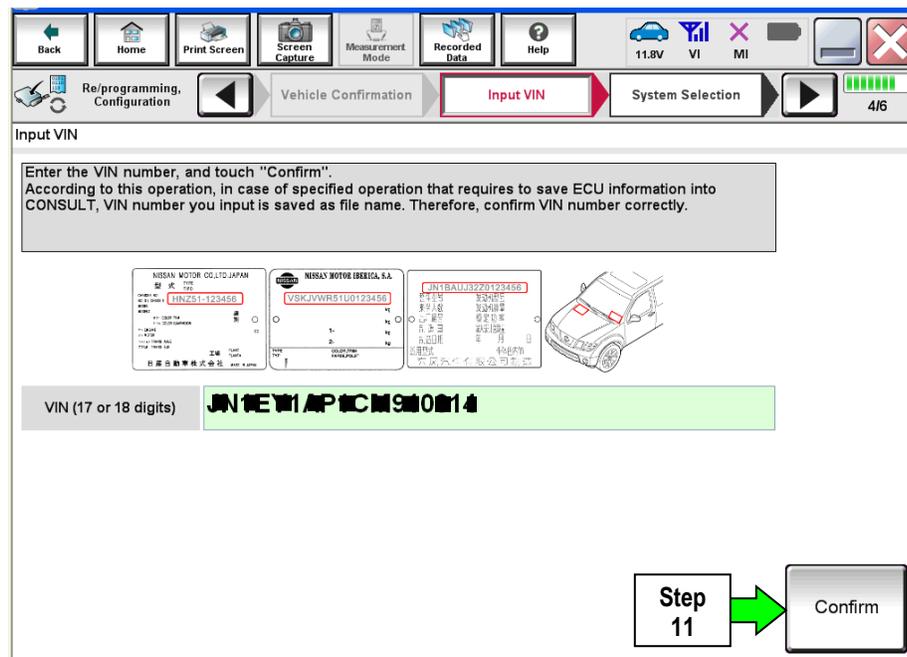
Figure 5

11. Select **Confirm** again.

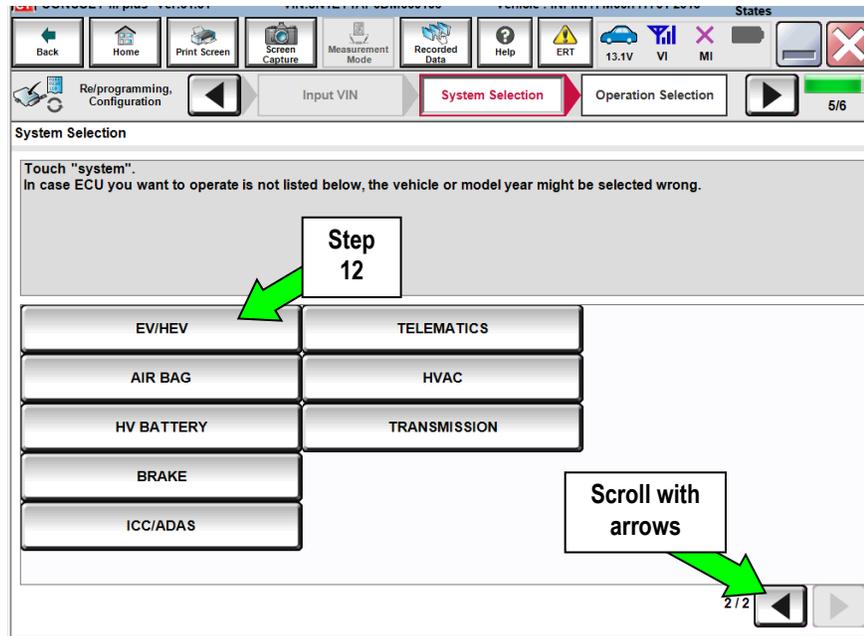
Figure 6

12. Use the page arrows to scroll and **select the correct control module** to be reprogrammed.

NOTE: EV/HEV and TRANSMISSION are shown in Figure 6; MOTOR CONTROLLER is not shown.

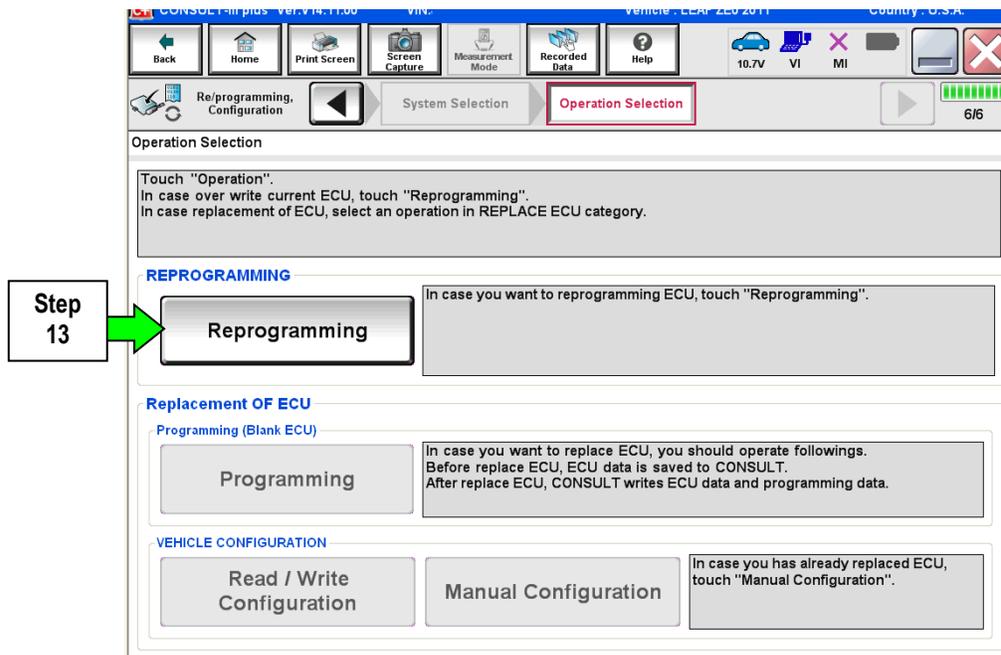
Figure 7

13. Wait for System Call to complete, and then select **Reprogramming**.

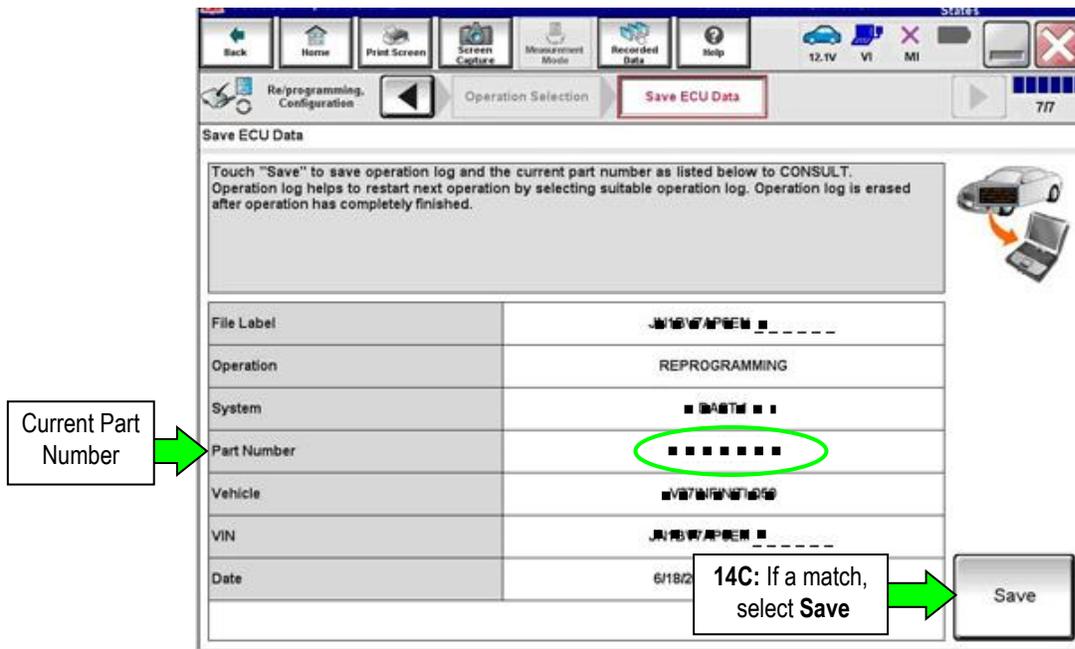
Figure 8

14. When you get to the screen shown in Figure 8, confirm reprogramming applies as follows:

A. Find the current **Part Number** and write it on the repair order.

16. Verify the **Current Part Number** matches the P/N written down in step 14, and then select **Next**.

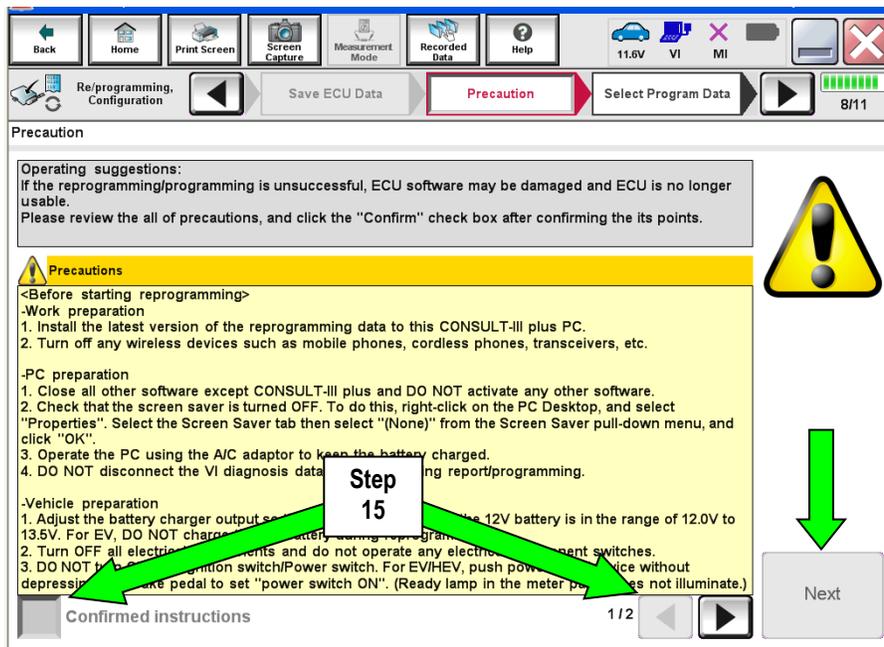
Figure 9

- Read the precautions on the C-III plus screen (use page arrow as needed). After reading, select **Confirmed instructions**, and then select **Next**.

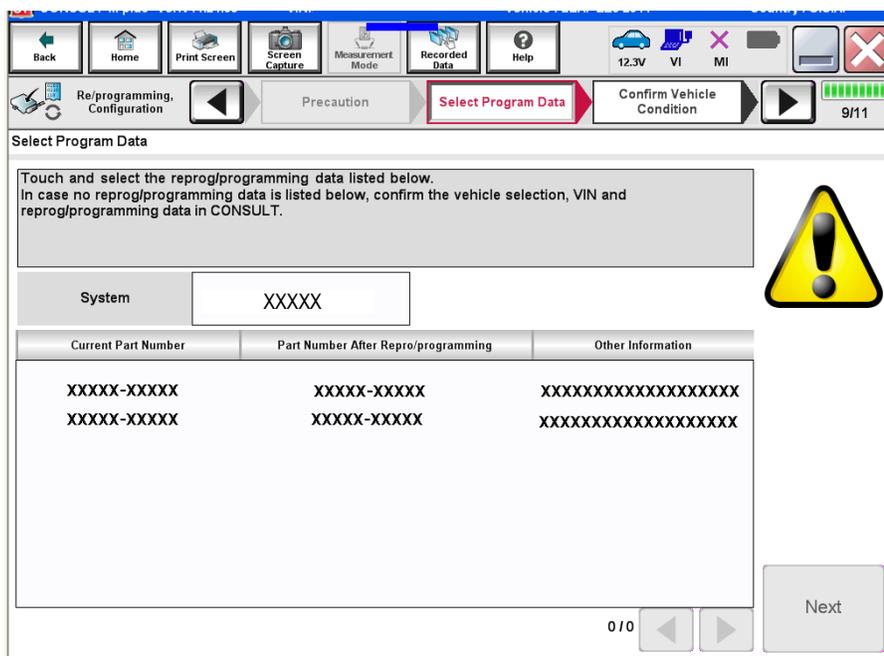
NOTE: In some cases, more than one new P/N for reprogramming is available.

- If more than one new P/N is available, the screen in Figure 10 will display.
- Select and use the reprogramming option that **does not** have the message “Caution! Use ONLY with ITBXX-XXX”.
- If you get this screen and it is blank (no reprogramming listed), it means there is no reprogramming available for that control unit.

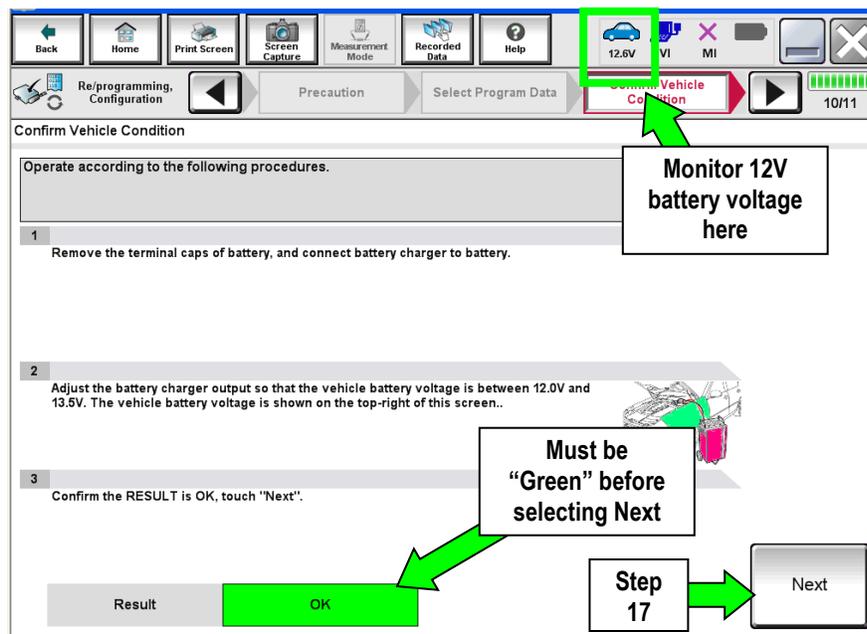
Figure 12

17. Confirm battery voltage is correct, and then select **Next**.

NOTE: Battery voltage must stay within the specified range to make the indicator turn green.

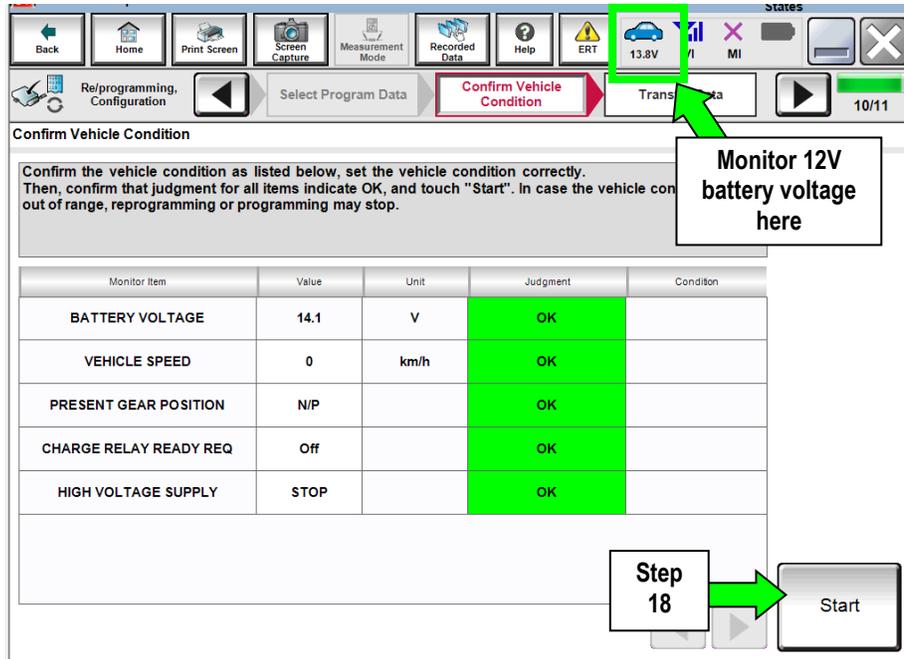
Figure 13

18. Confirm all items on the C-III plus screen are OK (green), then select **Start**.

- The reprogramming process begins when **Start** is selected.

NOTE: For reprogramming to continue, vehicle 12V battery voltage must stay within 12 volts and 15.5 volts.

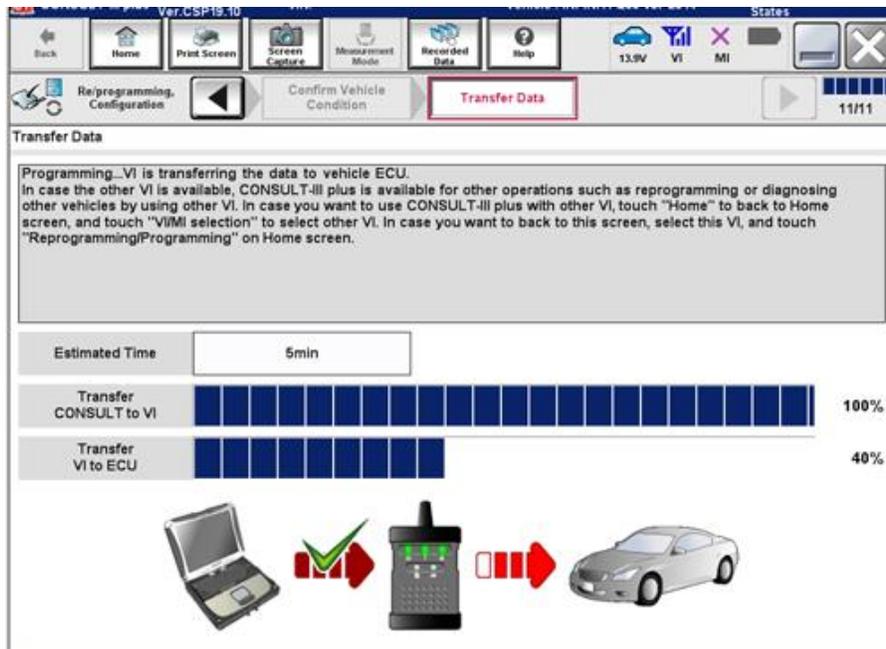
Figure 14

19. Wait for both bar graphs to complete.

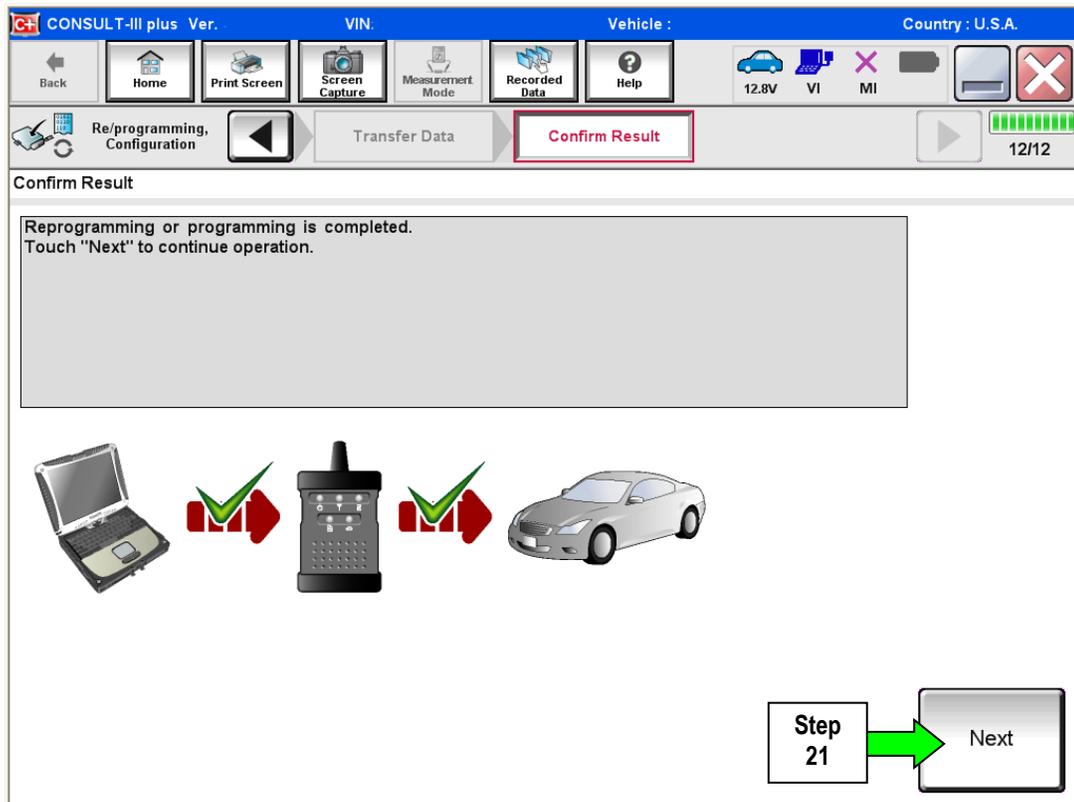
20. When the screen in Figure 15 displays, reprogramming is complete.

NOTE: If the screen in Figure 15 does not display (indicating that reprogramming did not complete), refer to the information on page 13.

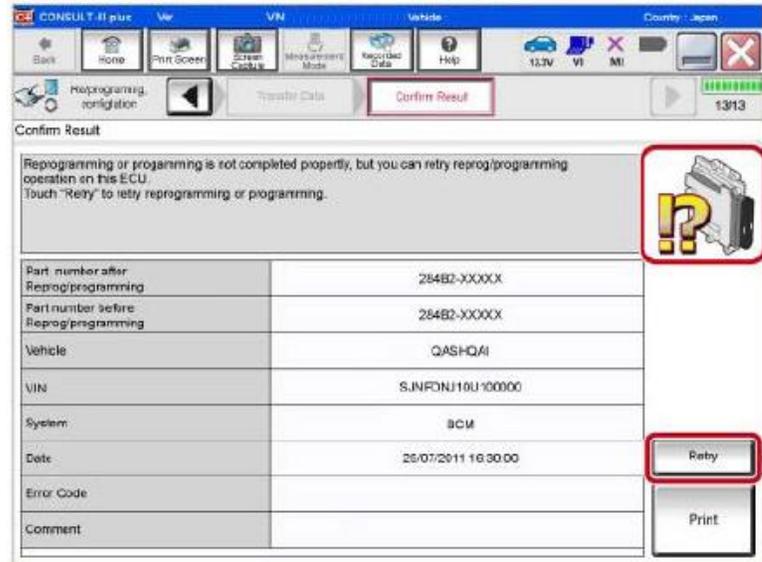
Figure 16

If reprogramming does **not** complete and the “!?” icon displays as shown in Figure 16:

- Check battery voltage (12.0–15.5 V).
- Ignition is ON, not ready.
- External Bluetooth® devices are OFF.
- All electrical loads are OFF.
- **Select retry and follow the on screen instructions.**
- “Retry” may not go through on first attempt and can be selected more than once.

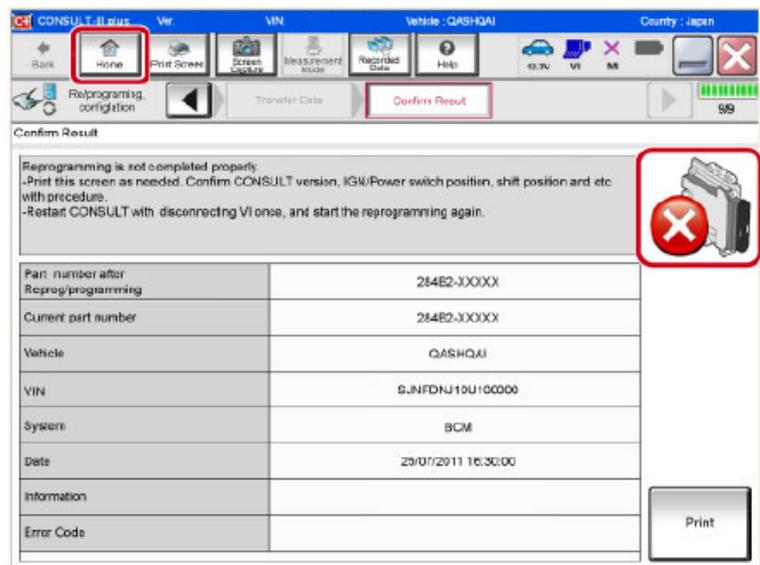
Figure 17

If reprogramming does **not** complete and the “X” icon displays as shown in Figure 17:

- Check battery voltage (12.0 – 15.5 V).
- CONSULT A/C adapter is plugged in.
- Ignition is ON, not ready.
- Transmission is in Park.
- All C-III plus / VI cables are securely connected.
- All C-III plus updates are installed.
- **Select Home, and restart the reprogram procedure from the beginning.**

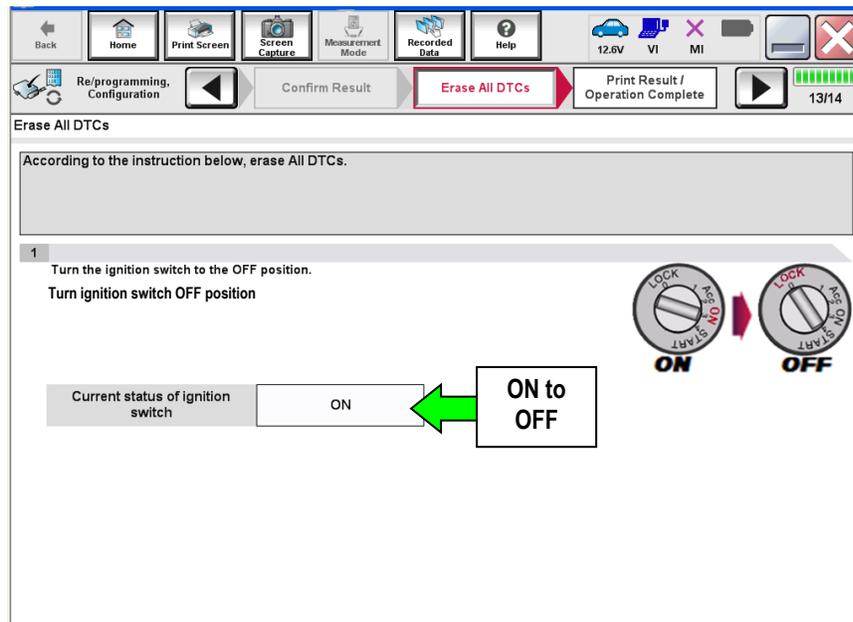
- a. Turn "ignition" OFF.
 - The screen in Figure 18 will read OFF after pressing the power switch once.

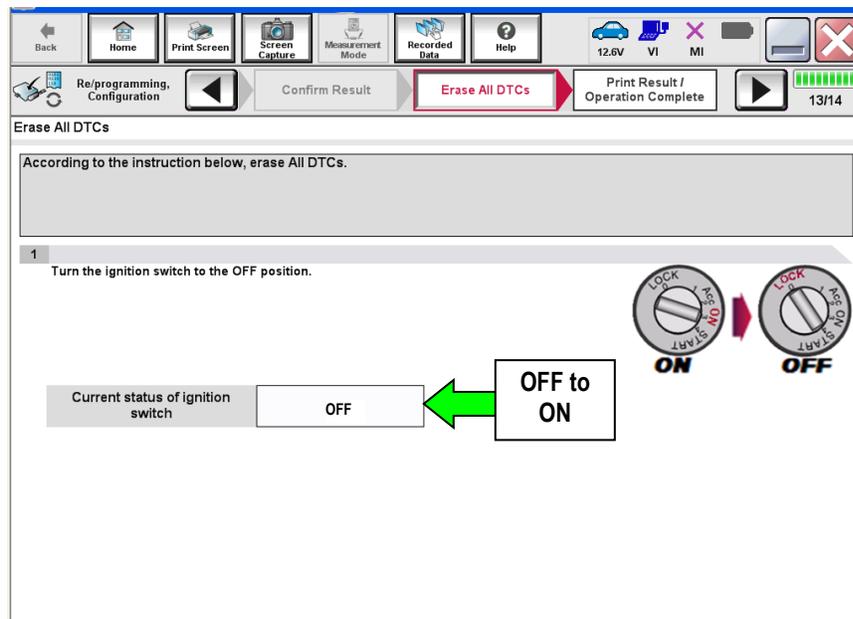
- b. Turn the ignition ON, not Ready (press switch twice, no foot on brake).
 - The screen in Figure 19 will read **ON** after pressing the power switch twice.

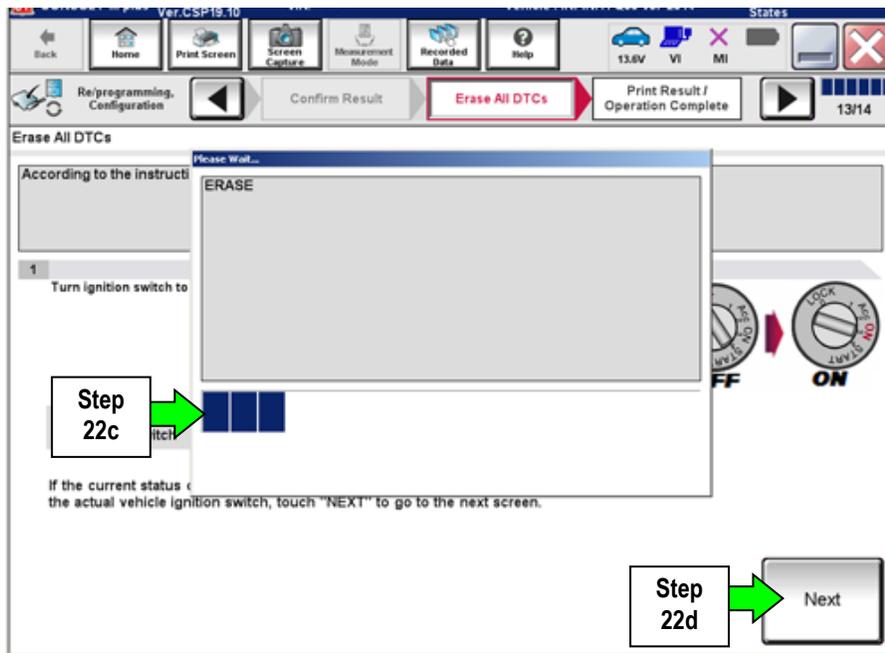
Figure 20

- c. Wait for the bar graph in the **ERASE** window to complete 100%.
- d. Select **Next**.

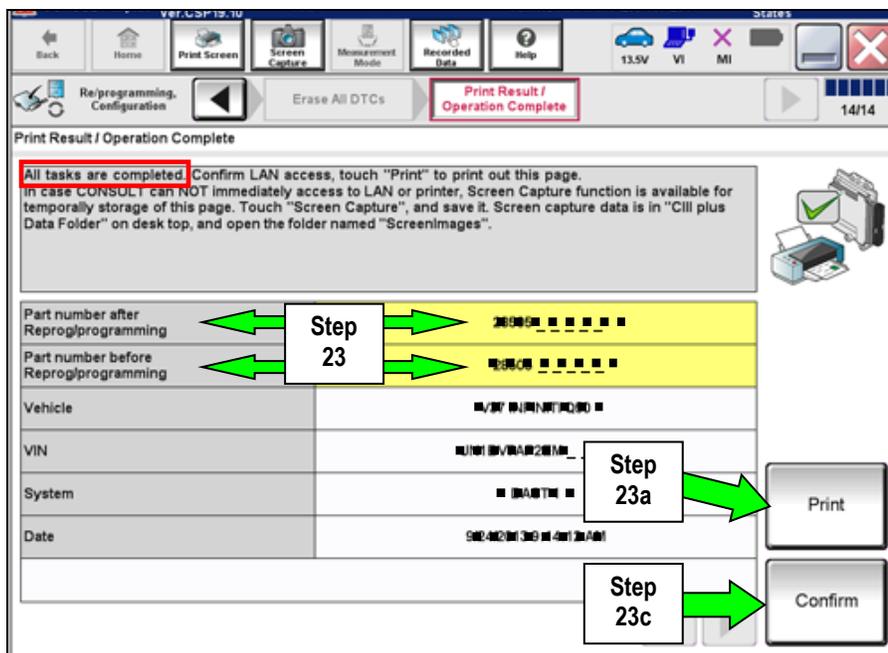
- 23. Verify the P/N has changed (before and after reprogramming P/Ns should be different).
 - a. Print a copy of the screen in Figure 21 by selecting **Print**.
 - b. Attach the copy to the repair order.
 - c. Once a copy has been printed, select **Confirm**.

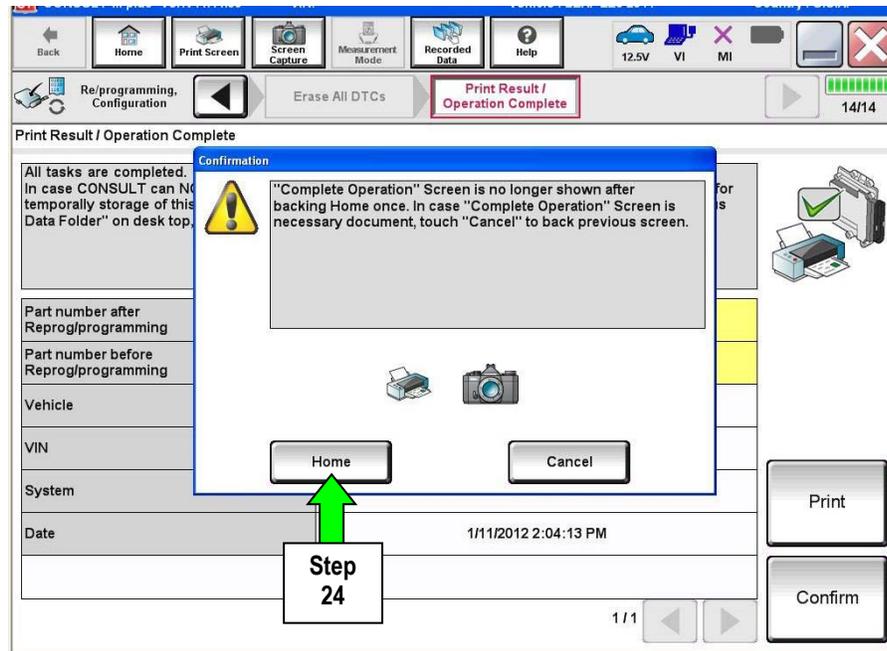
Figure 22

24. After confirmation has completed, select Home
