August 2012

From: **Chris Deakins, Service, Warranty & Parts Coordinator**

RE: **Notice of Recall 2009-02 (NHTSA 09V-437) Sprinter brake line clearance recall**

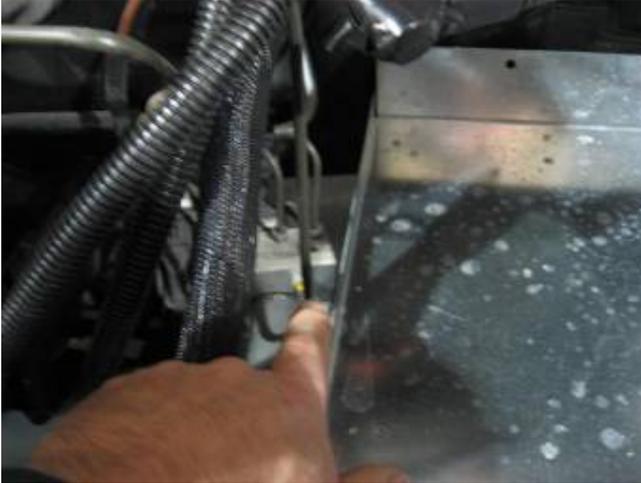
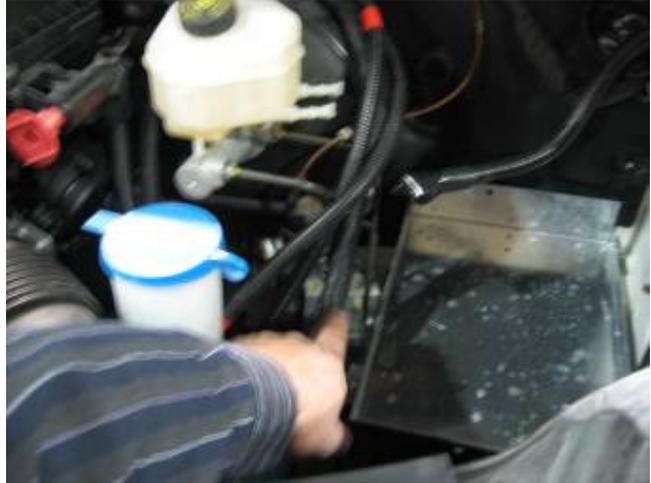
The recall pertains to the installation of the auxiliary/coach batteries on the vehicle chassis. The brake line comes in close proximity to the battery/battery tray. Due to some variation in brake line length coming from the chassis manufacturer and some inconsistency in the battery assembly process in some units there is zero clearance between the battery/battery tray and the brake line. This situation can cause friction/rubbing between the battery/battery tray and the brake line which can damage the coating on the line and expose the bare steel. Adding to the circumstances is if and when a battery is overfilled there is a risk of acid spillage out of the top of the battery while the vehicle is in motion. The acid can then get between the battery and the brake line and in time it may soften the brake line coating. Under the acid attack the brake line can corrode and create pin holes in the material. Once the pin hole is created the system will leak and it will affect the ability to brake on all 4 wheels. This failure of the brake line could result in a crash which could lead to personal injury and possible death.

First two pictures show the clearance with the battery removed.

Corrective action requires all vehicles to be inspected for brake line location and corrosion in the problem area and the line replaced if required. If the brake line is OK the dealer must ensure that there is adequate clearance (min 3/8") between the line and the battery/battery tray. After replacement or adjusting the brake line clearance all of the wire harnesses, vacuum lines, etc. that had to be moved to access the brake line need to be returned to their original position. All of the electrical wires must be bundled together properly. Electrical wiring and the vacuum line must not be touching the battery post or any other part of the battery that can get hot during the charging process. If all work is required it will take about two hours to complete. However, additional time may be required depending on how dealer appointments are scheduled and processed. To obtain this free service contact your Chrysler/Dodge/Freightliner Sprinter or Roadtrek dealer service department at your earliest convenience. Upon contact with this Dealer have them contact Roadtrek at 1-888-762-3873 for further information. If you no longer own this vehicle, please inform the dealer or Roadtrek of this when you call. For more information contact our Service and Warranty department toll free at 1-888-ROADTREK (762-3873).

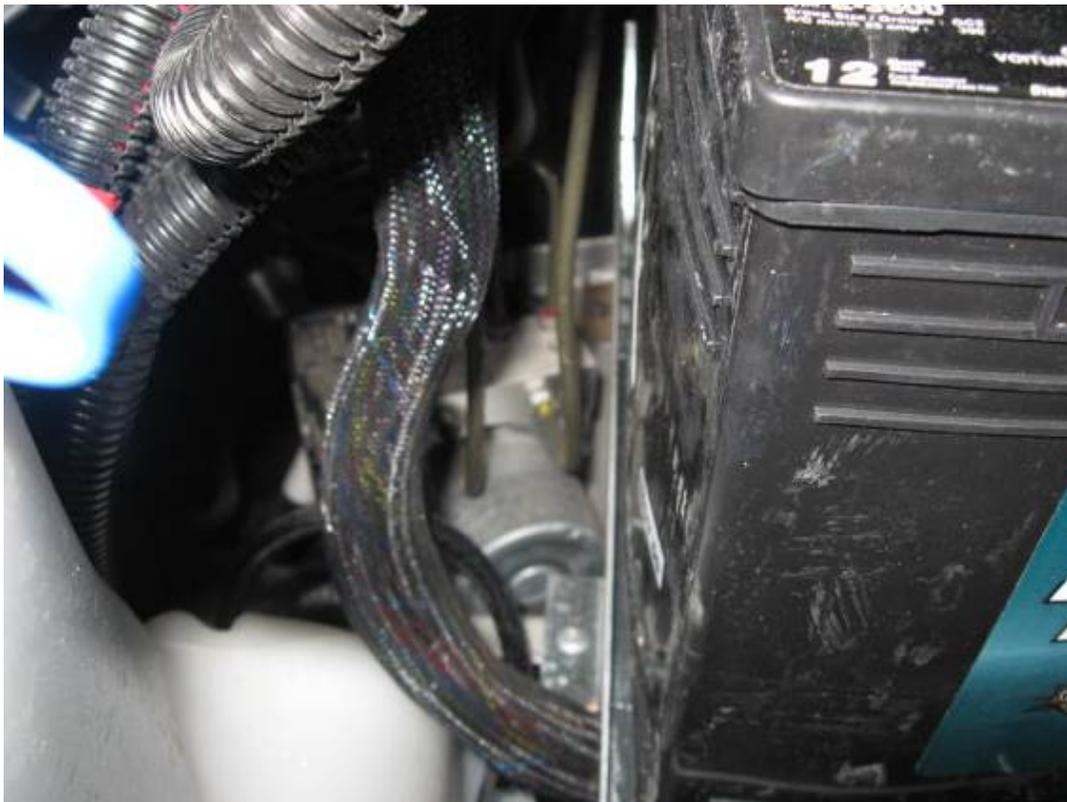
This is the clearance with the batteries in place.
