PRODUCT RECALL

TECHNICAL BULLETIN

9100 POWER AWNING, WEATHERPRO AWNING AND MOTOR SERVICE KITS

April 17, 2013

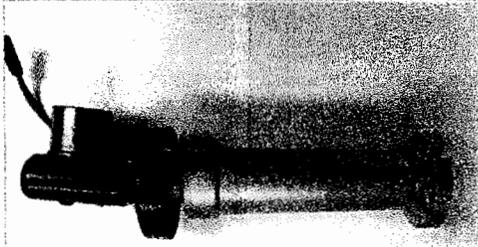
Awning Motor
Pre February 13,2013. This motor
is not affected by the product
recall.

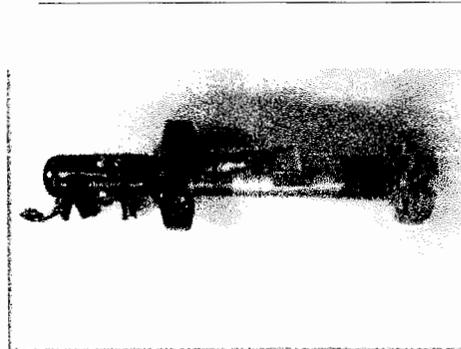
Awning Motor-
This motor is affected by the
product recall.
Serial Range 306xxxx to 314xxxx
Manufacturing Date Range
02/13/2013 to 04/09/2013
