Re: FUEL PUMP SAFETY RECALL: NHTSA CAMPAIGN NUMBER: 13E-043

THIS NOTICE IS SENT TO YOU IN ACCORDANCE WITH THE REQUIREMENTS OF THE NATIONAL TRAFFIC AND MOTOR VEHICLE SAFETY ACT. Airtex Products, LP has determined that a defect which relates to motor vehicle safety exists in certain **E3591M** Electrical Fuel Pumps (“Fuel Pumps”). You are receiving this notice because records show that you may have recently installed Fuel Pumps that are subject to this Recall.

THE AFFECTED POPULATION ARE REPLACEMENT FUEL PUMPS FITTING THE CHEVROLET MALIBU (2004-2008), THE PONTIAC G6 (2005-2008) AND THE SATURN AURA (2007-2008) AND WHICH WERE INSTALLED BETWEEN JUNE 10, 2013 AND AUGUST 16, 2013.

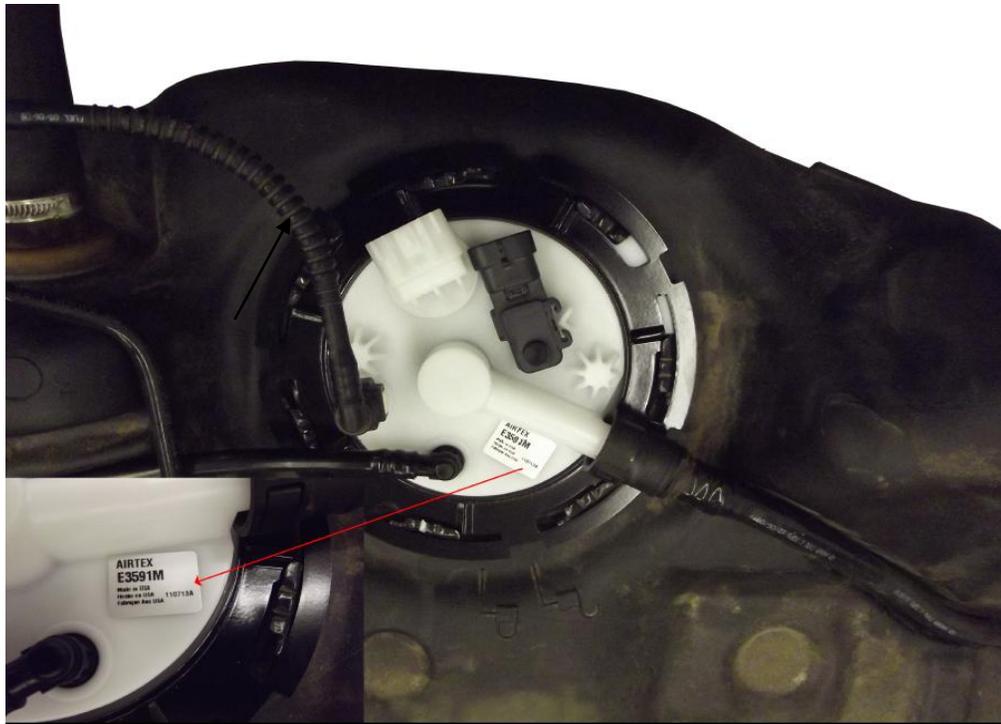
Figure 1.

Only Fuel Pumps with certain date codes are affected by this Recall. Affected Fuel Pumps are marked with certain date codes on top of the pump. *See Figure 1 on the Product.* In order to inspect the date code, it is necessary to lower the fuel tank. *See Figure 2 for example of where the Fuel Pump may be located on a lowered fuel tank.* However, once the tank is lowered, it is not necessary to remove the pump from the fuel tank in order to inspect the date code. If an inspected Fuel Pump has a matching date code, it must be replaced. If an inspected Fuel Pump does not have a matching date code, it is conforming and does not need to be replaced.

100613A	110713A	240613A	250613A
100613B	110713B	240613B	250613B
