RECALL CAMPAIGN BULLETIN

NTB13-087

VOLUNTARY SAFETY RECALL CAMPAIGN 2013 ARMADA AND TITAN BRAKE MASTER CYLINDER

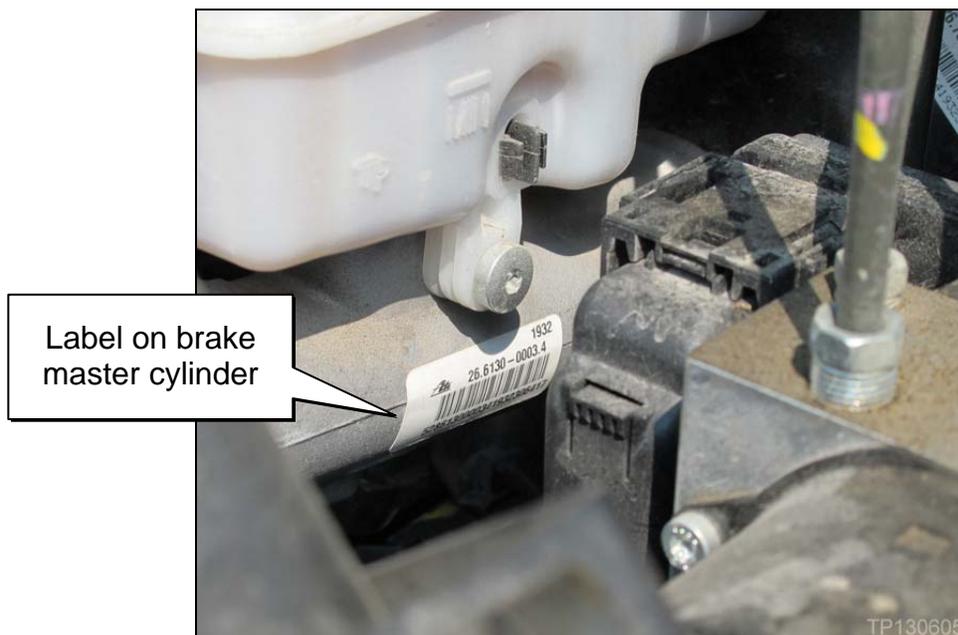
Figure 1

1. Locate the label on the brake master cylinder.

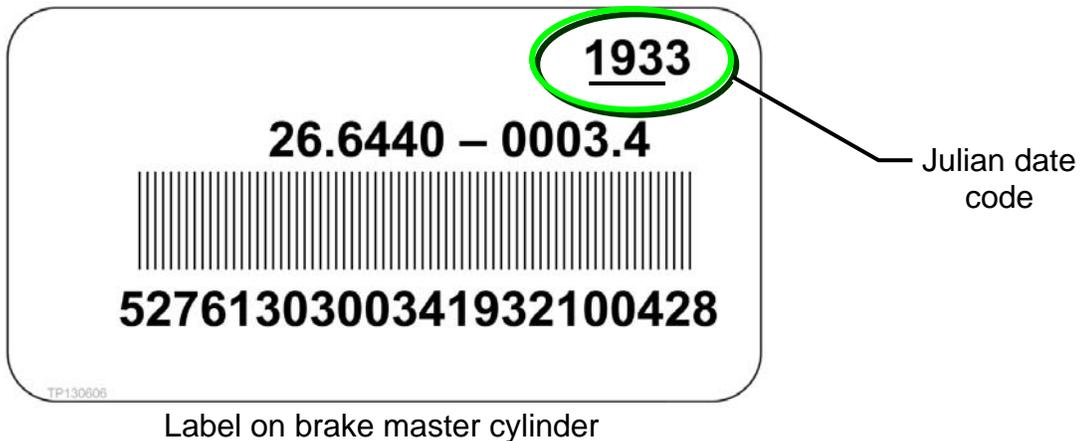
2. Check the Julian date code on the label.

- The Julian date code is a four-digit code in the upper right corner of the label.

If the **first three digits** of the Julian date code are **049** or lower – **OK**

If the **first three digits** of the Julian date code are **107** or higher – **OK**

If the **first three digits** of the Julian date code are **050** through **106** – **NG**

- Replace the brake master cylinder.
- Refer to **BR > REMOVAL AND INSTALLATION > Brake Master Cylinder** in the applicable Electronic Service Manual for replacement instructions.
