TOYOTA

Subject: Safety Recall **DSF (Supplement to D0F) – Remedy Notice (Phase 1)**
2003-2004 Model Year Corolla, Corolla Matrix, and Tundra Vehicles
2002-Early 2004 Model Year Sequoia Vehicles
Front Passenger Airbag Inflator Module

Safety Recall DSF (D3F) (Supplement to D0F)

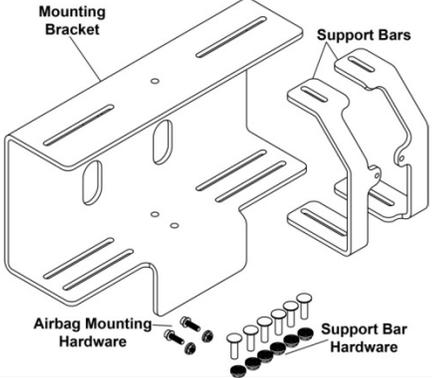
Name	Sample Image	Qty
Airbag Mounting Bracket & hardware

These tools are needed when performing the front passenger airbag inflator module campaign. These tools **ARE NOT** available through normal parts or tools channels. There is a very limited supply of tools, but if additional tools are needed, contact your regional representative.
