Enclosed with this letter is an Information Report addressing frame cracking and/or breakage behind and below the steering neck, which has been reported in certain 2005-2006 model year Suzuki GSX-R1000 model motorcycles.

INFORMATION REPORT

Service Bulletin

VOLUNTARY SAFETY RECALL CAMPAIGN #2A08
2005 AND 2006 GSX-R1000 MOTORCYCLES
FRAME REINFORCEMENT BRACE INSTALLATION/FRAME REPLACEMENT

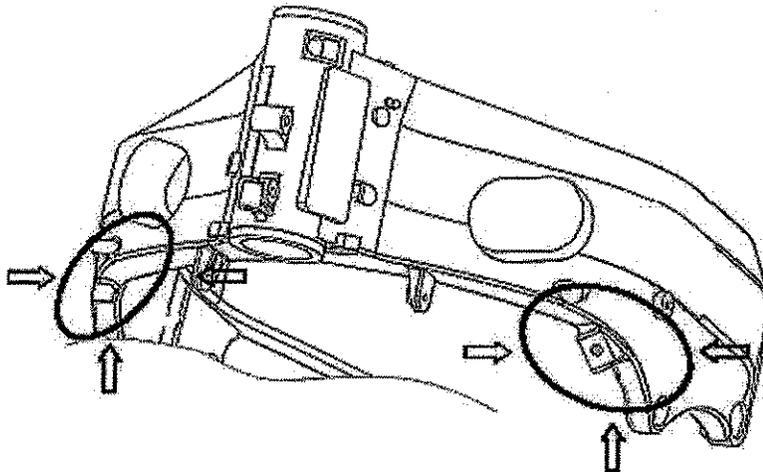
If your motorcycle is included in the safety recall and you have paid for the repair or replacement of the frame due to cracking or breakage of the frame in the relevant area shown below, you may be eligible for full or partial reimbursement. Suzuki's reimbursement plan covers the following affected motorcycles: all 2005 and 2006 model year Suzuki GSX-R1000 motorcycles. Please note the following for which Suzuki may exclude reimbursement:

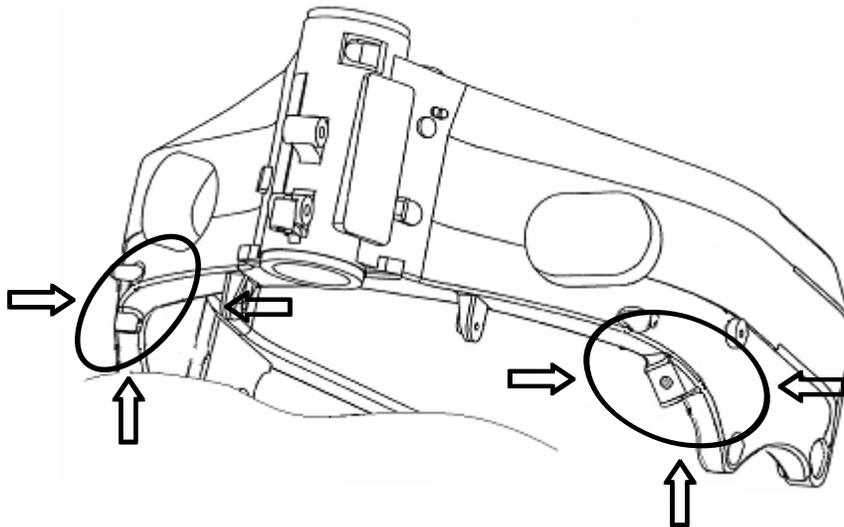
Dealers will inspect the relevant area of the frame for cracks. The illustration below shows the area to be examined for cracks. If no cracks are found, a frame reinforcement brace will be attached to the frame using bolts and epoxy adhesive. The brace is aluminum and very lightweight (less than 2 pounds). It is very slender and fits underneath the top spar of the frame behind and below the steering neck. The appearance, performance and handling of the motorcycle remain unchanged with the reinforcement brace installed.

Should cracks be found during the inspection, the frame will be replaced with a new frame that has the reinforcement brace installed (see exclusions on page 3).

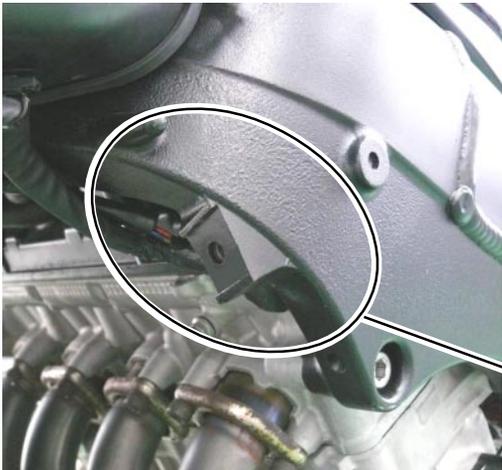
Left side

1. Inspecting the frame for damage:
 - a) Inspect the frame for cracks on the left and right sides of the frame as indicated in the photos and graphic below using the Dye Penetrant test kit which will be sent to your dealership by Jan.23th. This inspection has to be done not only on the outside but also on the inside of the frame spars.
 - b) If no cracks are detected, thoroughly clean the frame area using a clean cloth (not a shop rag) and the kit cleaner to remove the dye penetrant used for the inspection.

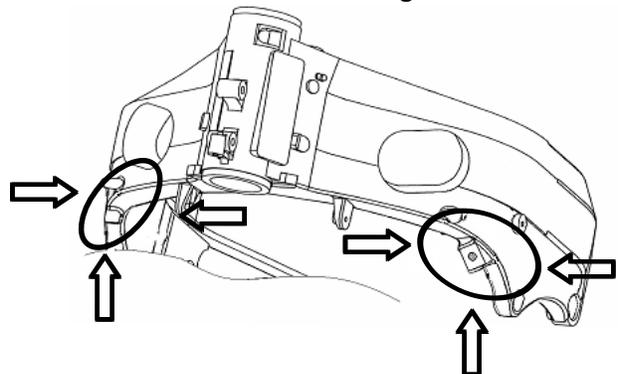
Inspection areas

Inspect the outside, the under-side and the inside of each frame spar as indicated.

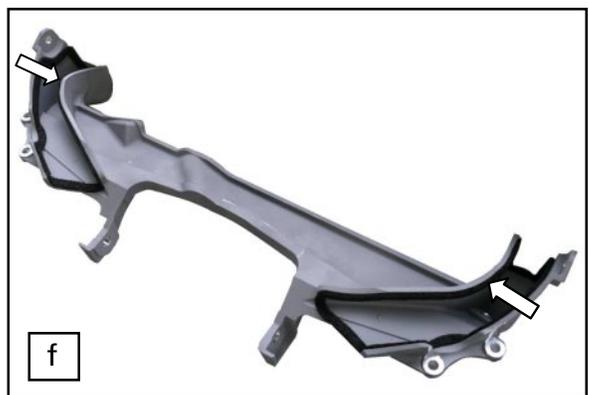
e) Degrease the surface area of the Frame Reinforcement with Suzuki Motorcycle Wash 99950-05034 where the Reinforcement Shield (weather strip) will be applied.

f) Adhere the Reinforcement Shield to the Frame Reinforcement. Start at the points indicated by the arrows. Apply the Reinforcement Shield 0~2mm down into the well.

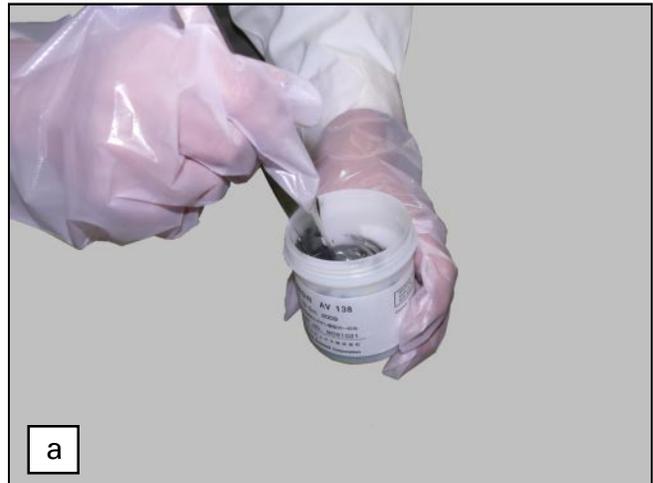
a) Pour all of the hardener (the small cup) into the epoxy resin (the large cup) and thoroughly stir with the aluminum stir stick that is supplied in the kit until the color of the epoxy becomes even throughout. (This will take approximately one minute).

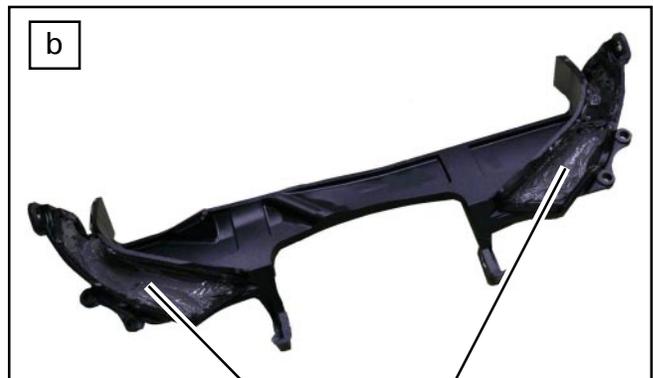
b) Evenly distribute the epoxy resin mix into the well areas (both sides) of the frame reinforcement. Use the plastic knife supplied in the kit to assist in evenly distributing the epoxy resin mix.

Keep the epoxy resin mix out of the horn bolt hole area.

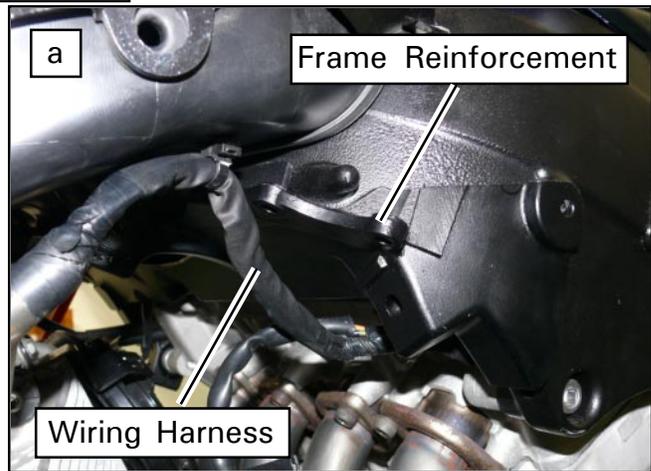
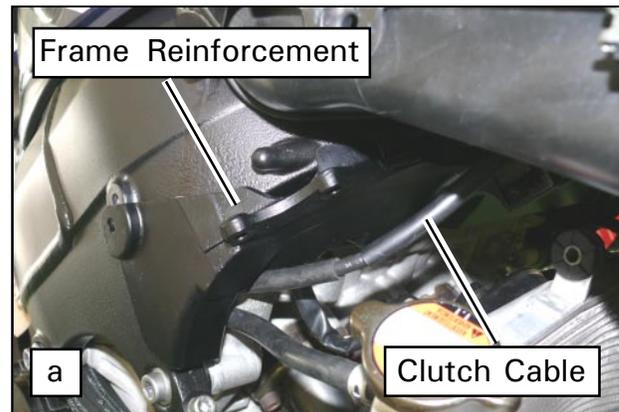
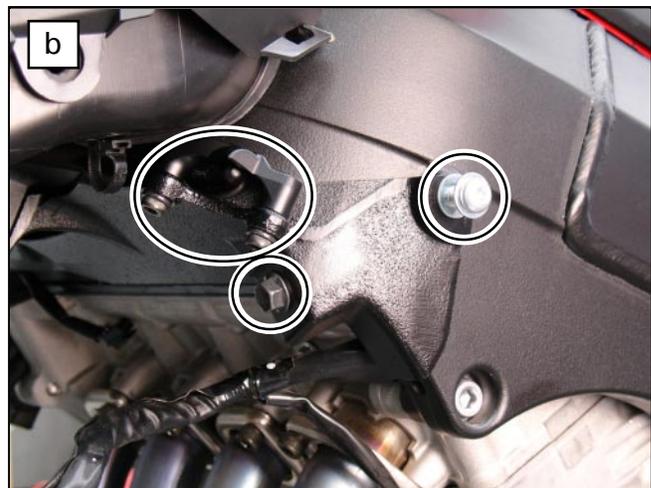
- c) Wipe off any epoxy that may have pushed past the reinforcement shield (weather stripping) with a clean cloth.

1) Reinforcement Brace Bolts	11 N.m (1.1 kgf-m, 8.0 lb-ft)
2) Horn Bolt	25 N.m (2.5 kgf-m, 18.0 lb-ft)
3) Radiator Bolts	10 N.m (1.0 kgf-m, 7.0 lb-ft)
4) Nuts, Radiator Bolts	12 N.m (1.2 kgf-m, 8.5 lb-ft)
5) Under Cowling Screws	10 N.m (1.0 kgf-m, 7.0 lb-ft)

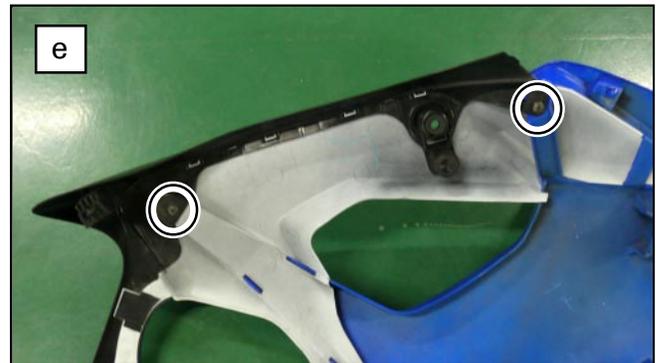
d) Replace the right and left Under Cowling Covers with the new parts supplied in the kit.

e) Install the flanged Under Cowling Spacers supplied in the kit onto the right and left Under Cowlings. The flanged spacers need to be installed from the frame side. Refer to the service manual and install the under cowlings and remaining parts in reverse order of removal. Refer to the torque chart on page 9 of this bulletin when tightening the under cowling screws.

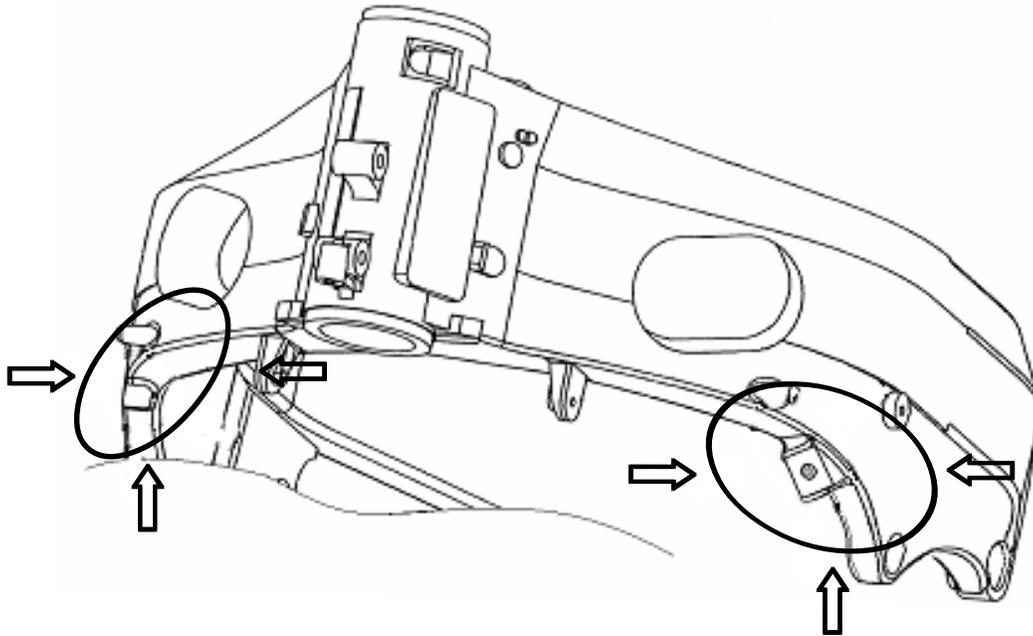
Your Suzuki dealer will inspect the relevant area of the frame for cracks. The illustration on page 2 shows the area to be examined for cracks. If no cracks are found, a frame reinforcement brace will be attached to the frame using bolts and epoxy adhesive. The brace is aluminum and very lightweight (less than 2 pounds). It is very slender and fits underneath the top spar of the frame behind and below the steering neck. The appearance, performance and handling of your Suzuki remain unchanged with the reinforcement brace installed.

Should cracks be found during the inspection, the frame will be replaced with a new frame that has the reinforcement brace installed (see exclusions at the bottom of this page).
