INSTRUCTIONS TO PERFORM CAMPAIGN 118

- Certain 2006/2007 Model 523J and 2008/2009/2010/2011 Model 524J Winnebago View® and Itasca Navion® motor homes equipped with standard dinette.

Install additional seat belt anchorage bolt(s).

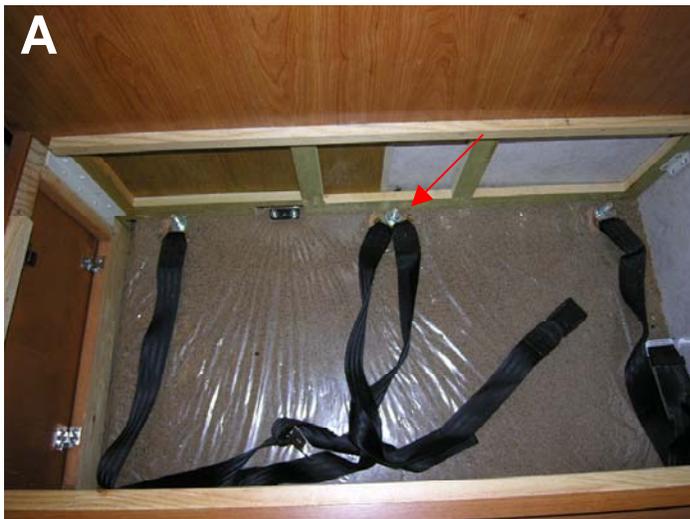
1. Extend left-hand slideout room.
2. Remove dinette seat cushions and bench board on forward facing dinette seat to access seat belt bolt assemblies.
3. Using a ¾" socket, remove the center nut from the bolt assembly, then remove outboard seat belt and lay aside. See Photo A.

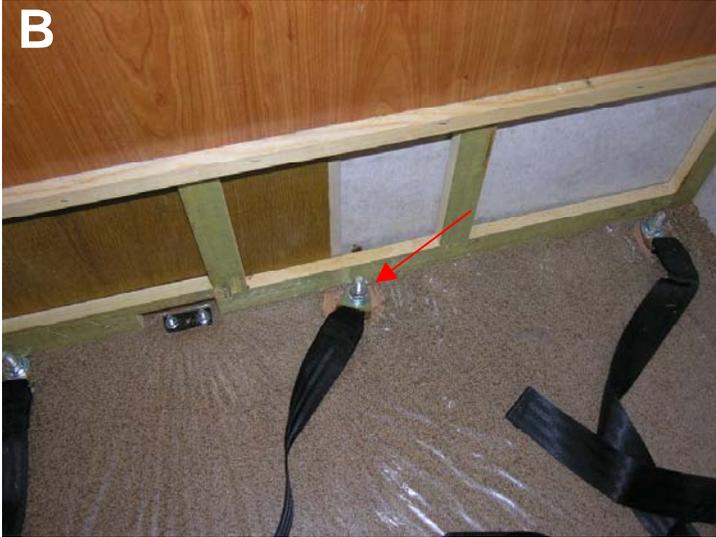
4. Install nut (from the kit) onto the center seat belt bolt assembly. Finger-start nut and tighten with $\frac{3}{4}$ " socket until fully seated. See Photo B.

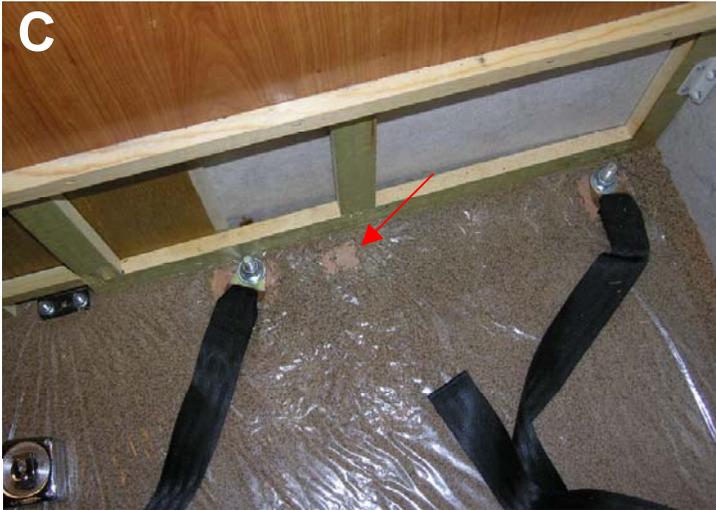
5. Using a blade knife, cut out a 2" x 2" section of carpet, centered 4" outboard from the center seat belt bolt assembly. See Photo C.

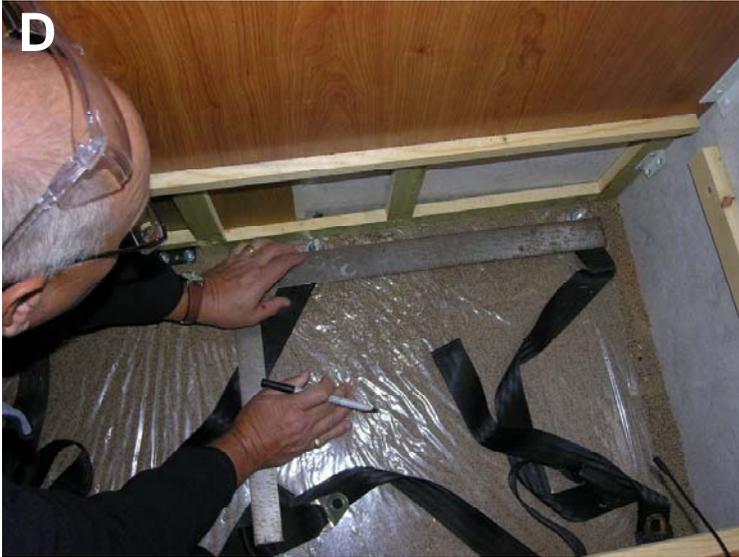
6. Place a straight-edge along front edge of seat belt bolts and using a writing utensil, draw a straight line over carpet cut-out. See Photo D.

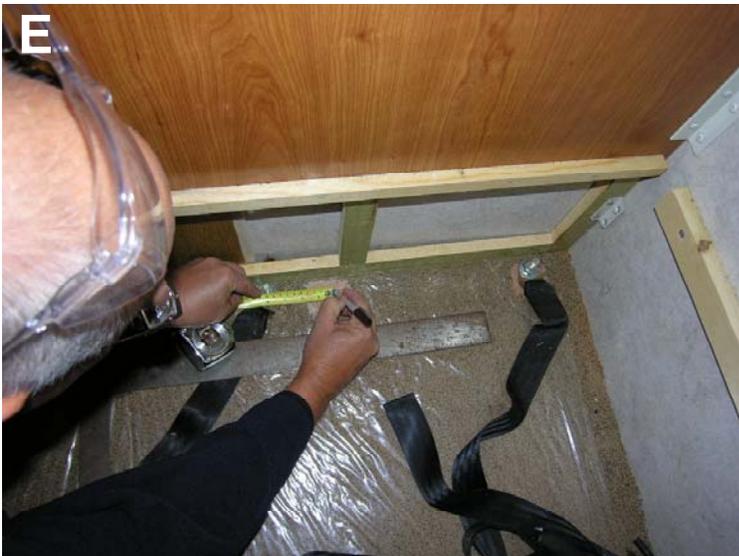
7. Mark location on floor 4" outboard from existing center seat belt bolt assembly, keeping it in line with existing bolts. Mark location point $\frac{1}{4}$ " rearward from line, thereby ensuring the hole to be drilled will be directly in line with the existing seat belt anchorage bolt holes. See Photo E.

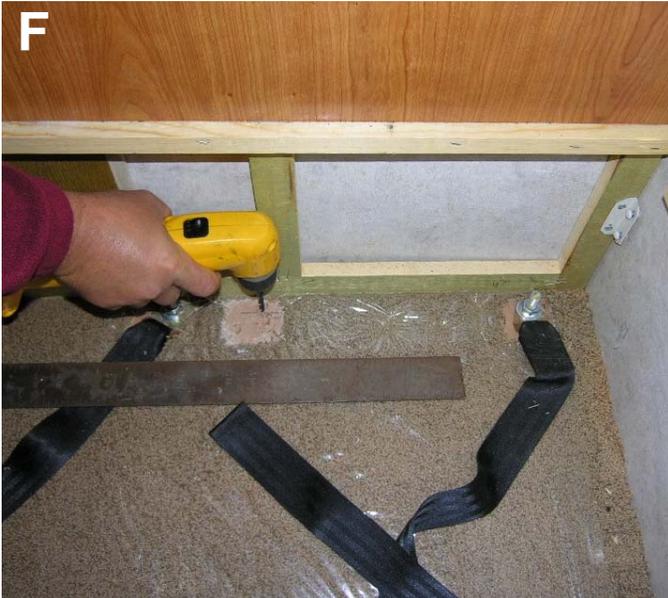
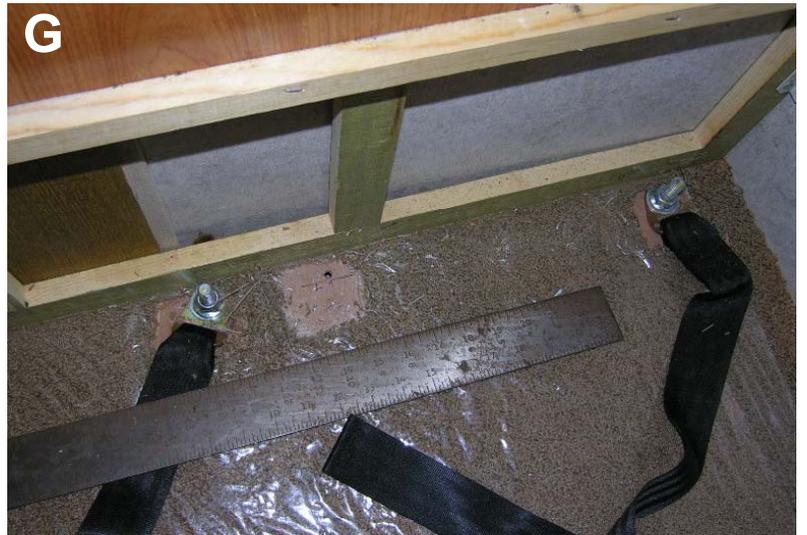
8. Using a drill or screw gun and 1/4" drill bit, place vertically on previously marked location (4" outboard from center seatbelt bolt assembly) and drill hole through slideout room floor. See Photos F and G.

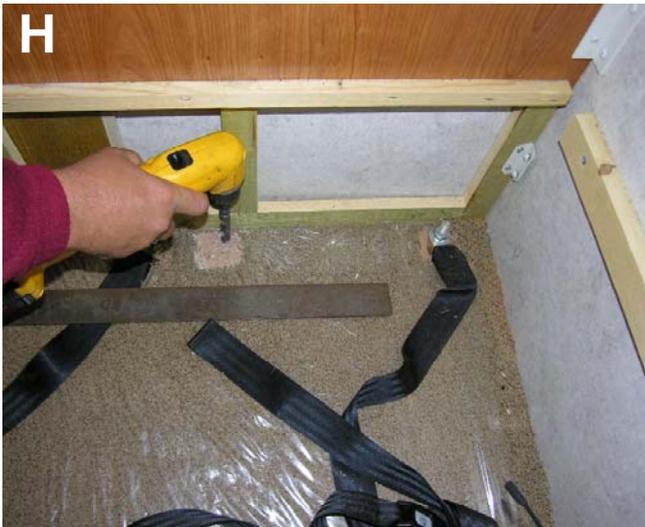
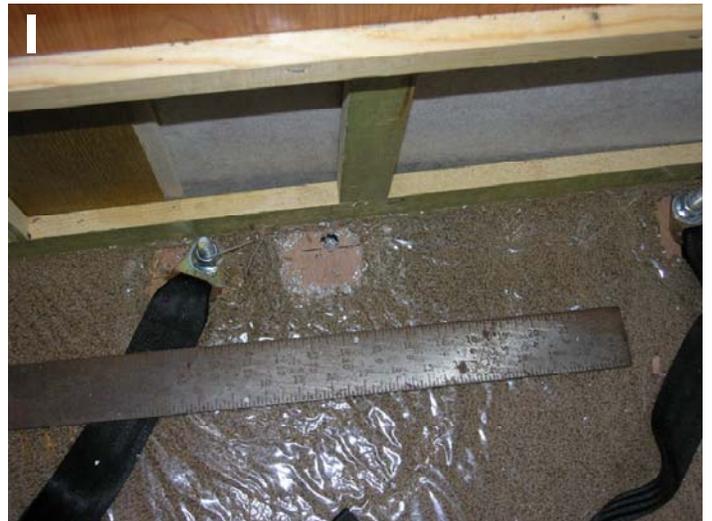
9. Using a drill or screw gun and 5/8" drill bit, place vertically on previously drilled hole and drill larger hole through slideout room floor. See Photos H and I.

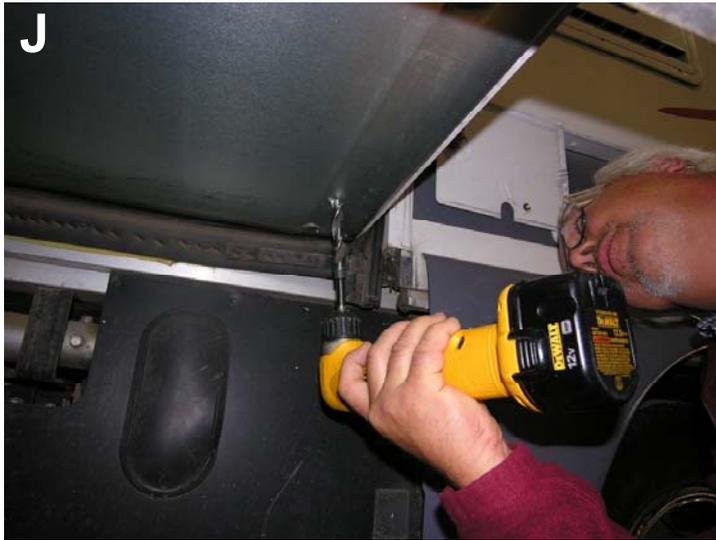
10. It may be necessary to finish drilling the 5/8" hole from the underside of the slideout room. See Photo J.

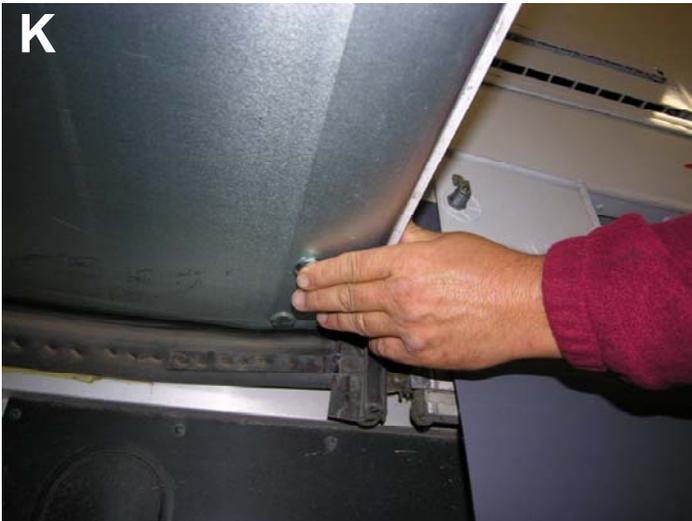
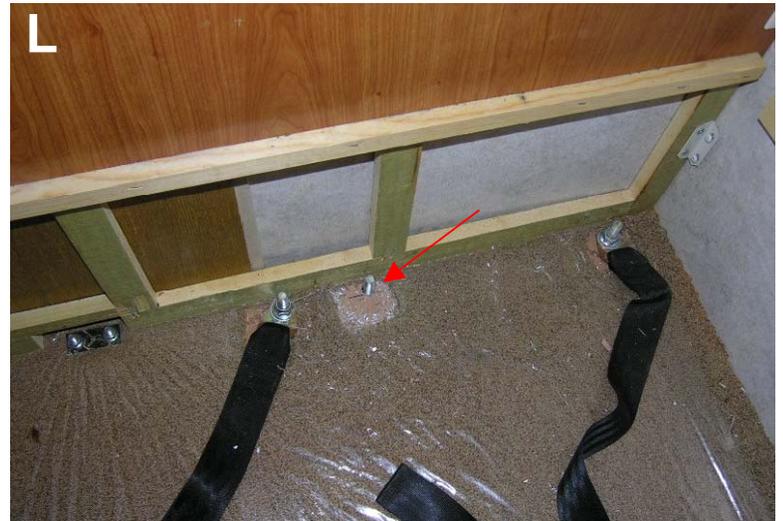
11. Have an assistant insert and hold carriage bolt (from the kit) up through the previously drilled hole underneath the slideout room, ensuring it is accessible from inside the coach. See Photos K and L.

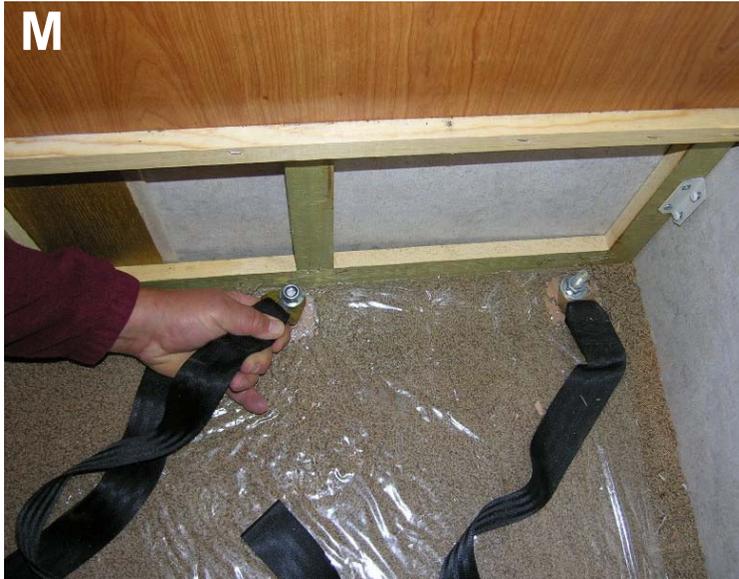
12. Install outboard seat belt (that was previously set aside in Step 3) to the newly installed carriage bolt. Finger-start nut (from the kit) onto the carriage bolt. See Photo M.

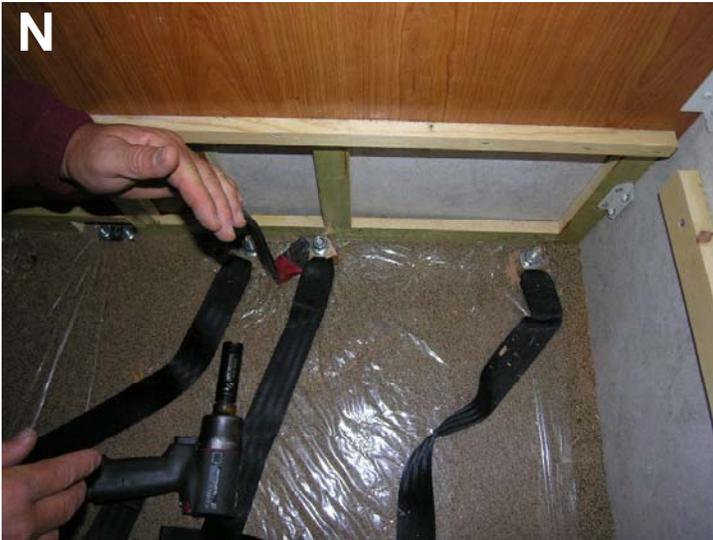
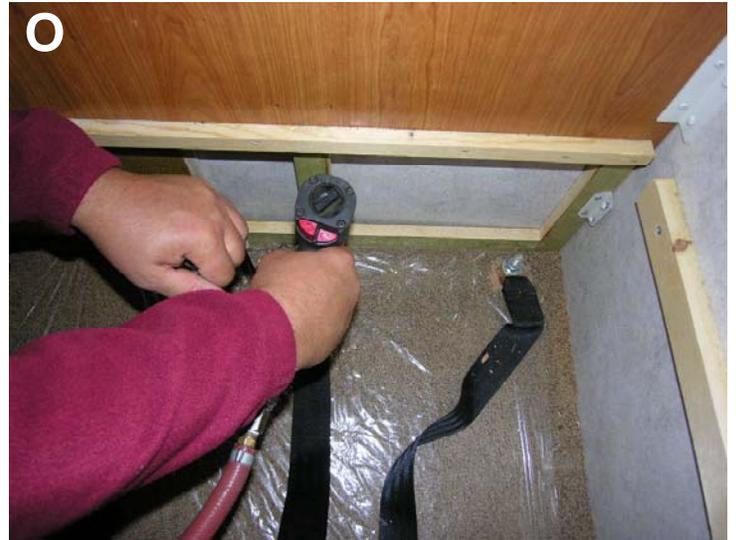
13. Using a pry bar, lift up on new seat belt bolt assembly to hold snug. Tighten with $\frac{3}{4}$ " socket until fully seated. See Photos N and O.

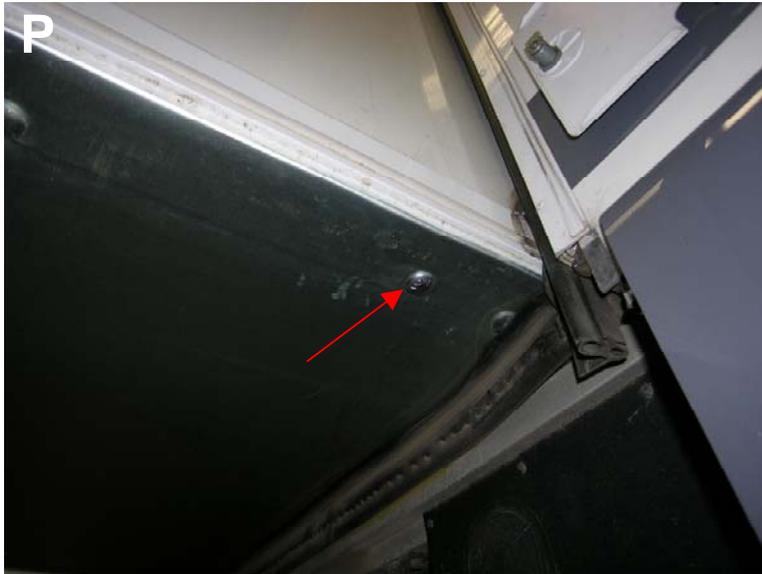
14. Check the underside of the slideout room floor and ensure the carriage bolt has drawn snug to the floor, eliminating the possibility of interference when the slideout room is retracted. See Photo P.

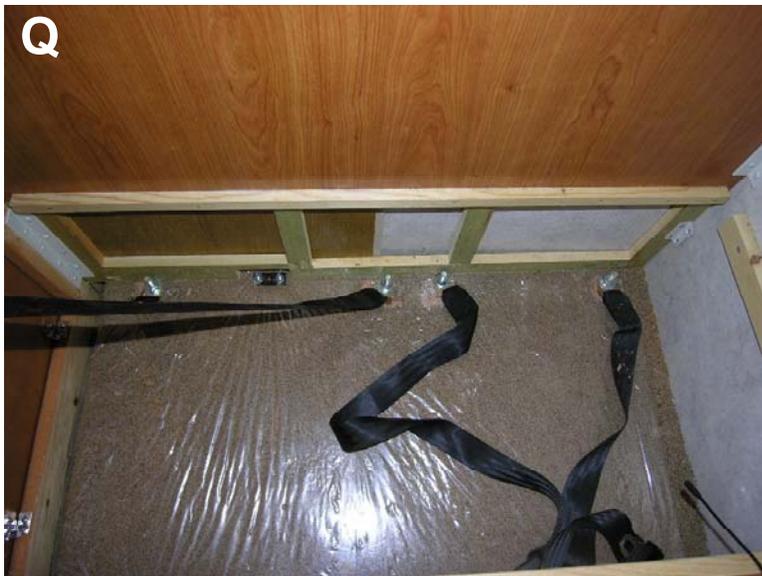
15. Installation complete. See Photo Q.

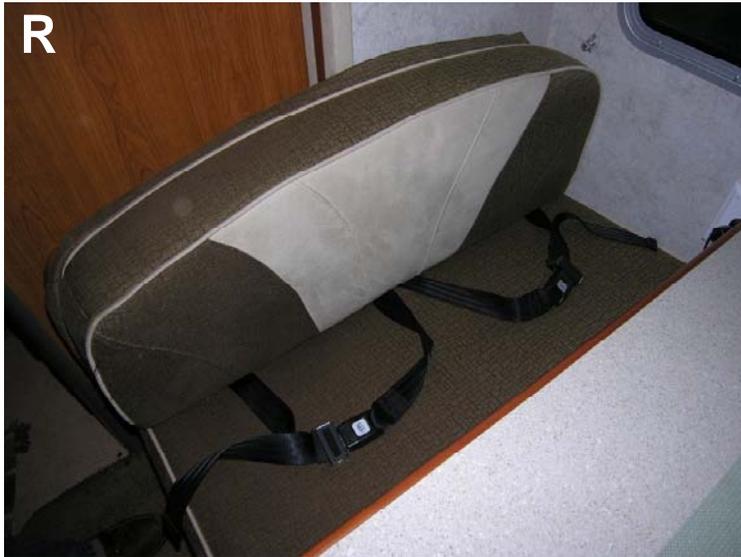
16. Reinstall dinette bench board and cushions, ensuring seat belts are accessible and ready for use. See Photo R.
