IDENTIFICATION OF DEFECTIVE CONTROL ARM ASSEMBLIES

MOOG® Brand Control Arm Assembly Recall: K7425 & K7427

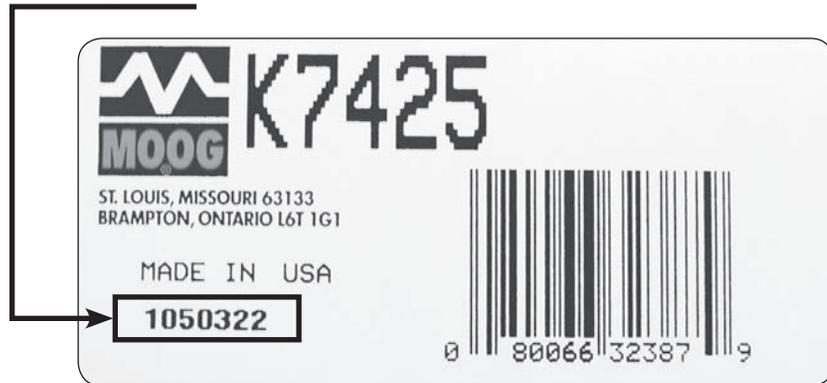
Figure 1

Figure 1: Date Code on the Control Arm Assembly package (see page 2, column 5, for the affected date codes)

NOTE: If a GREEN DOT is present on the package (the green dot will be located left of the part number label), the part is good.
If no green dot is present, check the packaging date code.

ACTION REQUIRED: If you find defective product in your stock, please **quarantine** those control arm assemblies and return per the instructions in the accompanying letter.

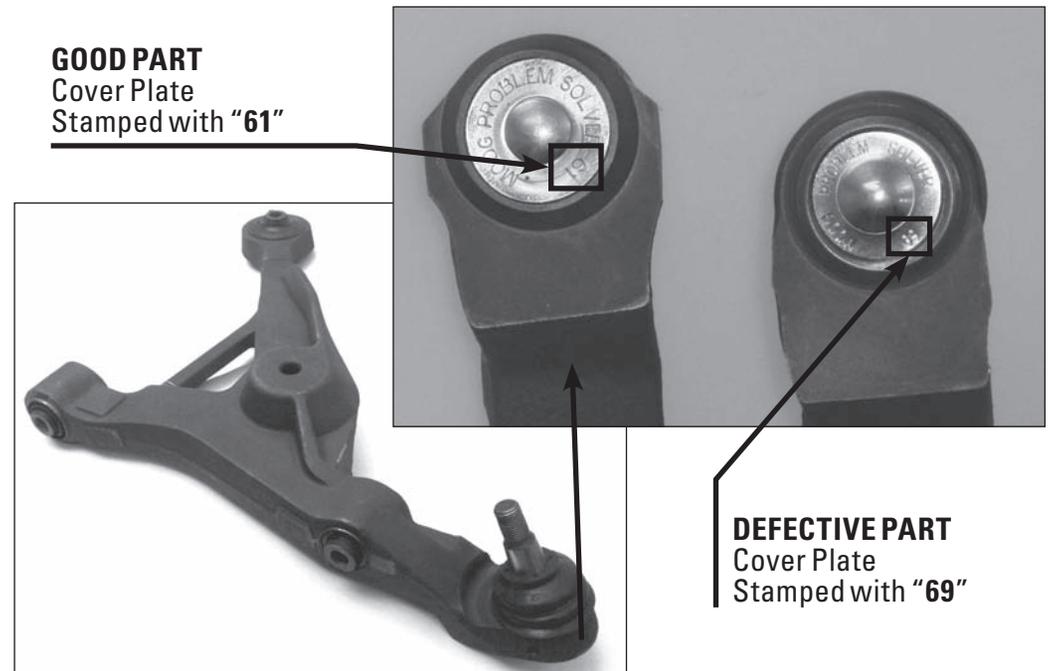
Figure 2

Figure 2: Numerical Stamp on the Control Arm Assembly's ball joint cover plate (see page 2, column 6, for the affected numerical stamp)
