Department	Customer Service		
Category	Product Recall		
Title	Battery Box Mtd. Circuit Breaker		
Number	03KW7		
Initial Release Date	09/03/03		Page 1 of 2
Revision Date

FEDERAL RECALL CAMPAIGN 03KW7

T600, T800 AND W900 MODELS BUILT AT THE CHILlicothe FACTORY JULY 1, 2002 THROUGH JULY 28, 2003 WITH AN OPTIONAL BATTERY-MOUNTED 50 AMP AND/OR 60 AMP CIRCUIT BREAKER

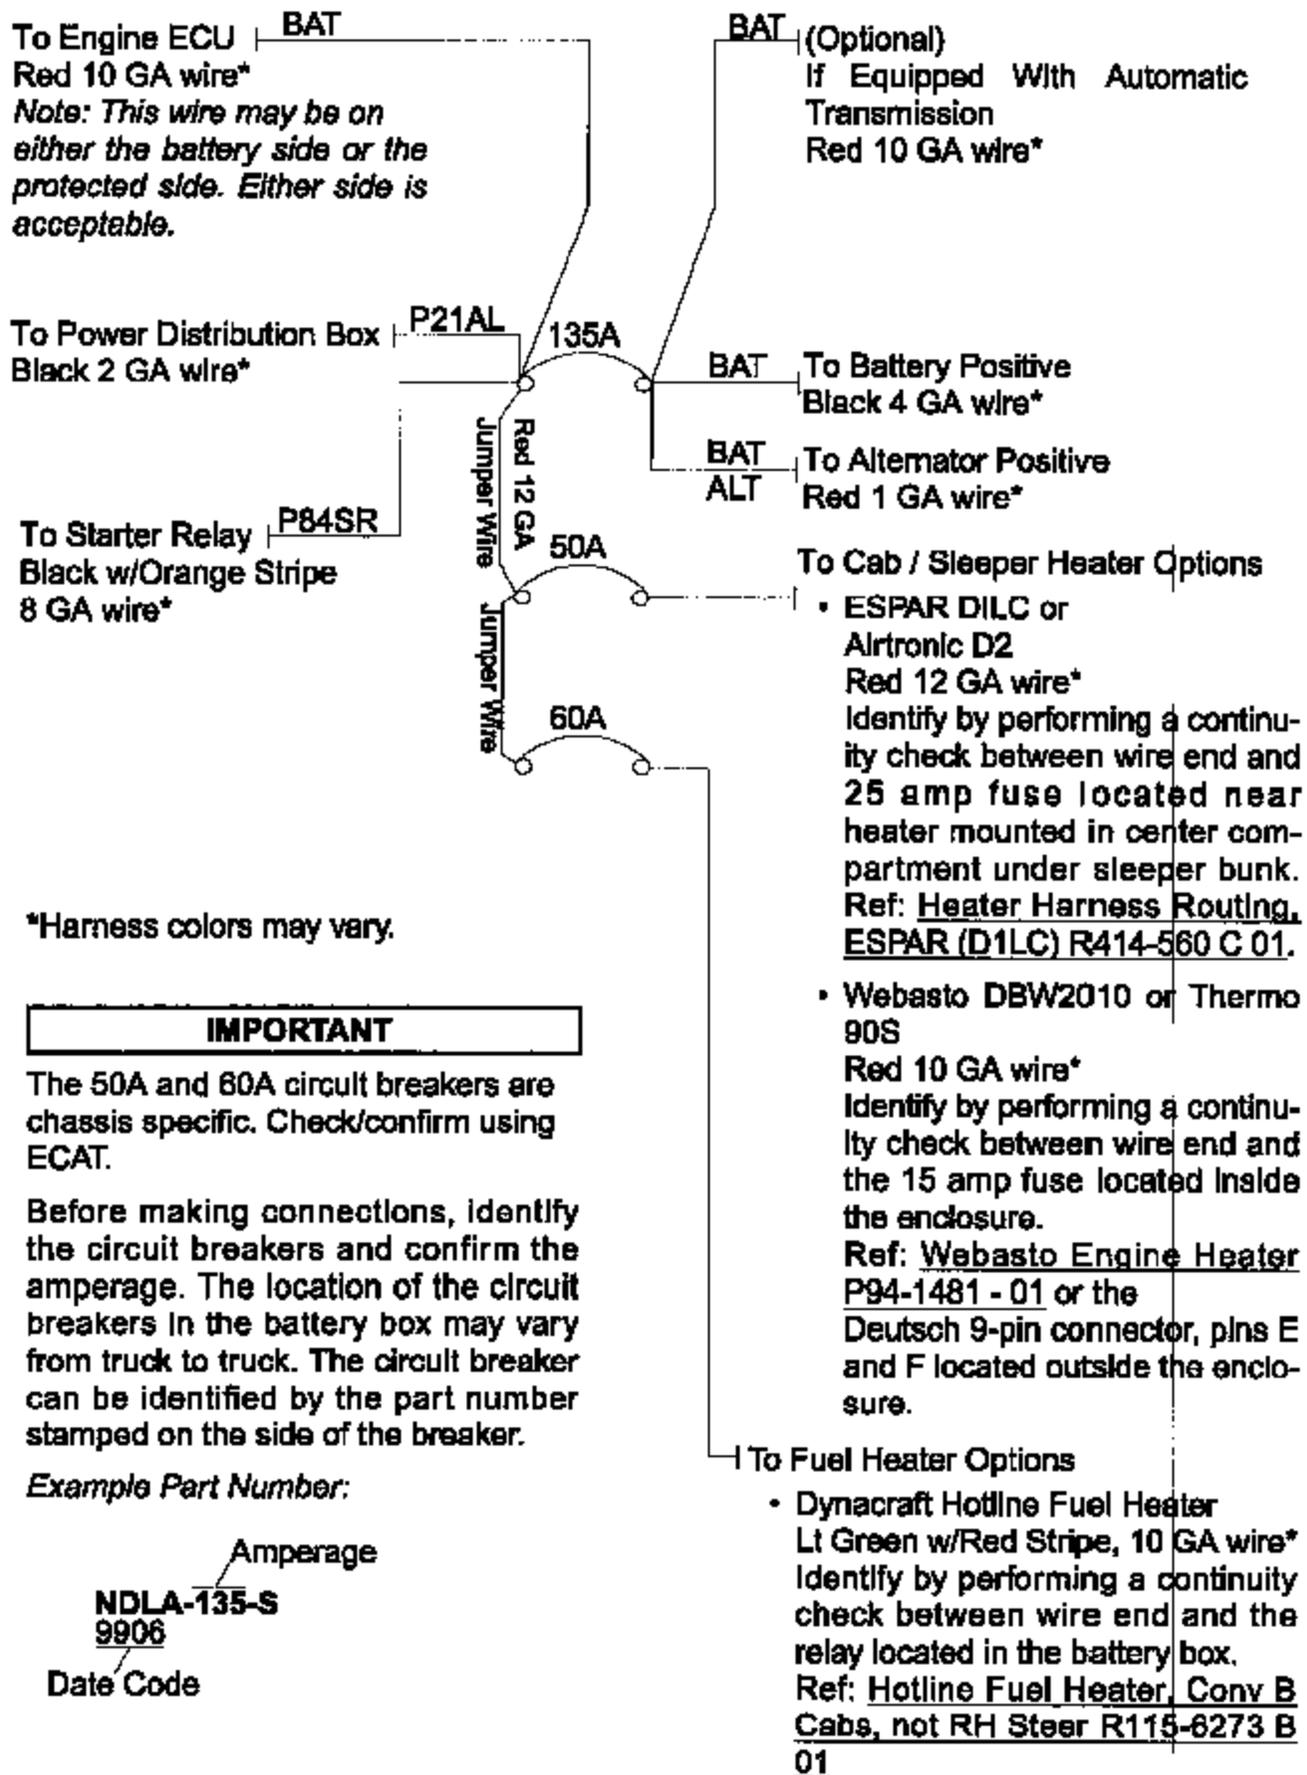
Electrical Schematic For Battery Box Mounted Circuit Breaker

During the referenced time period and on vehicles built with these optional circuit breaker(s), the three main power circuits (cab/PD box, engine ECU and starter relay) were incorrectly connected to the smaller amperage circuit breaker instead to the correct 135 amp breaker. If enough accessories are being used simultaneously during operation of these vehicles, this error in wiring can cause the cab power and engine to shut down prematurely without warning which could result in loss of vehicle control and cause a crash.

Kenworth has initiated a recall to inspect and correct the battery box circuit breaker wiring, if necessary. Refer to "Electrical Schematic For Battery Box Mounted Circuit Breaker" on page 2 and ensure that chassis wiring matches this schematic.
